KEEL CRACK REPAIR

## Smiles All Around

<b>Catalina Yachts</b> 21200 VICTORY BLVD. WOODLAND HILLS, CA. 91367 - (818) 884-7700		
SCALE: NONE	APPROVED BY:	DRAWN BY: K.W.N.
DATE: 4/12/05		REVISED
<b>LEAKY KEEL BOLT REPAIR</b>		
BOAT: TYPICAL		DRAWING NUMBER CTY-20050-1

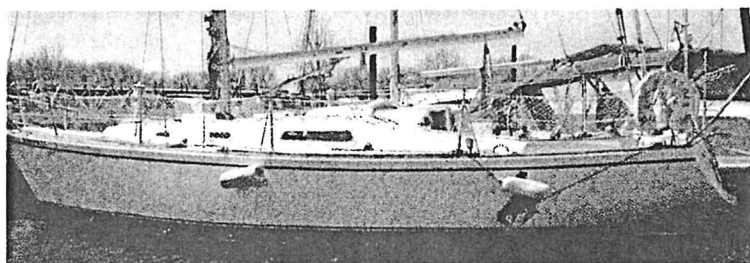
*Rough Rider, one of many boats successfully repaired*

In the years since G/flex was introduced, we have had many customers (and employees) inquire about using it in this application. Year after year we recommend it, and year after year more sailboats are repaired like this. Several customers have used our method and been happy with the results. None of these repairs have had to be redone.

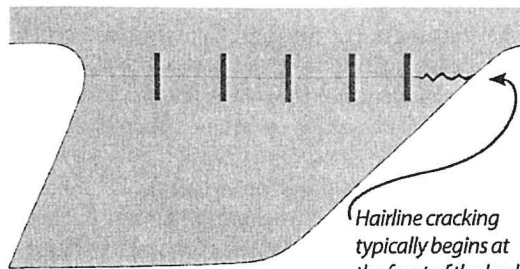
Many people try to fix this crack by fiberglassing over it, and it seems to work well... for about a year. After a fairly short amount of time, the crack comes back because there is so much flexing that the repair laminate cracks and breaks. Instead, this repair should be done with a structural, yet flexible, epoxy: G/flex 655 Thickened Epoxy Adhesive.

*Hairline cracking typically begins at the front of the keel.*

Open up the joint a bit with a Dremel tool or metal cutting saw blade to expose bright metal and fiberglass laminate. Once the crack is cleaned and widened, bevel the opening generously into the surrounding fairing putty to provide a gentle transition. Dispense G/flex 655 Resin and Hardener in equal amounts on a plastic sheet (or 1.2:1 by weight) and mix by folding it over itself. Begin applying it into the crack then follow up by filling the trough formed by the shallow bevel on both sides of the crack. The pot life of G/flex is 45 minutes, so unless a huge batch is mixed, there should be enough time to dispense it, although mixing multiple batches would give even more time. G/flex 655 has 32% elongation before breaking, which helps to prevent cracks from reappearing in the joint. It can then be wet-sanded, dried and painted for a lasting repair.
