## Catalina 30 Aqua Lift Muffler Repair

Mark Hamilton, S/V *Freedom*; 1980 C-30, Hull #1776; mhamilton64@hotmail.com

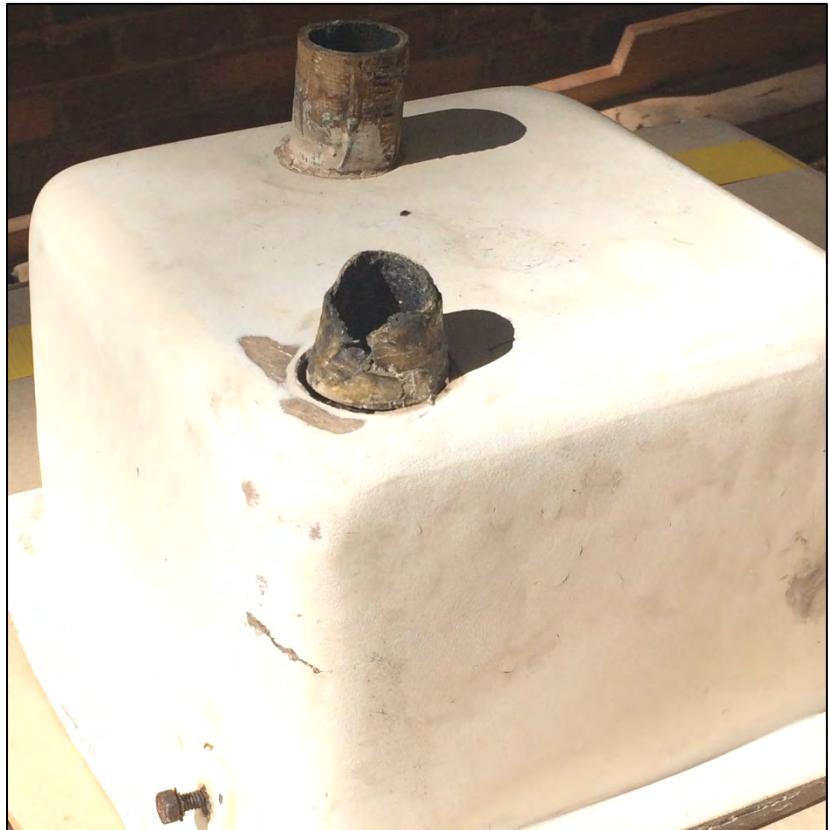
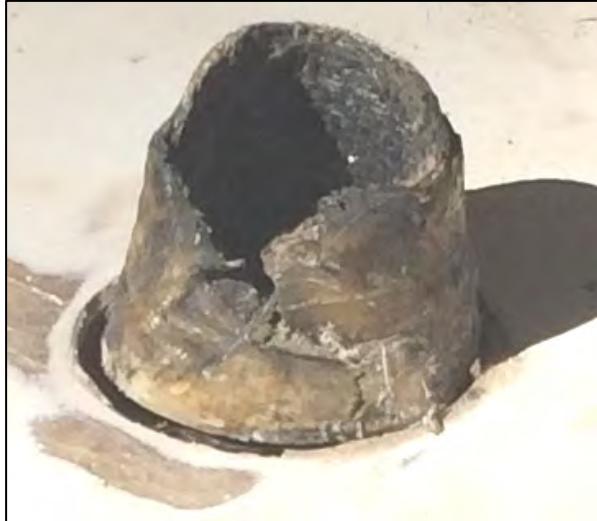
As with most mufflers that fail, according to the posts and messages I have read, the muffler failed at the inlet tube, likely due to vibration caused by the exhaust from my Atomic 4. The neck on the tube was crushed by attempts to tighten the hose clamp holding the exhaust onto the inlet tube. After checking the price for a new muffler at \$375 or so from Catalina Direct, I decided to see how well I could do at repairing it myself, before shelling out the extra money for a new one.

This is the muffler after being removed from the boat and brought to the house for inspection and repair.

Note: I had already cut off the inlet tube prior to this shot and just set it back in place to show how it was crushed. There was simply no material remaining to support the exhaust connection from the motor.

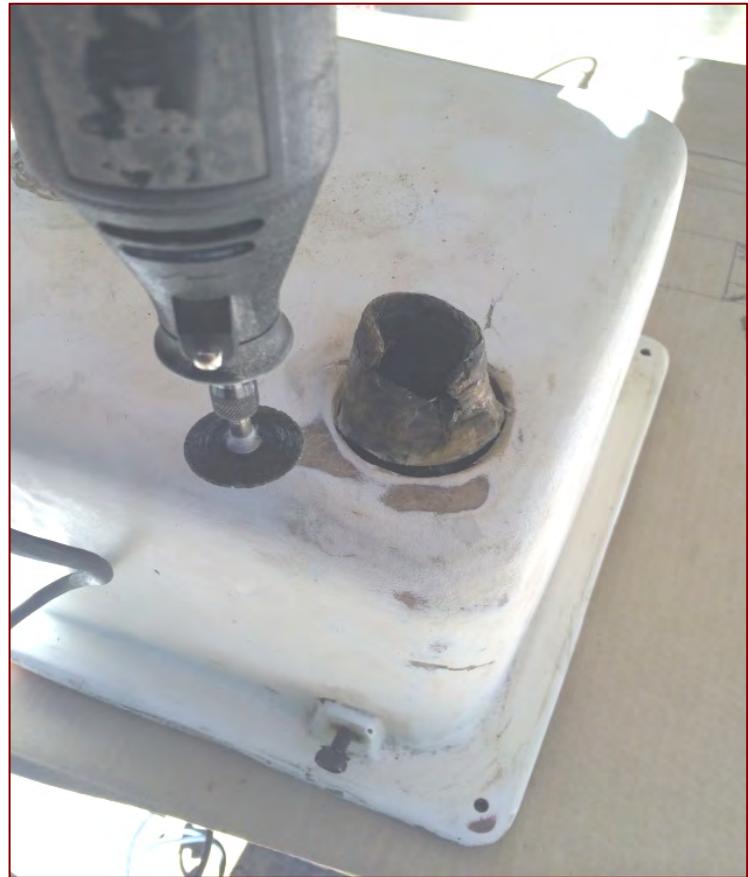
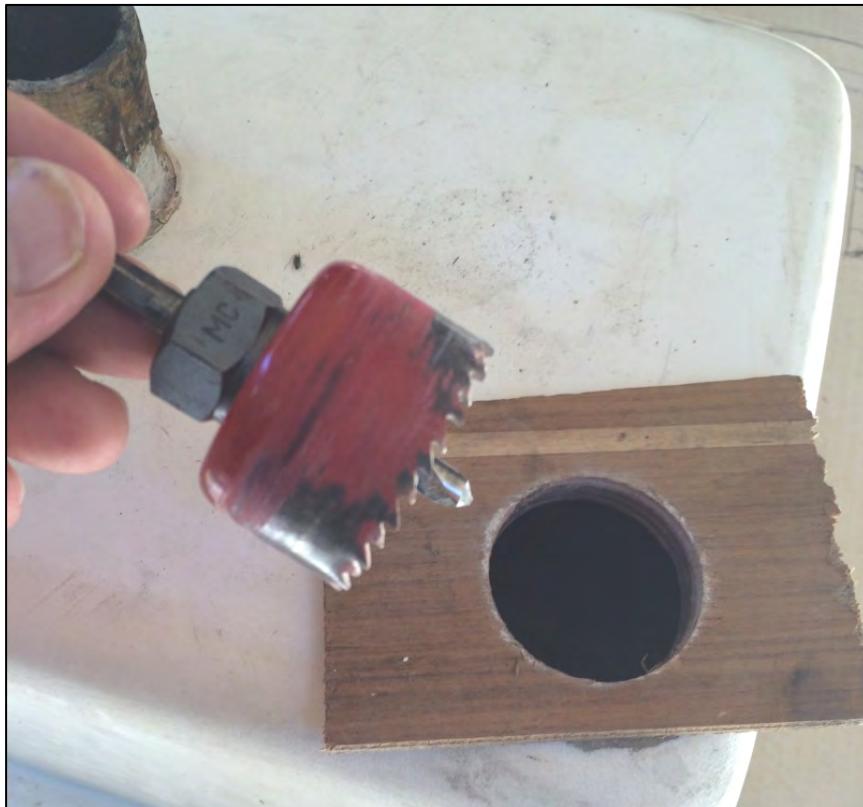
Cut off the inlet tube from the top of the muffler with a Dremel Tool and a cut-off wheel. This leaves about a 2" tube protruding into the muffler. To remove that, I used a hole-saw.

To get a clean hole, I made a template by cutting a hole in a piece of scrap wood and then clamped it over the hole in the muffler. This gave me a guide for the hole-saw. I took this picture after the cut was made, so the template hole and the hole in the muffler are now exactly the same size. Before the cut, you could see the tube protruding down into the muffler and about  $\frac{1}{4}$ " of fiberglass material around the hole. That all came out with the hole-saw cut.

Once I had the muffler on the bench, I cut off the crushed inlet and then used a hole-saw to enlarge the hole from the outside and pull out the 2-inches or so of inlet drop tube that was inside the muffler.

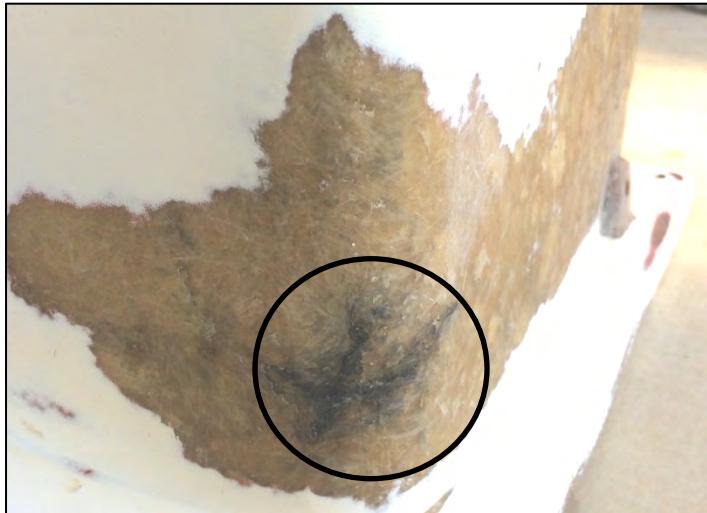
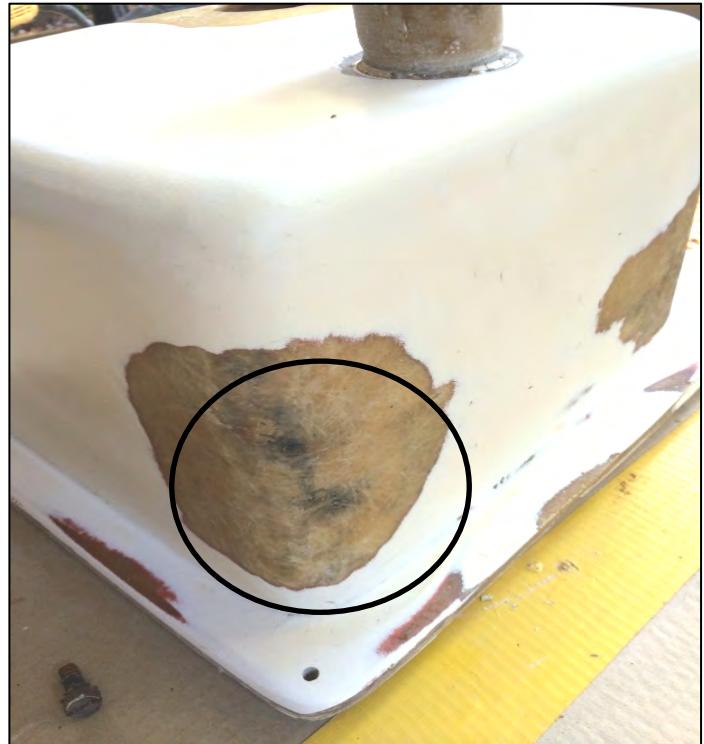
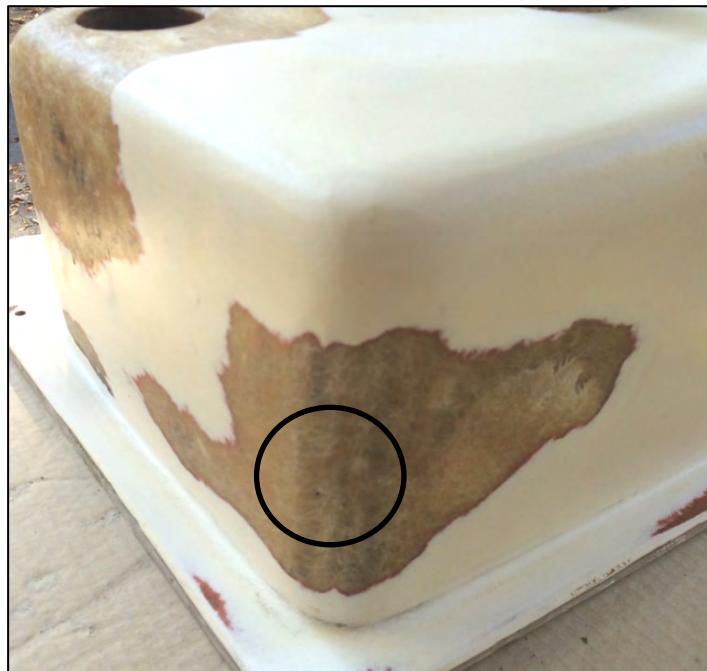
Once the old inlet tube was removed, I had a pretty clean piece ready to be repaired. Then I decided to start looking a bit closer. On inspection of the corners of the muffler, I found some dark lines that looked like cracking beneath the gel coat. These turned out to be structural cracks in the muffler that were likely seeping water a bit. I never noticed this with the muffler in the boat, but decided that they needed to be addressed. So I started sanding off gel coat anywhere that I suspected there might be cracking. And I found cracking on three of the four corners.

Here are the pics of 3 of the 4 corners with either cracking just below the outer layer of glass, or pitting in the glass. After some research on this, I found that this is common in any molded fiberglass production. Rounded corners are usually pretty difficult to lay-up in a mold, resulting in trapped air, which over time will result in cracking like this.

To repair these areas, I first used a Dremel tool and a small grinding wheel to cut out the bad material. Then I filled the holes with Structural Fiberglass filler from West Marine. This is pretty stout stuff, perfect for these repairs where the back side of the repair is not accessible. The material is Polyester filler with long strands of fiberglass mixed in. Wear a respirator and do this in a well-ventilated area. This product rates a 10 on the organic fumes scale.

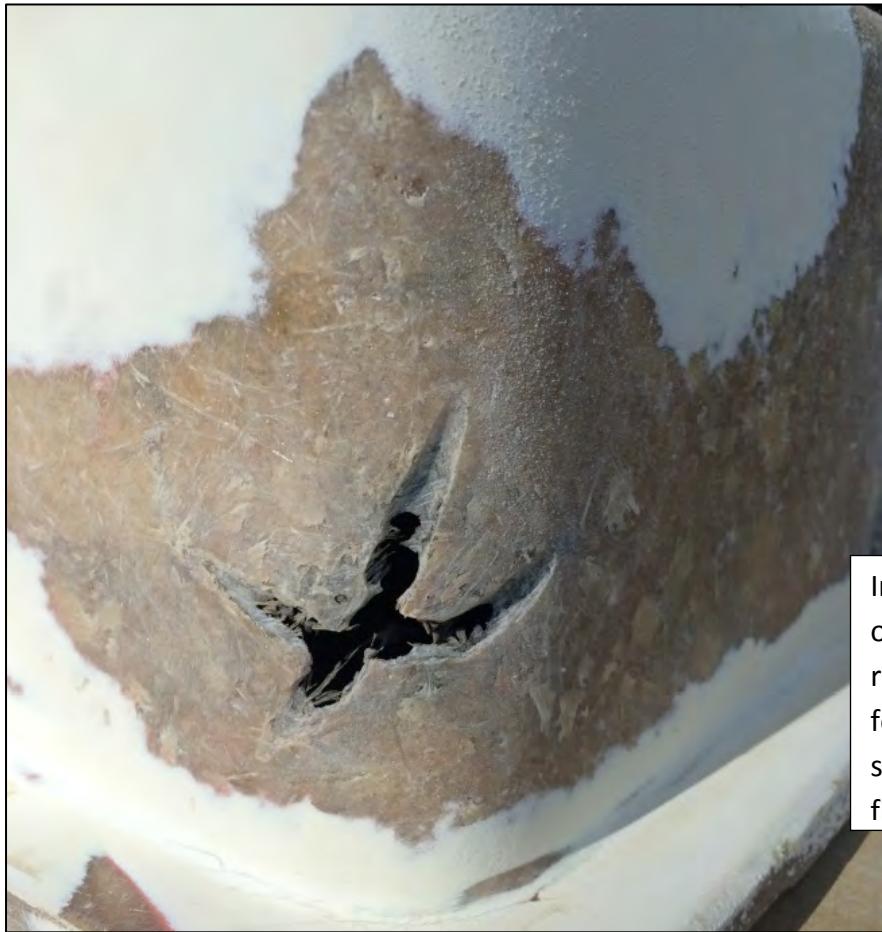
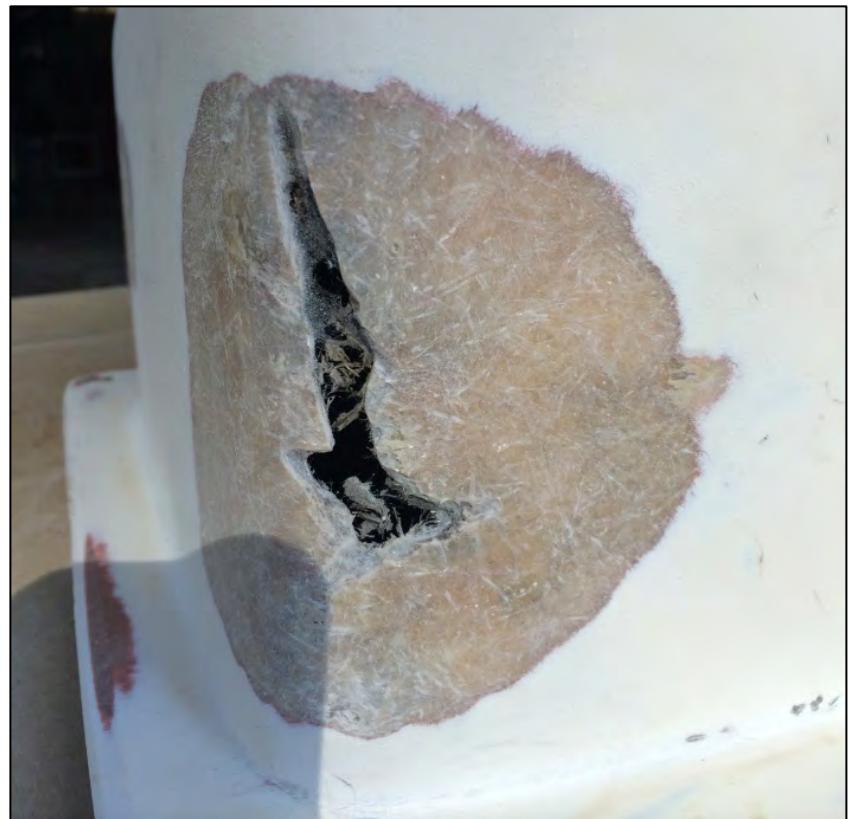
In cutting this out, I was careful to cut out only the damaged material, which was rather easy as it was really rotten. Then I feathered the edges to create as much surface area as I could for the structural filler to bond to the good fiberglass.

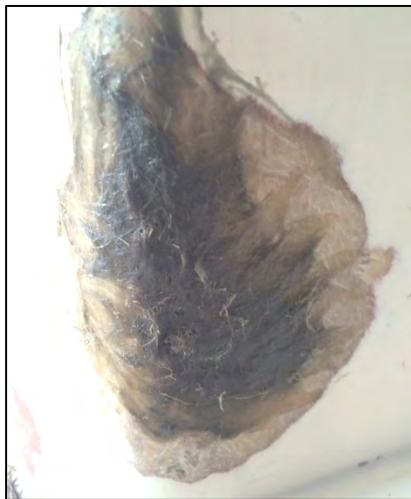
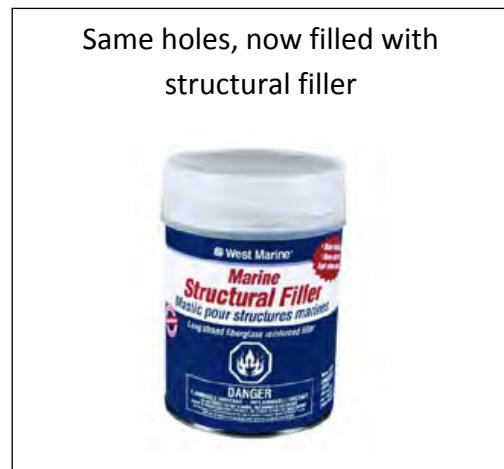
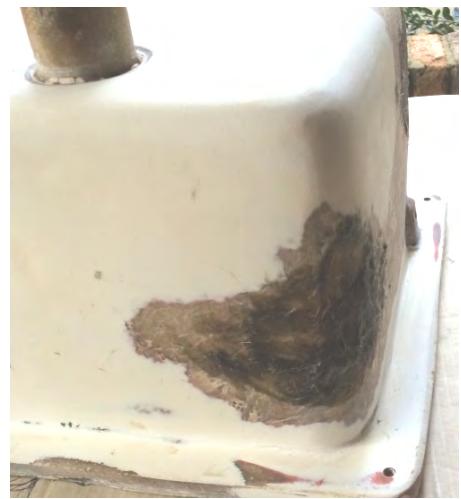
Once these holes were sanded out, I laid up two layers of fiberglass cloth and epoxy over them to provide some additional strength to the corners then sanded the whole thing down. Here are the finished repairs on these areas.

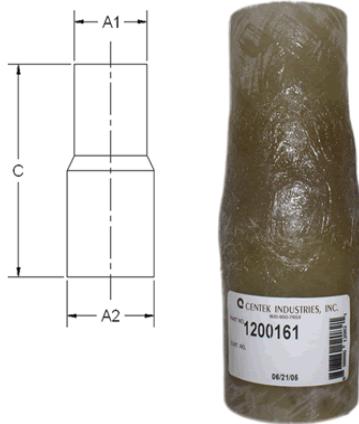
REDUCER COUPLING					
A1	A2		C		
NOM. O.D.	NOM. O.D.		LENGTH		
INCHES	MM	INCHES	MM	INCHES	MM
1.50	38	1.75	44	6.00	152

This seemed to be the same design and material as the tube that I cut out of the muffler. Centex part Number 1200435.  
This is a 38mm to 44mm reducer

Now time to replace the inlet tube, which started the whole project. I found a new 6" tube manufactured by Centex. I found the tube online and ordered through the nearest marine distributor listed on their site. The tubes are cheap...like \$12.95. My marine supply shipped me two, just because they felt bad about the shipping. Total for the 2 tubes and shipping was about \$50.

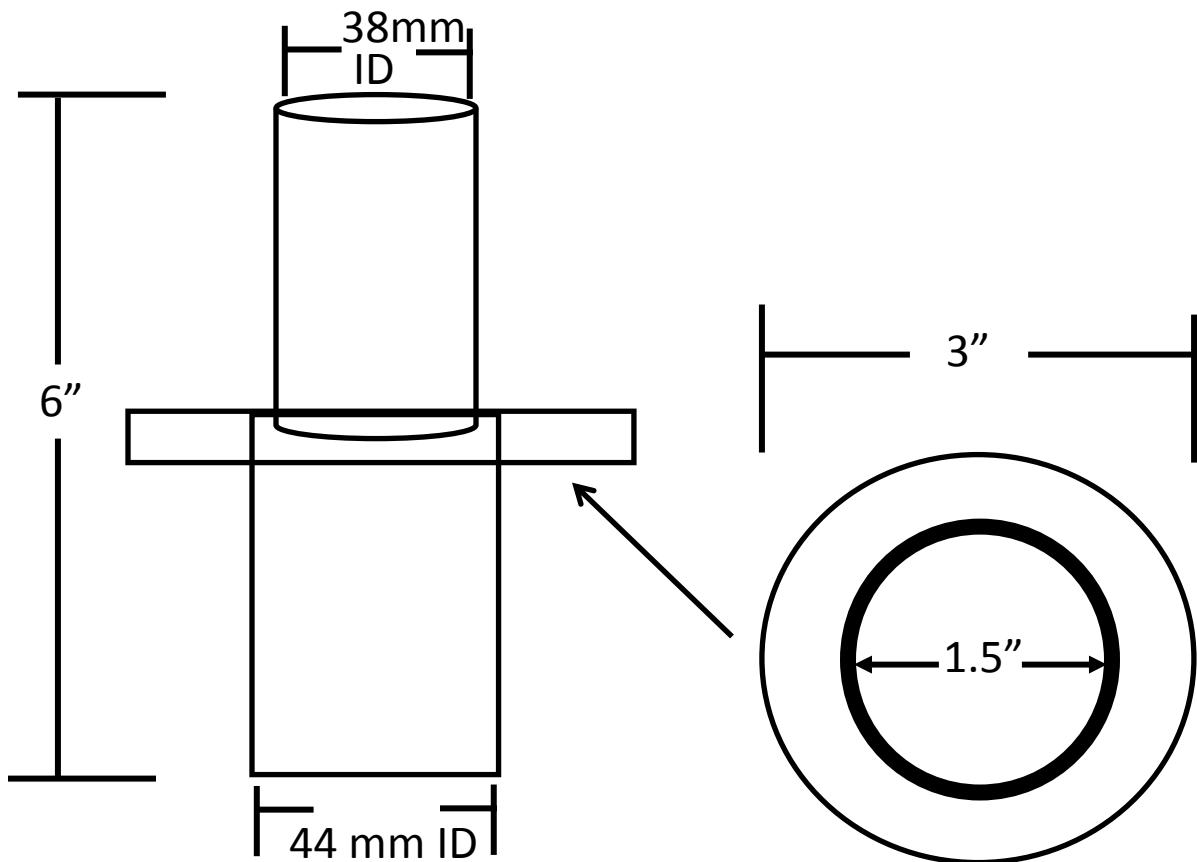
Now I have the part and needed to figure out how to attach it to the muffler from the outside. The key is to attach enough surface area to the muffler so that the attach point is strong and durable enough to withstand the constant vibration from the engine and exhaust connection. Here is my design.

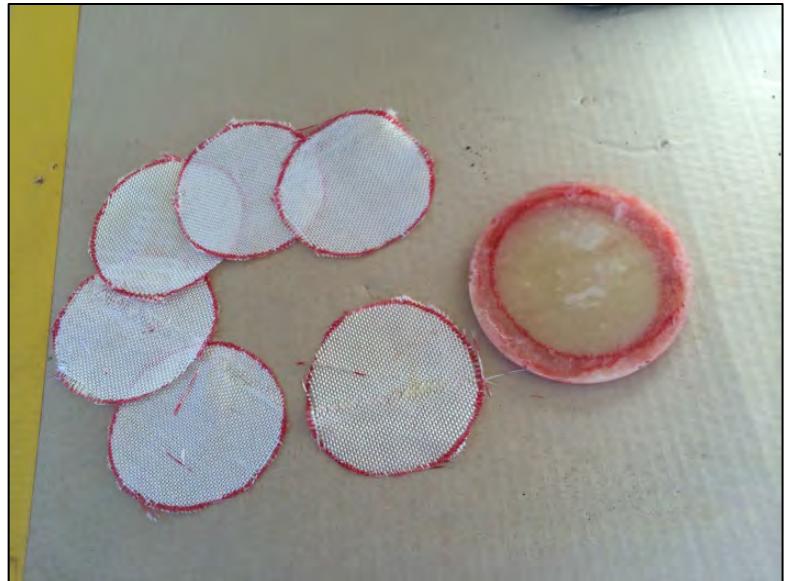
Here is how I constructed the flanged inlet tube. First I made the flange out of about 5 layers of fiberglass cloth (cut into a circle) and resin. I used the top to the West Marine marine filler as my mold and just laid-up the fiberglass in that. It ended up being a bit bigger than 3", but I figured if there were more surface area on the flange then it would add more strength to the joint.

Here is a picture of the fiberglass cloth and the molded flange. I used some of these same circles to patch and reinforce the corners of the muffler.

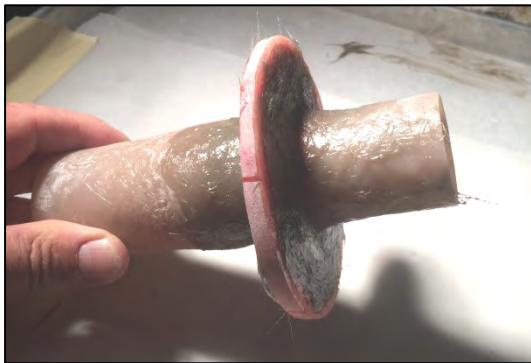
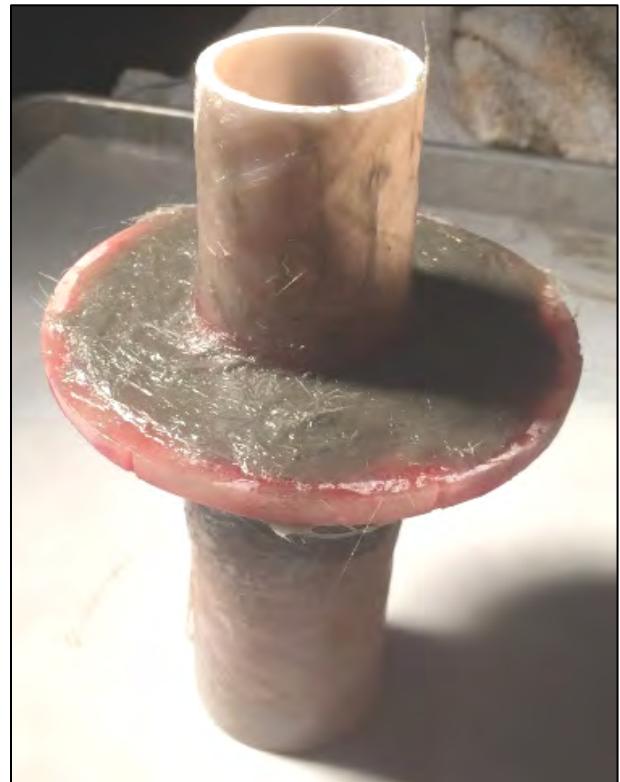
After the flange was complete, I cut out a 1.5" hole in it and slipped it over the new inlet tube. I glassed these together using first the polyester filler and then finished it with a small amount of thickened epoxy. Here are a couple of pictures of the results.

Now that I had my new tube completed, it was time to attach it to the muffler. I accomplished this using thickened epoxy. I used West System epoxy and thickened with colloidal silica. I mixed this to the consistency of peanut butter, coated the bottom of the flange liberally and then pressed it into the hole on the muffler, making certain to align the new inlet so that it was as perpendicular as possible to the muffler top.

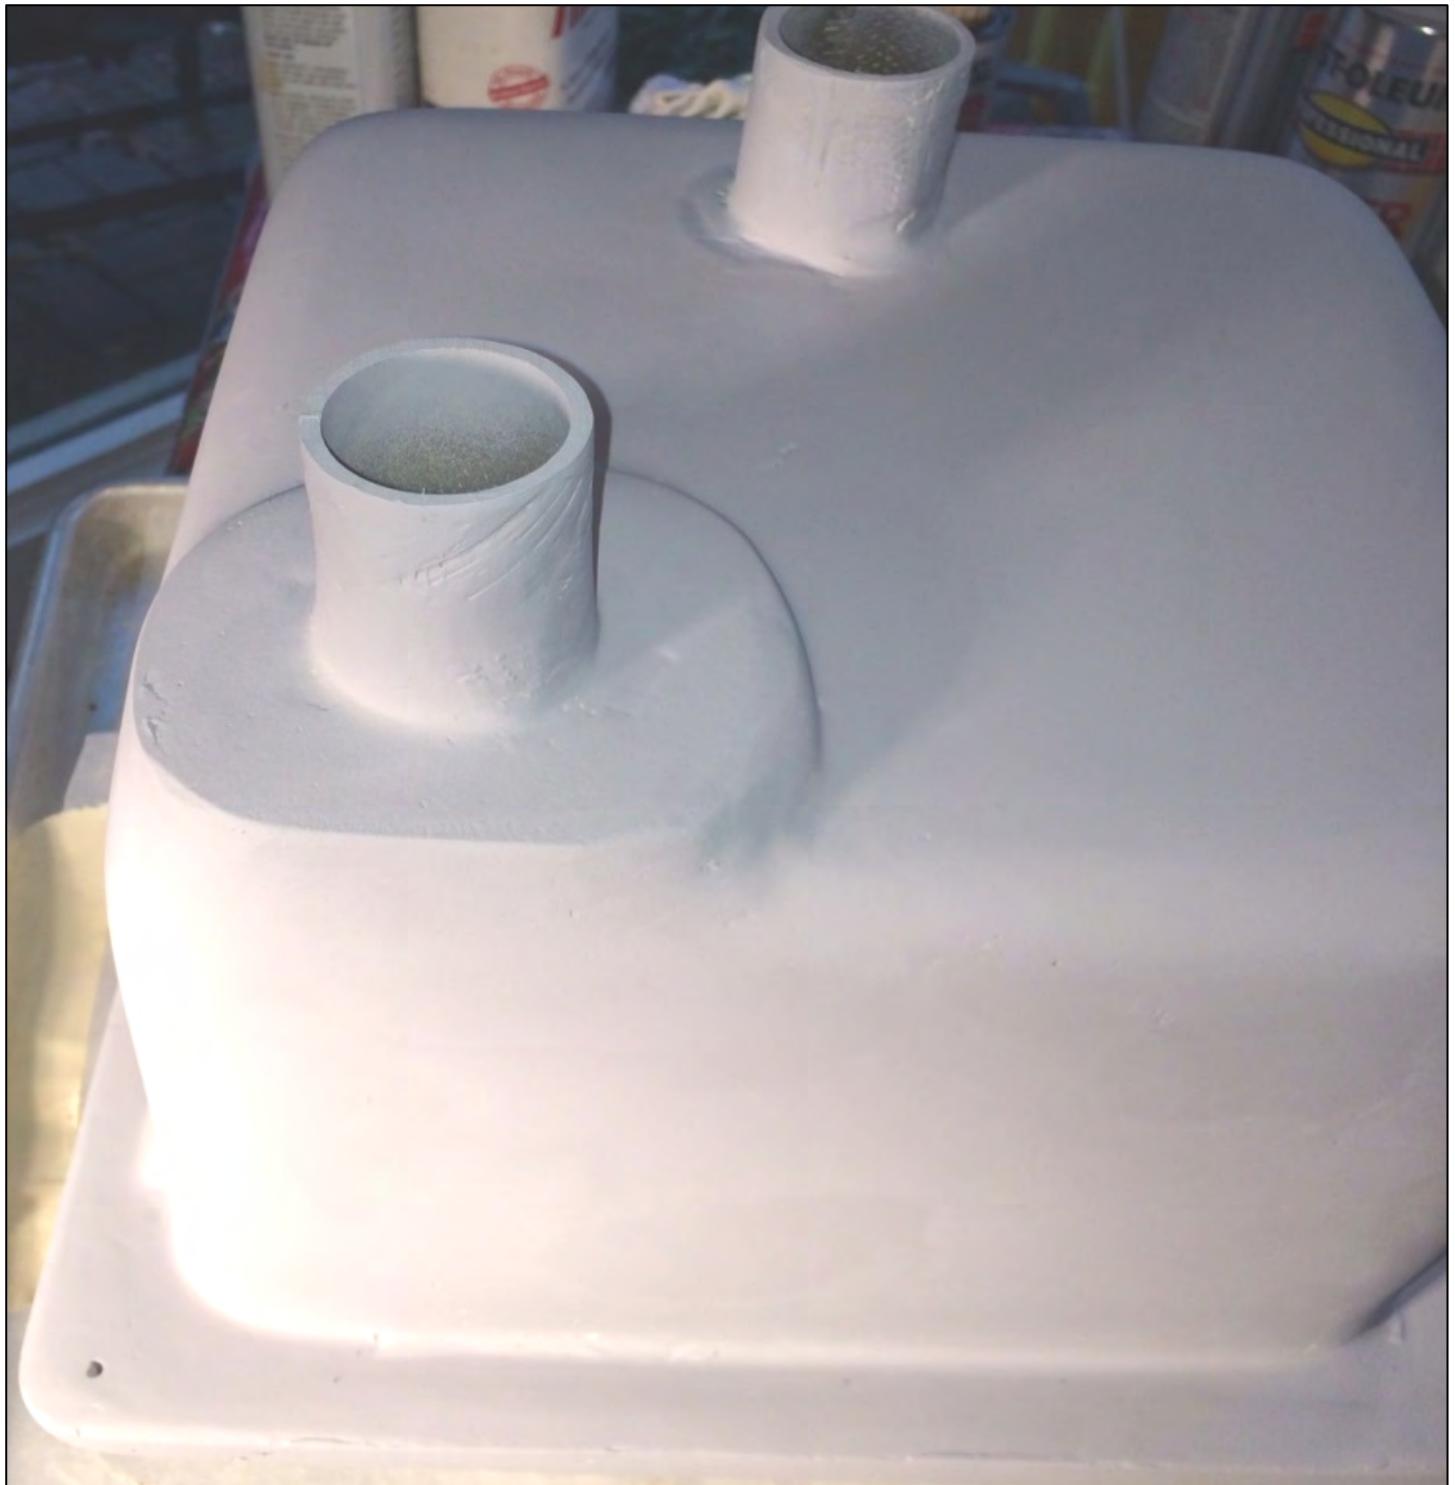
Once the new tube was attached to the muffler, I filled any gaps between the flange and the muffler with polyester body filler (Bondo), shaped the flange that hung over the side of the muffler with an angle grinder and a 80 grit flap disk, then sanded the whole part from 80 grit to 220 grit and then primed with Rustoleum Primer. Not my first choice, but considering weather (getting cold) and the ultimate location of this piece (in the bilge) I decided to use something quick and easy. Below is a shot of the primed muffler ready for a final sanding and paint.

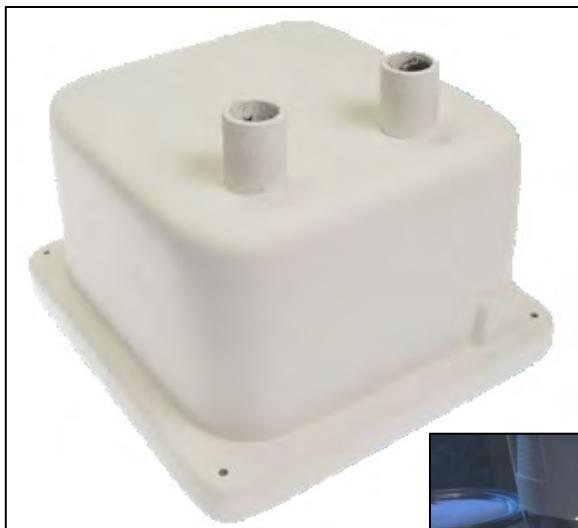
Aqua Lift Replacement Muffler - \$375

Here is a comparison of what I did to the new Aqua Lift from Catalina Direct. I spent a total of about \$100, considering materials that I used from what I had on hand plus the purchase of the new inlet tube. The Catalina Direct replacement is \$375. Proof will be in the permanence and performance of the product. I will update if I have any issues. But I am pretty confident that it will be fine.
