1987 MK 1 Catalina 34 Electrical System Upgrade

By Jon Windt; s/v Della Jean

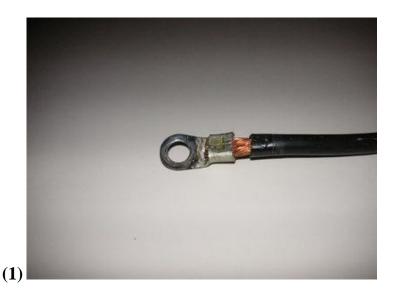
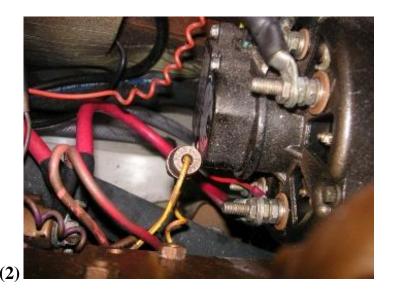
Photo (1) looks down at the original red 4 AWG cable from the 105A alternator output to the starter. The other red 4 AWG cable runs from the starter, ~ 20 cable feet to the 1-2-Both switch at the Navigation Station. Photo (2) is one example of a negative battery cable and lug with electrical tape removed. Notice the crimp terminal and the exposed wire end by the ring.

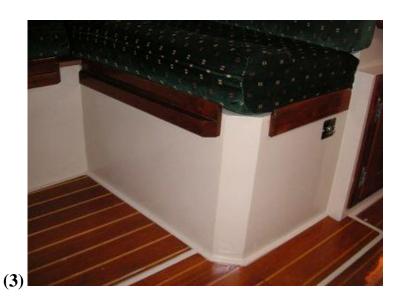
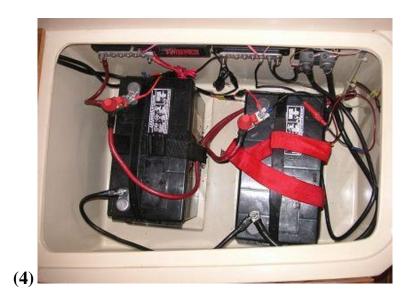
Photo (3) is the outside of the OEM battery compartment showing no ventilation openings. The switch in the upper right inboard side of the battery compartment is where the auto/on/off bilge pump switch was originally located. Photo (4) shows the original 2x Group 24 batteries, the 2 busbars, a Power Pulse battery maintenance widget, and a shunt for the Link 10 inside the battery compartment.

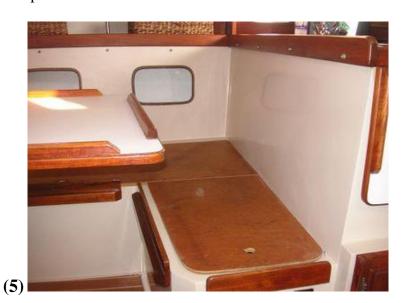
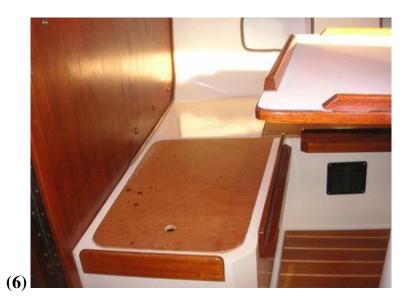
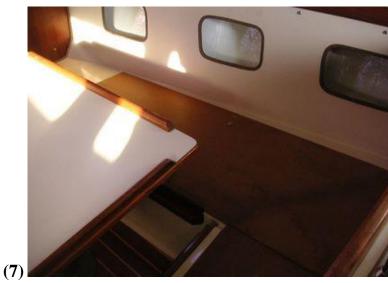
Photos (5) through (7) are of the traditional C34 salon area with all of the cushions removed. The black cover in the second photo is the existing ventilation cover for the DC refrigerator compressor.

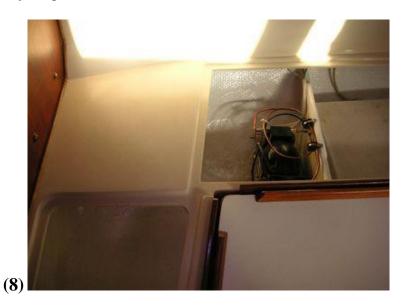
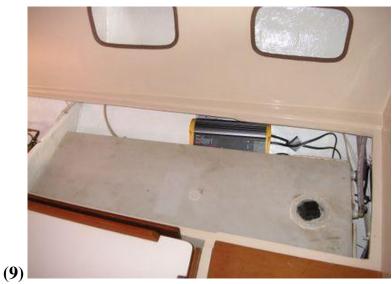
Photos (8) and (9) show the salon area with the wood covers removed. You can see the fridge compressor on the left, and the water tank and 20A AC charger (which wasn't fastened to anything) in the center.

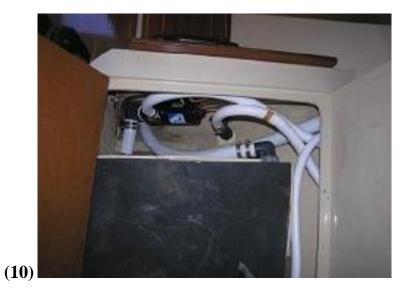
Photo (10) shows the holding tank, macerator pump, hoses, and if you look close the original wiring and cables running up to the master distribution panel at the Navigation Station.

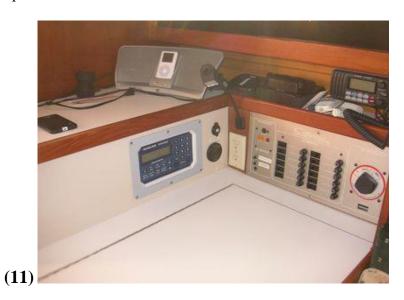
Photo (11) shows the Navigation Station with the OEM Main Panel, Link 10 battery monitor and 12VDC outlet installed by a PO. The panel has a single pole main, the polarity lights flickered, the lens for a light and the light under the battery switch were missing, the Link 10 did not operate.

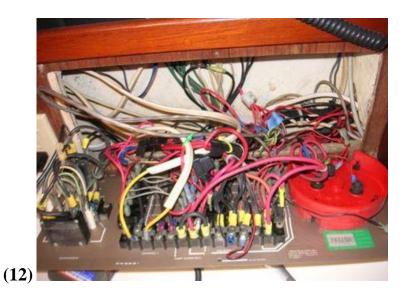
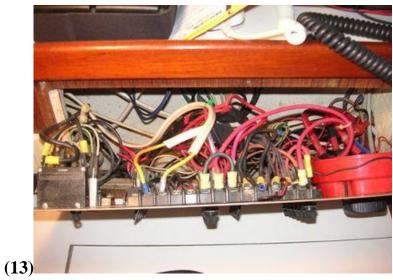
Photos (12) and (13) show the wires behind the main panel. To be polite, it was a corroded mess.

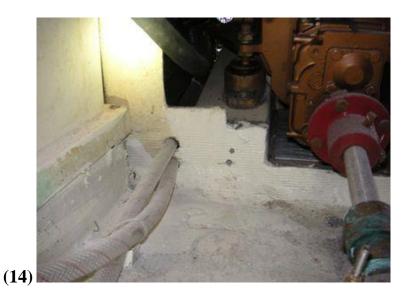
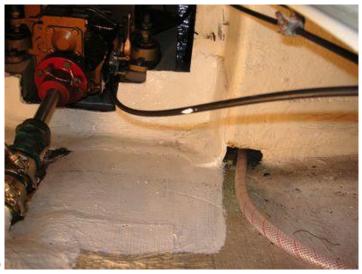
Photos (14) and (15) are taken under the aft cabin with the cushions and wood cover removed. My original plan was to run the cables from the battery compartment under the floor and engine compartment through a hole in this area. (I recently painted this area with white bilgekote when I replaced all the fresh water and vent hoses). In the left photo, you can see 2 small pilot holes I drilled under the port engine mount. I drilled the pilot holes about 1" deep but did not break through. So I plugged the pilot holes with hardwood dowels and 3M 5200 and changed plans. My fall back plan was to run the cables through the opening shown in the right photo where the water hose from the aft tank went under the floor to the sink area.

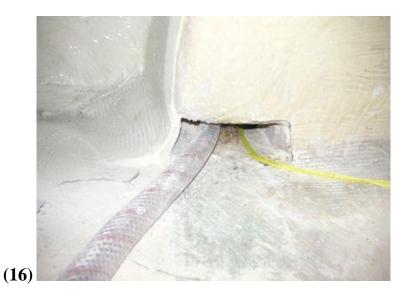
Barely visible in photo (16) is a dark clump of old adhesive sitting in the opening. It appeared to be excess adhesive for the conduit from the original build of the boat. A light tap with a screwdriver removed it, and now the path is clear to pass the 1 AWG cables through. The yellow strings are messenger lines to pull new cable.

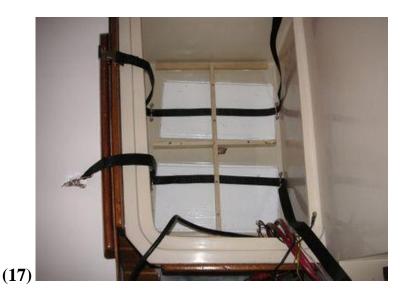
Photos (17) and (18) show the 2x8 painted wood fillers, the "egg crate" made from ¾" x ¾" hardwood strips screwed and countersunk to the bottom, and the battery straps all to keep the batteries in place while underway. The right photo shows 2 existing holes in the bottom of the box with cables passing through. (I was later glad to have 2 entry holes). I drilled holes for #8 screws for wire ties along the upper battery box wall, and 2 thru holes for #8 screws in the radius at the bottom of the box on the water heater side. These are to attach wire ties outside of the box near the water heater for the cables that will run in that area. The 2 thru holes were covered with the same silicone caulk used earlier to seal them from a possible battery leak. Be sure the screws do not extend into the battery box or you'll damage the batteries.

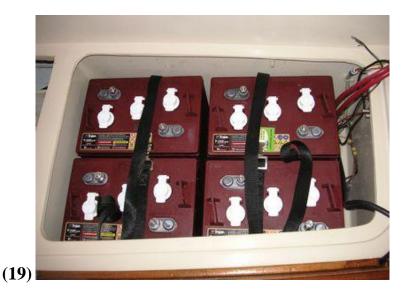
I didn't want to make the final attachments, and then find out the tie down straps interfered with the fill caps on the batteries. So I temporarily installed all of the house batteries to ensure the eggcrate matched up like intended, and the battery straps didn't interfere with the battery fill caps as shown in photo (19).

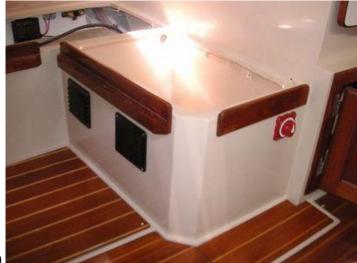
(20)

Photos (20 and (21) show the 2 new black ventilation covers installed in the battery box and the 1-2-Both battery switch installed where the bilge pump auto/on/off switch used to be. (In the center photo background you can see the breadboard for the Xantrex Digital Echo charge, house negative busbar, and BMV-700 shunt, but more on that later). The battery switch is a Blue Sea 6007 installed with the front panel mounted option. I used a 2 5/8" Milwaukee Dozer hole saw to drill the hole for the battery switch. It was tricky since I was using the hole saw to enlarge the existing smaller bilge switch hole. The battery box is two walls that are hollow in between. I wedged a piece of wood into the hollow section to give the hole saw pilot bit something to grab on to. I lined up the hole saw with the top of the existing bilge switch hole and went for it. It worked but maybe not the safest couple of minutes I spent on this project.

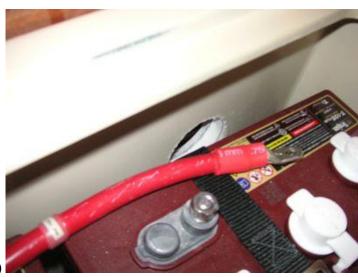
(22)

I used the same 2 5/8" hole saw for the vent covers along the forward side of the battery compartment instead of buying a larger hole saw for two holes. This surface is also two walls and hollow in between. To avoid gases collecting, I rolled up paper towels and stuffed them inside just below the edge of the hole to act as a backing for the caulk I used. The caulk provided a seal with a nice finished appearance as can be seen in photo (22).

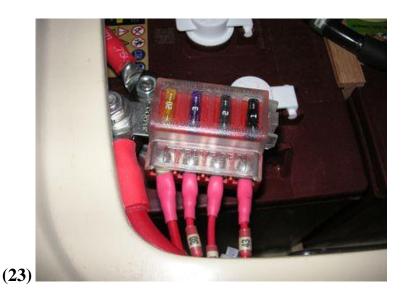
Photos (23) and (24) show the Trojan T105's installed waiting for inspection. I used the Blue Sea 5024 fuse block in the photo (23) to combine 4 fused runs into one small space with one connection point directly on the battery. The battery posts are short taking only 2 lugs comfortably, and many devices require connecting directly to the battery or as close as possible for best results, and is preferred by ABYC code. This does that neatly. In photo (24) I cut a piece of red oak into a "T" shape to fit between the batteries to avoid them tipping together when the battery strap is tightened. The black plastic clips came with the NAPA battery box for the reserve battery. I'm using a higher quality battery strap and stainless steel clips to hold the reserve battery, so I decided to use the plastic clips here to keep the wood from sliding. The house bank connects to position 1 on the 1-2-Both battery selector switch. In photo (24), the battery ID #'s are bottom right is #1, bottom left is #2, upper right is #3, and upper left is #4. See the schematic attached at the end of this write-up for the details.

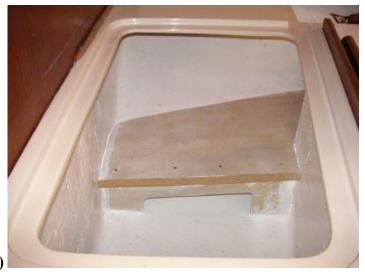
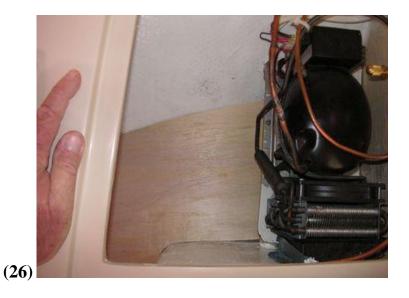
(25)

The most common location others install a reserve/start battery on a C34 is under the aft cabin. When I looked at under aft cabin installations, although done well, it was cramped, dark, wet, and hard to service. I chose to add a shelf under the forward outboard starboard corner section of the salon shown in work in photo (25). A loss of storage area, but my storage is limited here due to the refrigerator compressor anyway which you can see in phot (26). Using ½" birch plywood I fabricated a shelf to match the hull, bulkheads, and refrigerator compressor shelf. I cut an opening in the vertical leg of the new shelf for water drainage and access. The underside was painted in the non-bonding areas with white bilgekote before final installation. The hull and bulkheads were sanded for good adhesion, then I used 3M 5200 to bond the shelf to the hull and countersunk screws to bond the top and vertical leg of the shelf together. The screws were covered with a ½" cove molding for looks and a little additional ledge surface to help when removing the battery. The reserve battery was used as a weight to apply pressure while it cured. The exterior is finished with white bilgekote.

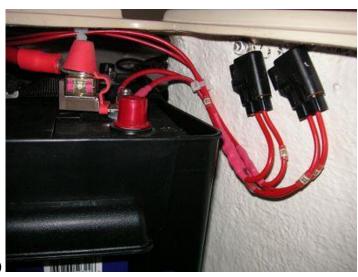
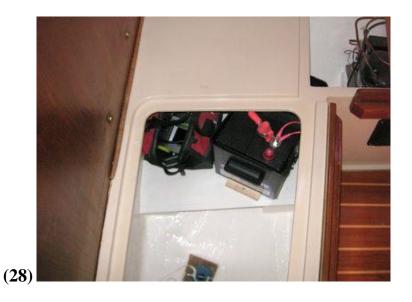
I added hardwood strips, and the same type battery strap as the house bank to keep the battery box from moving while underway. The terminal posts and all fuses (SmartGauge and Digital Echo charge fuses shown mounted on the bulkhead) shown in photo (27) are easily accessible by removing a cushion and the wood cover. I also have space to stow a small tool bag as shown in photo (28).

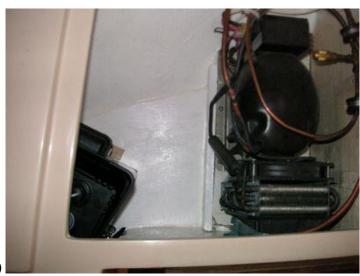
In photo (29) you can see that this arrangement also provides space for a future electric windlass breaker to fit between the battery and fridge compressor.

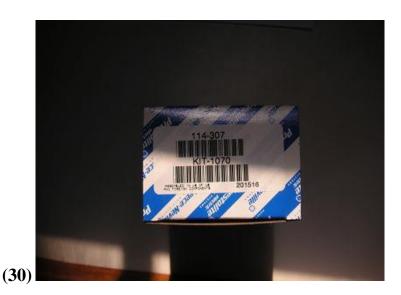
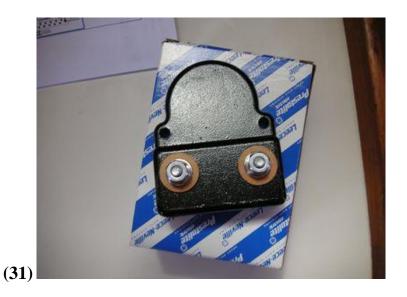
Internally regulated alternators are not designed to periodically recharge a large discharged battery bank rapidly. Technical details and graphs on this subject are discussed at length in my posting 1987 MK1 Electrical System Upgrade – Feedback Requested, and Electrical Systems 101. To take advantage of my existing 105A alternator, I installed an external regulator. This requires a conversion kit I purchased from ASE Supply Inc. for Leece-Neville. Photo (30) shows the part # 114-307, Kit 1070. Photo (31) shows an outside view of the assembled kit before installation.

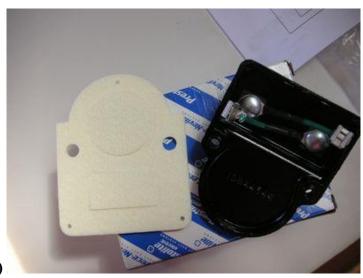
Photo (32) shows an inside view of the same assembled kit before installation.

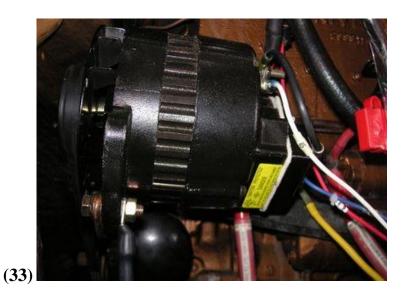
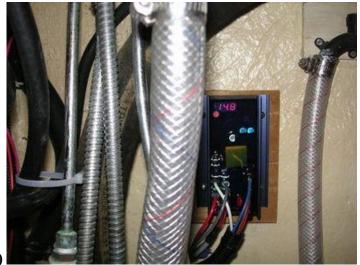
(34)

I used the Balmar MC-614H external regulator with the 54" long harness, and installed battery and alternator temperature sensing. To install the alternator temperature sense wire I replaced the original 1" long alternator bracket screw with a 1 ¼" long grade 8 screw as shown in photo (33). The MC-614H is installed under the head sink attached to a piece of ¾" plywood bonded to the bulkhead. It is easy to read the display and use the reed switch for adjustments as shown in photo (34). The regulator wires run to the engine compartment in the split loom. The existing ¾" conduit under the shower pan is used to connect the positive sense wire to the house bank, and the regulator negative to the house negative busbar after the shunt.

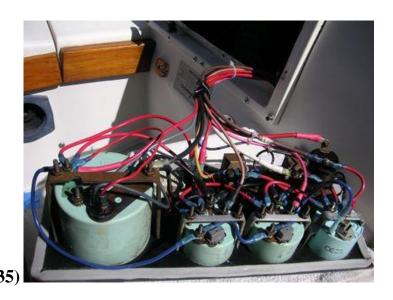
In photo (35), the brown ignition wire, ID # 50, connects to the ignition switch in the cockpit. The gray material around the perimeter of the cockpit panel is foam tape for weather protection when installed. FYI –I set the belt manager to level 4. The engine was started and run at 1500 rpm. The alternator was charging the house at 80 Amps, the alternator was at 32°C and the house bank was at 18°C. Just like advertised!

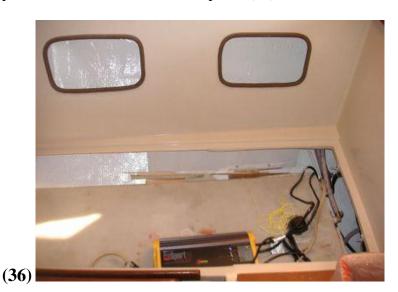
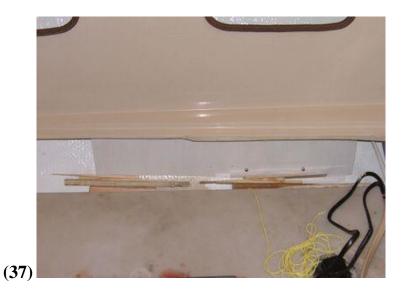
Photo (36) shows the vertical breadboard that is made out of ½" birch plywood cut to match the hull shape and the underside of the storage area behind the starboard salon seat where it's dry and has good ventilation. **Before** installation, I located all the parts to be mounted on the breadboard for best fit of the cables, and screws, then drilled the mounting holes. I then cut a notch into the top edge of the breadboard to make a pass through for the cables and wires to run. The breadboard extends from the end of the water tank ~24" forward and sits back from the fiberglass opening to the water tank ~4" to protect the components from falling items or liquids. The breadboard was then painted with white bilgekote on all sides except for the bonding surface. The hull bonding area was sanded and the breadboard was bonded to the hull and underside of the storage area with 3M 5200. It was held in place with wood shims to apply pressure as it cured as shown in photo (37).

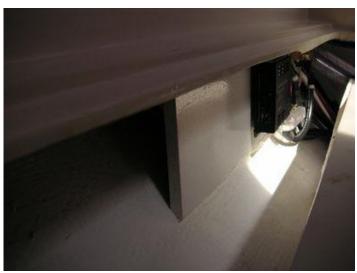
Photo (38) shows the bottom of the breadboard matched and bonded to the hull. After drying, it was repainted with white bilgekote before installing the components as shown in the next group of photos.

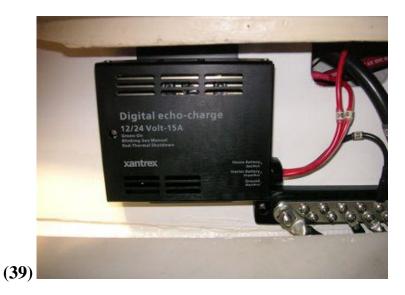
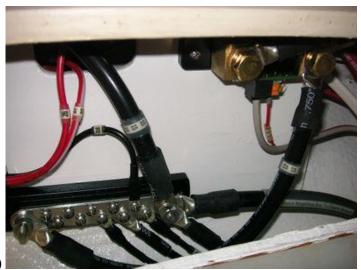
In photo (39), the Digital Echo Charge is shown installed and wired. The busbar comes with a cover that is removed for clarity. Installing the busbar and the wires connecting to it, requires a stubby screwdriver due to limited space between it and the water tank. Photo (40) shows the house negative busbar with negative wires connected and labeled. The 1AWG negative cable to the main engine ground is on the right. The 1AWG negative from the shunt crosses over to the far left post on the busbar.

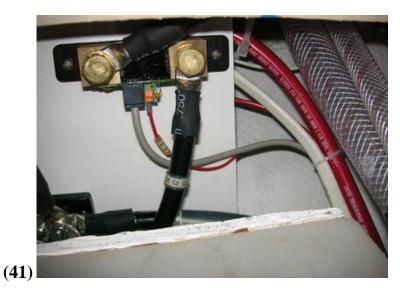
In photo (41) you see the shunt for the BMV-700. The house bank negative is connecting to the brass bolt on the left. This orientation of the shunt was used to have the battery monitor connections pointing down to reduce stress on the wires, and avoid condensation from humidity seeping into the connection points.

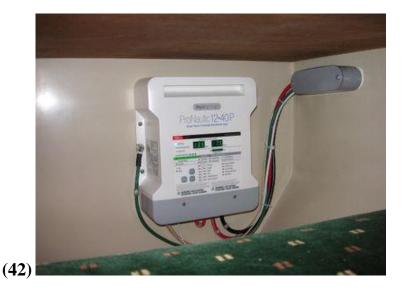
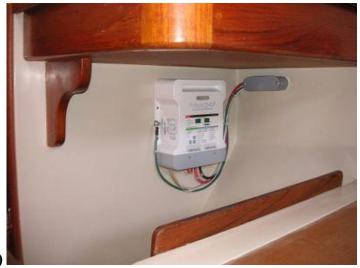
(43)

I removed the original ProMariner ProSport 20A AC battery charger that was lying on the hull **unattached** to anything, and replaced it with a ProNautic 40A multistage smart charger. The ProNautic uses battery temperature sensing, and can be programmed for several battery types and profiles for safe and efficient charging. I installed it with 4 screws on the common hanging locker bulkhead underneath the Navigation Station desk, see photos (42) and (43). This allows vertical mounting with plenty of ventilation in a relatively cool dry area. The location does not interfere with my knees when sitting at the desk, but is close enough to get at and change programming if needed. The AC charger wires run through the outboard bulkhead through a conduit LB under the Navigation Station desk. This reduces wires running in the hanging wet locker, provides a shorter run to the back of the Main Distribution Panel which is directly above it, and the conduit LB hides the hole.

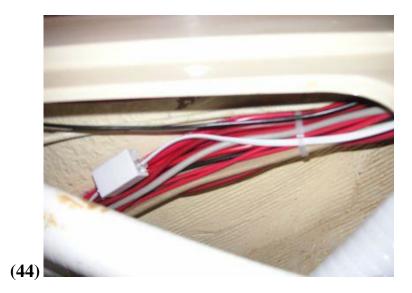
Unfortunately the temperature sense wire is only 10 feet long and will not reach the house bank from here. To solve this, ProMariner suggested using an RJ6 phone coupler and an RJ6 telephone line the length needed. Photo (44) shows the RJ6 phone coupler and the added 12 foot RJ6 wire tied to the main wire bundle just before the macerator pump/motor. Not sure yet if I'll plug the open RJ6 phone coupler ends with butyl tape and rescue tape to seal it from mositure.

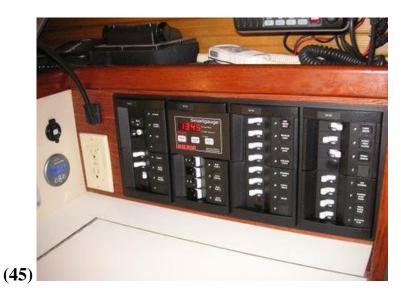
Photo (45) shows the Navigation Station with the new Blue Sea 360 Main Distribution Panel installed. The AC power is on the left side of the panel with a new ELCI 30A double pole main breaker, separate outlet, water heater, and AC battery charger breakers, plus two spares. Next is the SmartGauge battery monitor located above the bilge pump restricted off and manual on breakers, the right two columns are the 14 DC breakers plus 2 spares. Photo (46) shows the BMV-700 battery monitor and the 12VDC outlet that are installed on the bulkhead shared with the hanging locker, and to the left of the GFCI outlet.

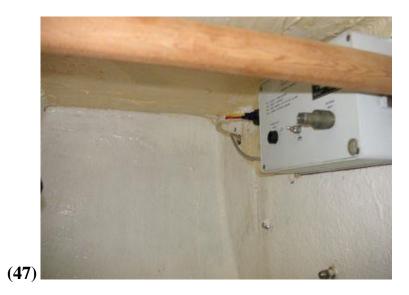
Photo (47) shows the cables from the back of the BMV-700 and the 12VDC outlet in the hanging locker running through the bulkhead, and behind the main panel.

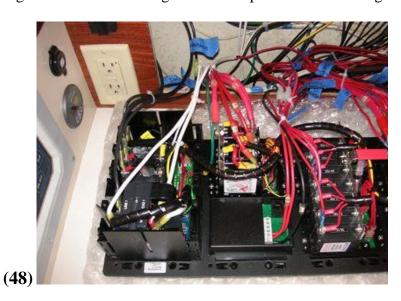
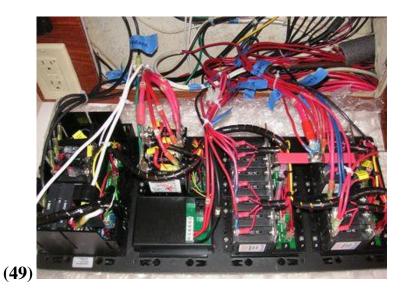
In photos (48) and (49), more breakers means more wires connecting to the main panel, but the organization of the wiring has been improved from the original.

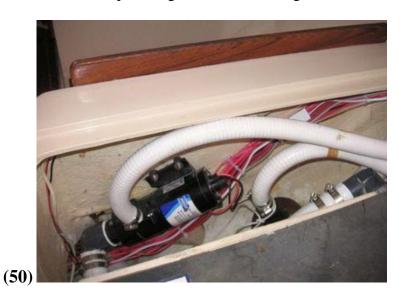
Here in photo (50) you see the wire bundle going by the macerator pump and motor up to the main distribution panel higher than before to get them off the hull and out of the way.

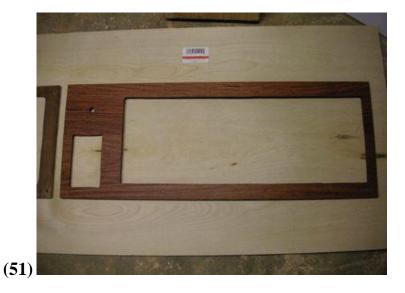
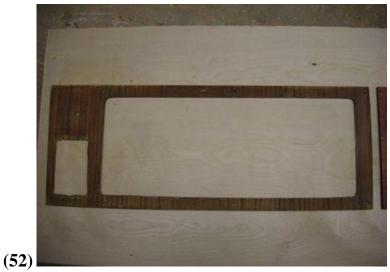
I also replaced the old ¼" teak plywood with a new piece of solid teak 5/16" thick. The new teak is shown in photo (51) and the old is shown in photo (52). The new teak improvement is more dramatic in person, and is seen a little better in photos (53) and (54). New is shown in photo (54).

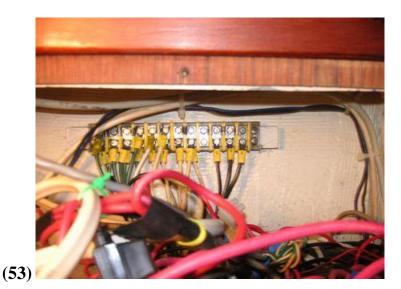
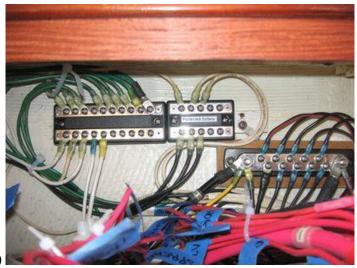
(54)

AC Busbar Replacement: I removed the original terminal strip in photo (53) and replaced it with a 10 screw dual busbar and a 5 screw dual busbar as shown in photo (54). In photo (53) you can see dark spots under the screw at the end of each wire. Those are corroded spade fittings with open crimps at both ends. I removed and replaced all with heat shrink adhesive lined ring terminals. They are now all nice and shiny new in photo (54). The 10 screw dual busbar is for most AC neutrals and all grounds. The smaller 5 screw dual busbar is dedicated to line and neutrals for the cabin, galley, and head protected AC outlets. The AC outlet power leaves the panel breaker and connects to the GFCI outlet at the Navigation Station. From there it connects to the 5 screw dual busbar for the downstream AC outlets, and is labeled "Protected Outlets". In this arrangement the cabin, galley, and head outlets are all protected by the Navigation Station GFCI outlet. The down side to this arrangement is the AC outlets are limited to a combined total of 30A. This may or may not be a nuisance item. I plan to wait and see if it is an issue before changing anything.

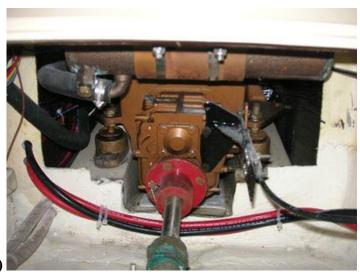
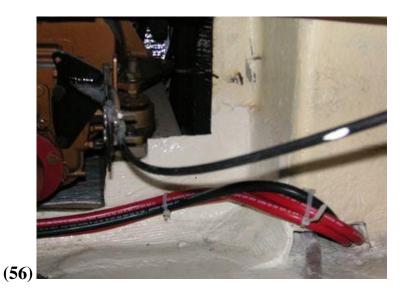
For the primary battery and charging circuit cables I used 1 AWG. There was a lot of discussion on what is the proper cable size to use on the Message Board. Refer to my post 1987 MK1 Electrical System Upgrade – Feedback Requested. The following photos (55) and (56) show how the starter, alternator output, and main negative to the house negative busbar cables run under the aft cabin. I ran them under the propeller shaft instead of over it near the heat exchanger to avoid the risk of them falling on the propeller shaft if they came loose from their tie wraps. The cables then pass through the bulkhead opening next to the aft tank water hose and on to the galley by the foot pump for the refrigerator drain.

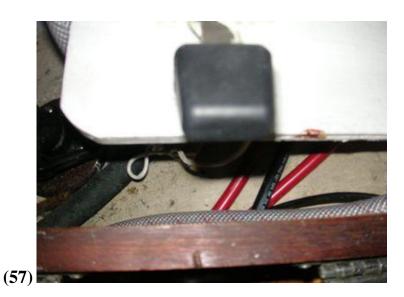
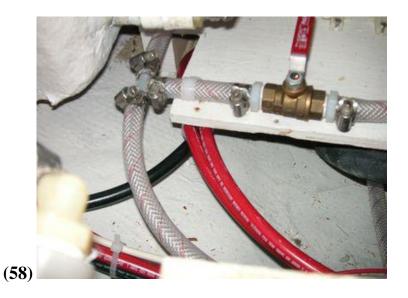
Photos (57) and (58) show the same three cables from the aft cabin as they exit from underneath the galley floor, then pass under the foot pump shelf and appear near the water heater and water tank. They then travel to either the battery box, or go to the negative house busbar mounted on the breadboard discussed earlier.

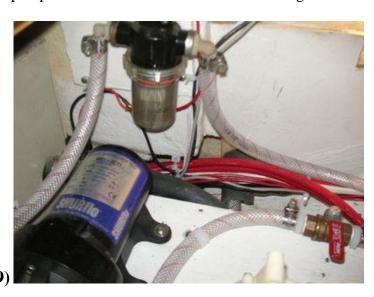
In photo (59) you can see I added insulation foam for $\frac{3}{4}$ " pipe on the water tank hose and band clamp to protect the cables and wires from chafing.

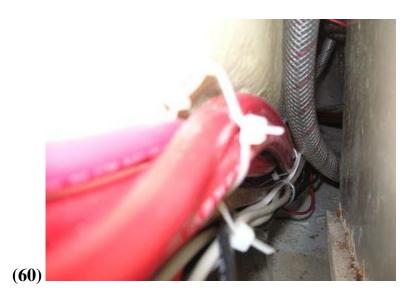
Photo (60) shows cables running between the water heater and the outside of the battery box. The wire tie mounts are attached to the thru holes I drilled in the battery box in the beginning. No other way to get in there and drill a hole. Photo (61) shows another use of the insulation material to cover the corner of the water heater support and shelf to avoid any cable or wire chafe. The insulation is attached to the heater shelf with a #8 SST screw fastened to the wood shelf so it doesn't move and leave the wires/ables exposed to the corner.

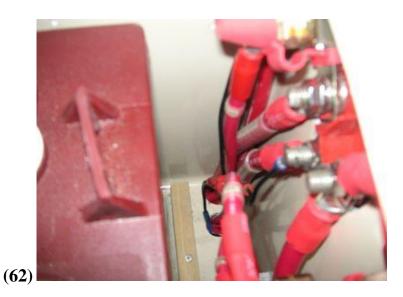
Photo (62) shows the cables entering the bottom of the battery box thru the larger of the two existing holes and connecting to the back of the 1-2-Both battery selector switch in the battery box, the "always on" busbar, and the house battery bank. Remember I said I was glad there were two holes? This is why, it is big stuff.

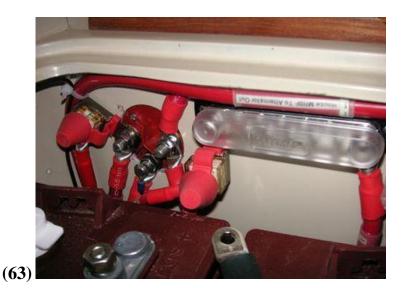
Battery Box Busbar: Photos (63) and (64) are looking inboard from the water tank to see inside the battery box. Photo (63) shows the primary cables inside the battery box connecting to the back of the 1-2-Both battery use switch. Position #1 (house bank) is on the right, Position #2 (reserve battery) is on the bottom, and Position C is on the left. The MRBF fuses (covered with the red caps) for the main distribution panel supply connecting to the C post, the AC battery charger, and power for the bilge pump breaker connecting to the "always on" busbar can also be seen. Photo (64) shows the alternator output cable running above the "always on" busbar. The protective cover is removed from the "always on" busbar for clarity. The alternator output cable is labeled upside down so it can be read from above when standing on the boat centerline looking down into the battery box. You can also see the jumper connecting position #1 of the 1-2-Both battery use switch to the "always on" busbar. The most critical DC item currently attached to the "always on" busbar are the bilge pumps. If the house battery bank were to fail, switching the 1-2-Both battery use switch to position #2 would not provide power to the always on busbar. To address this, I made the jumper long enough to be moved from position #1 to position #2 of the 1-2-Both battery use switch to provide temporary power. This failure mode is a remote possibility, but it could occur so I added this no cost redundancy feature.

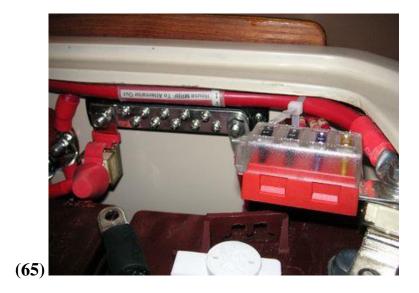
In photo (65), you see the end of the Blue Sea 5024 fuse block discussed in the House Battery section.

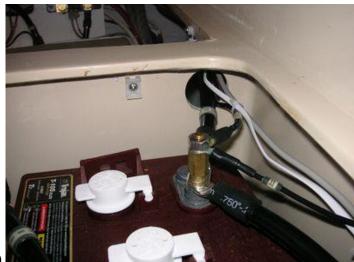
(66)

Looking at the bulkhead between the battery box and water tank in photo (66), you see the 1 AWG negative leaving battery #4 and going to the shunt through the hole in the battery box. Also visible are the temperature sense wires from the AC battery charger, and from the Balmar external voltage regulator. I separated most of the positive wires from the negative wires by running the positive's into the battery box through the two bottom holes shown earlier, and the negatives and temperature sense wires running through this hole at the top of the other end of the battery box near the water tank. I was only comfortable connecting two wires or cables to a battery post, so I purchased the extension from the battery supply house for ~ \$5. In photo (67), the 1AWG negative leaves the battery box and runs under the lip that the outboard salon cushion wood cover sits on.

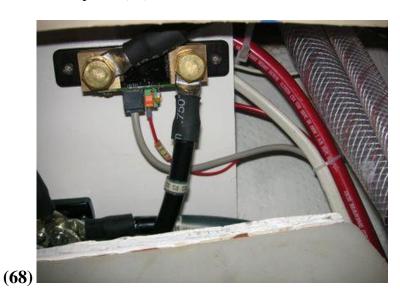
That same cable then connects to the left bolt on the BMV-700 shunt attached to the breadboard as shown in photo (68).

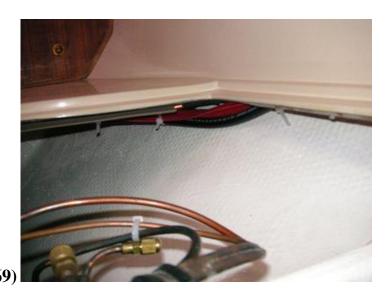
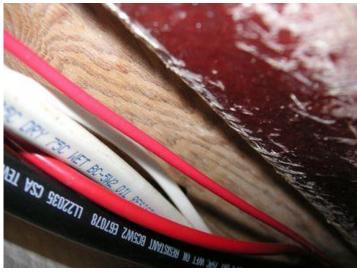
Photo (69) shows the positive and negative cables running to the reserve battery from the Digital Echo Charge, the SmartGauge, the 1-2-Both battery selector switch position #2, and from the house bank negative busbar. The shiny bit you see is the refrigeration line. To protect the refrigeration lines in case there is a gas leak from the maintenance free battery, I covered it with the material used to cover wires on the floor so you don't trip. Photo (70) shows the wires and cables from the reserve battery, Digital Echo Charge, and the SmartGauge running underneath the storage cubby holes behind the outboard salon seat cushion. The white Nomex is the existing DC wiring for the refrigerator compressor and fan. The wood you see is glassed in and is part of the boat. It wasn't added by me for this project.

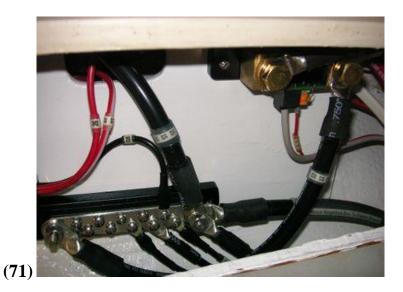
The 1 AWG negative continues to the breadboard where it passes through the cutout to connect to the right post on the house negative busbar as shown in photo (71).

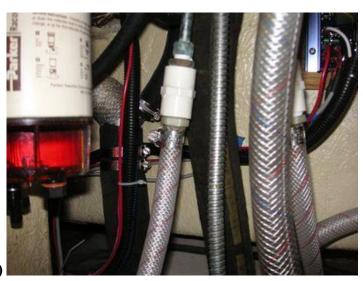
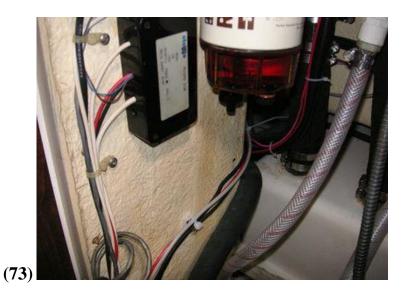
Photos (72) and (73) show the external regulator wiring under the head sink in the split loom, then is runs along the engine compartment bulkhead under the Racor filter.

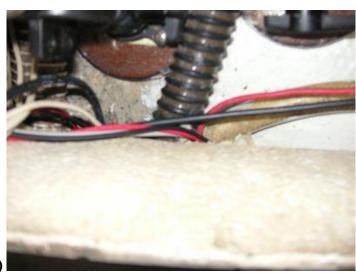
Photo (74) the external regulator wires enter the ³/₄" conduit under the shower pan. They exit the conduit by the macerator pump/motor in photo (76) of the next photo group. The black box by the Racor is part of my non-working depth/temp/speed system.

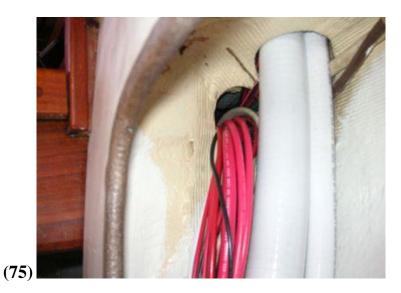
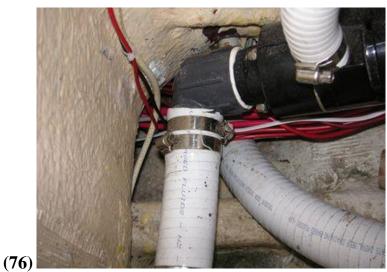
Finally photos of the wires running from behind the Main Distribution Panel, to the battery box area. Photo (75) shows the bundle exiting from behind the Main Distribution Panel, and photo (76) shows where they pass under the macerator pump/motor and pick up the external regulator wires.

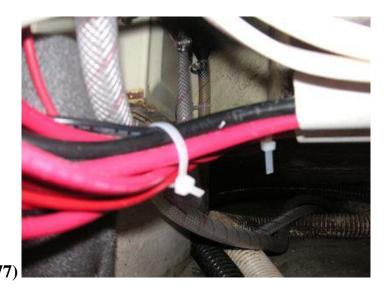
Photo (77) is where they cross over above the bilge. The hoses lying on the hull are for the hot and cold water to the head and the existing manual and electric bilge pumps.

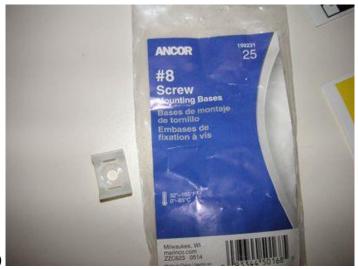
(78)

Lots of wire ties are used throughout to secure the wire and cable. A great fitting I used is #8 mounting bases; Ancor part # 199231 from West Marine shown in photo (78). Drill a hole for a #8 screw, screw it in, slip the wire tie through the slots, wrap around the wire/cable and tighten. Very secure. A valuable tool to have is a 90 degree drill. I didn't have one, so bought the 90 degree adaptor shown in photo (79) from Harbor Freight for ~\$20 before shipping and handling. It's a light duty tool, but worked well to get into tight areas to drill holes I wasn't able to without it.

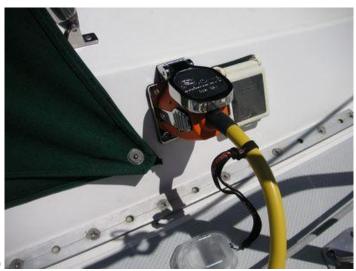
Photo (80) shows the final upgrade in this extensive electrical upgrade. What I thought would be a quick 30 minute job, turned out to be about 1 1/2 hours. The reason being the OEM boatside AC wire terminations to the old shore power connection used ring terminals (not heat shrunk by the way), with zero slack in it. When the ring terminals were cut off, the stripped wire conductor would not reach the SmartPlug terminal. To solve this, I added 8-10" long 10AWG pigtails to each conductor of the OEM 12 AWG cable with adhesive lined heat shrink butt connectors. Worked fine, and in the end I replaced my original twist on AC shore power plug with the more secure SmartPlug assembly, a new cable, and the optional protective cover that can be used when the plug is disconnected from the boat. The cover to the right of the SmartPlug is an old Marinco fitting for cable and telephone. It isn't connected to anything that I can find and will eventually be removed. Not sure what I'll replace it with.
