1987 MK 1 Catalina 34 Macerator Change

By Jon Windt; s/v Della Jean

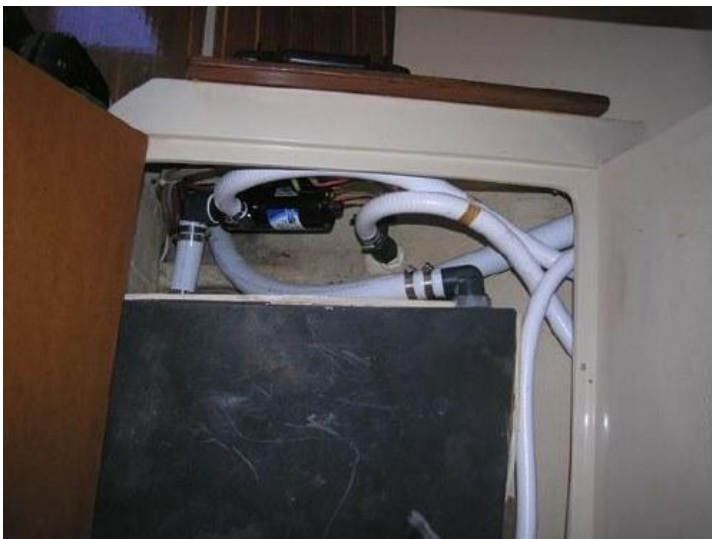
Photo (1) is the original macerator pump installation I had. The 1 ½” sanitation hose running under the macerator is the discharge hose from the toilet to the holding tank. The short 1 ½” sanitation hose connects the holding tank to the macerator pump via a Spears 90 degree 1 ½” FPT x 1 ½” hose barb threaded onto the macerator pump housing. The macerator discharge is a 1” hose connecting to the anti siphon loop located behind the seat cushion then to the thru hull. The 1” hose on the right side of the photo is the vent to the vented station on deck, and the other 1 ½” sanitation hose running to the right along the hull connects the holding tank to the pump out connection on deck.

FYI: This is an old photo. One of the first projects I did was to replace all thru hulls with proper flanged sea cocks and backing plates. Also removing the macerator pump for maintenance will be a horrible project so as part of fixing the leak I decided to change the layout to minimize future problems

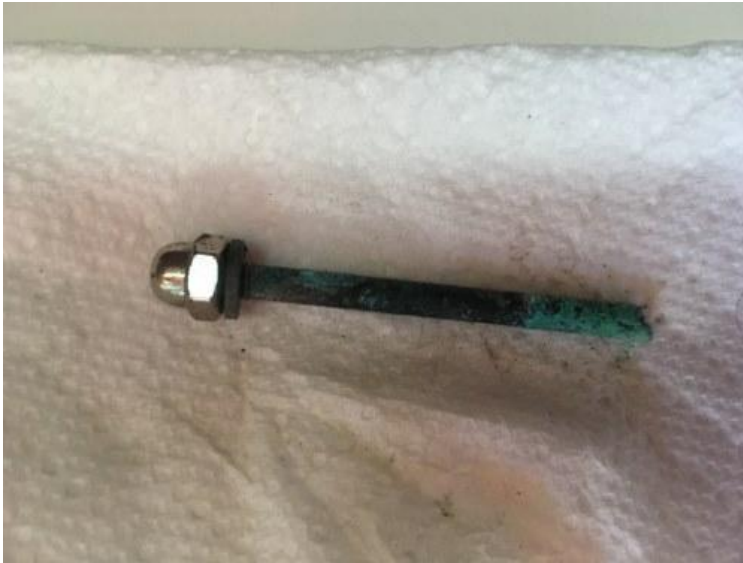
The PO may have done that, but I noticed the pump leaking while I was running the 12 volt outlet wires to a dedicated fuse block. Looking closer I noticed the nut was loose that holds the pump housing to the pump/motor. It turns out the nut wasn't loose, the actual stud had failed. When I looked at the other three, a second stud had also failed. When I took the pump housing off it turned out all 4 were in the process of failing from severe corrosion.

Photo (2) is a close up of one of the corroded studs that held the pump housing/pump/motor together. Photo (3) shows what is left of a couple of the original studs. This was the reason for the leak.

1. Fix the leaking macerator pump/motor with JABSCO Macerator Pump Service Kit (18598-1000).
2. Replace the broken studs with JABSCO Macerator Stud Replacement Kits (17288-10000). These are SST bolts from Jabsco so this must not be an unusual problem.
3. Replace the Spears 90 degree 1 1/2" FPT x 1 1/2" hose barb threaded onto the macerator pump housing with a Spears 1 1/2" hose barb x 1 1/2" hose barb elbow.
4. Relocate the macerator pump/motor up higher on the bulkhead to be easily accessible and serviceable with minimal discharge from the holding tank.

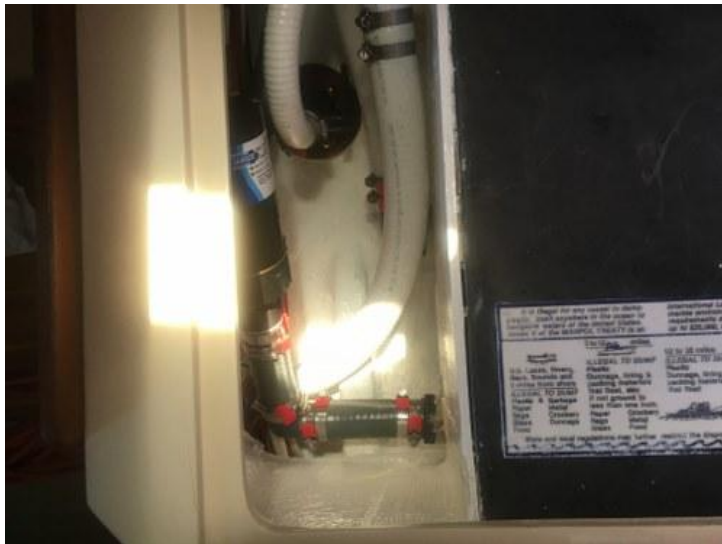
Photo (4) shows ! 6" of the new 1 1/2" ID SHIELDS RUBBER Poly X sanitation hose from the holding tank to the new Spears 1 1/2" hose barb x 1 1/2" hose barb elbow and another ~6" of the new 1 1/2" ID SHIELDS RUBBER Poly X sanitation hose from the new elbow to the macerator pump housing.

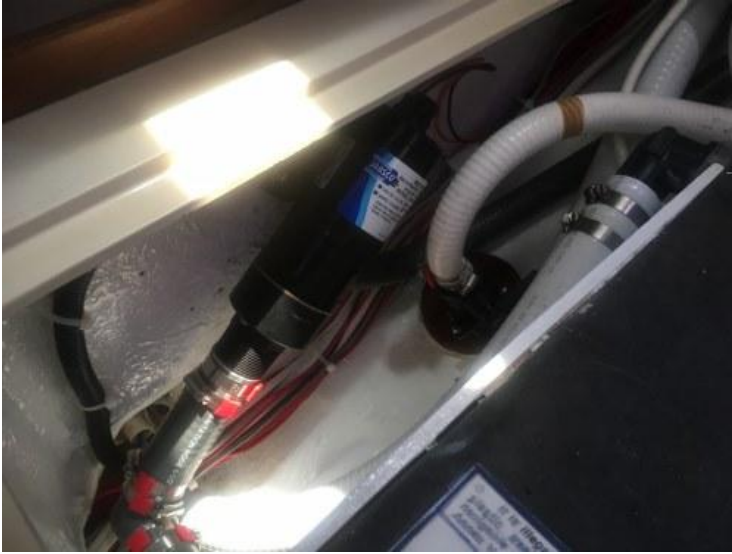
Photo (5) provides a clearer view of the new macerator pump installed higher up on the bulkhead than before, and I am now using the hose barb connection instead of the threaded portion of the pump housing. This will make removing the pump much simpler and cleaner when it's time for maintenance in the future. (hopefully distant future). With the pump up higher, I had to rotate the 1" pump discharge 180 degrees so the 1" discharge hose from the pump now points down toward the hull instead of up toward the cover as it was originally.
