1987 MK 1 Catalina 34 Macerator Change

By Jon Windt; s/v Della Jean

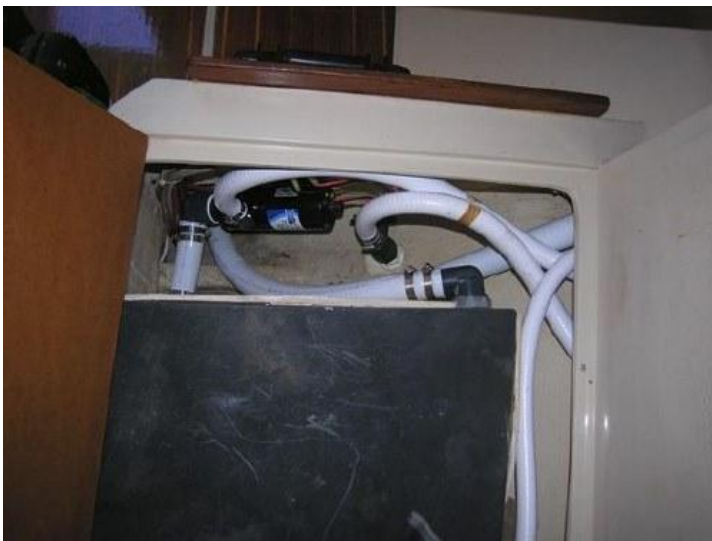
Photo (1) is the original macerator pump installation I had. The 1 ½” sanitation hose running under the macerator is the discharge hose from the toilet to the holding tank. The short 1 ½” sanitation hose connects the holding tank to the macerator pump via a Spears 90 degree 1 ½” FPT x 1 ½” hose barb threaded onto the macerator pump housing. The macerator discharge is a 1” hose connecting to the anti siphon loop located behind the seat cushion then to the thru hull. The 1” hose on the right side of the photo is the vent to the vented station on deck, and the other 1 ½” sanitation hose running to the right along the hull connects the holding tank to the pump out connection on deck.

FYI: This is an old photo. One of the first projects I did was to replace all thru hulls with proper flanged sea cocks and backing plates. Also removing the macerator pump for maintenance will be a horrible project so as part of fixing the leak I decided to change the layout to minimize future problems

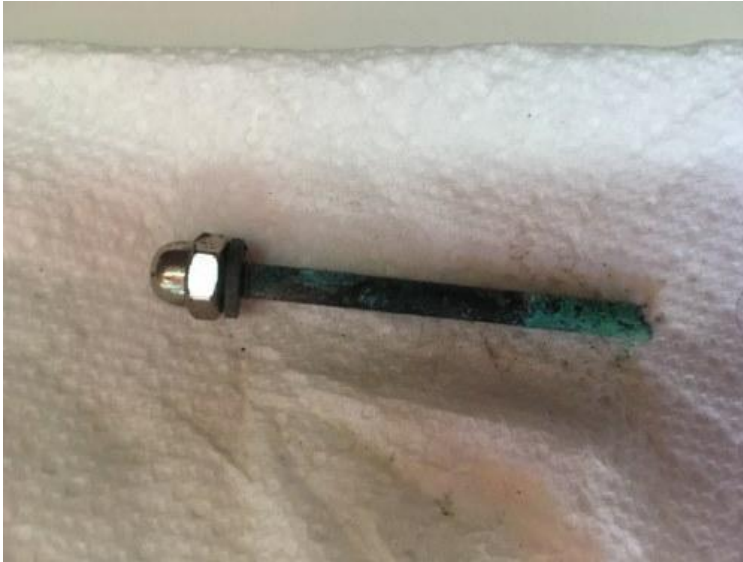
Photo (2) is a close up of one of the corroded studs that held the pump housing/pump/motor together. Photo (3) shows what is left of a couple of the original studs. This was the reason for the leak.

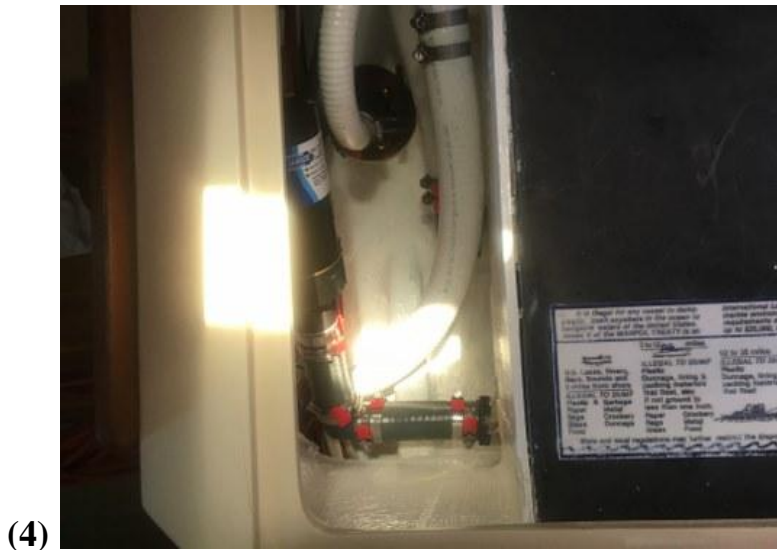
Photo (4) shows ! 6" of the new 1 1/2" ID SHIELDS RUBBER Poly X sanitation hose from the holding tank to the new Spears 1 1/2" hose barb x 1 1/2" hose barb elbow and another ~6" of the new 1 1/2" ID SHIELDS RUBBER Poly X sanitation hose from the new elbow to the macerator pump housing.

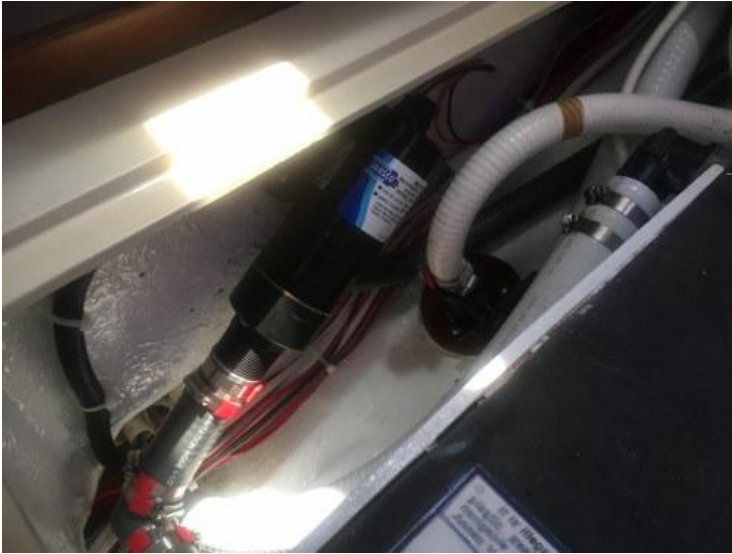
Photo (5) provides a clearer view of the new macerator pump installed higher up on the bulkhead than before, and I am now using the hose barb connection instead of the threaded portion of the pump housing. This will make removing the pump much simpler and cleaner when it's time for maintenance in the future. (hopefully distant future). With the pump up higher, I had to rotate the

1" pump discharge 180 degrees so the 1" discharge hose from the pump now points down toward the hull instead of up toward the cover as it was originally.

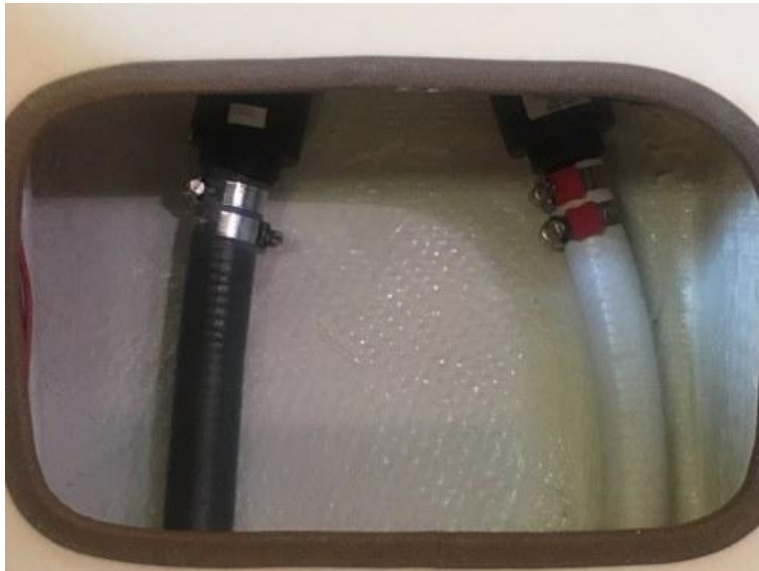
Photo (6) shows the anti siphon valve and loop that is behind the seat cushion next to the Navigation Station.

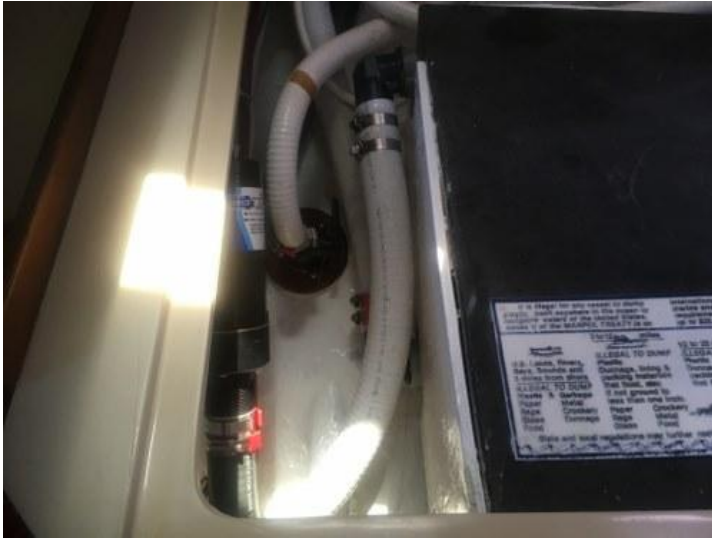
Photo (7) shows access to the flanged sea cock for the macerator pump discharge.
