1987 MK 1 Catalina 34 Electrical System Upgrade

By Jon Windt; s/v Della Jean

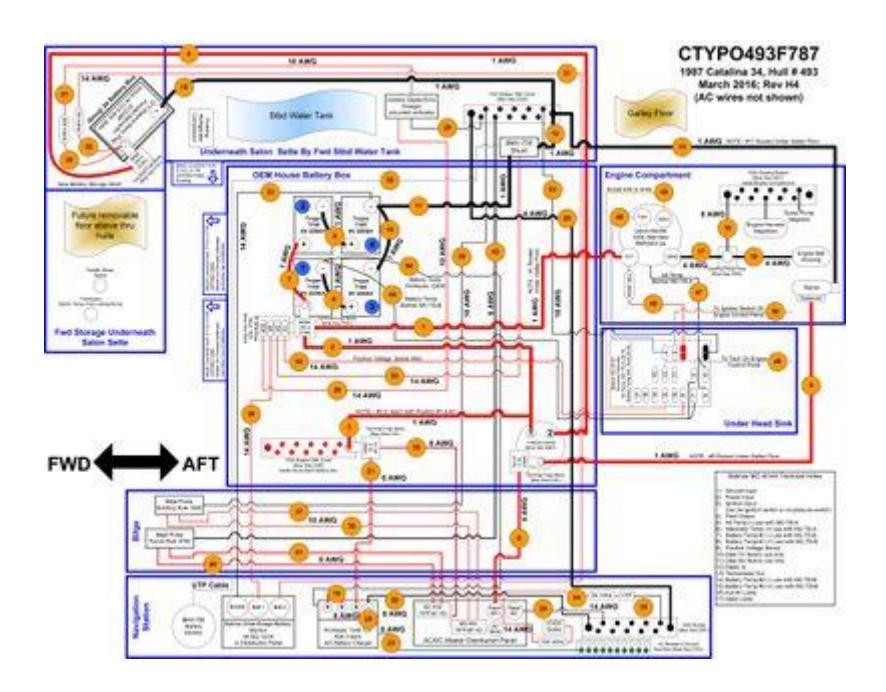
For me this was a very complex project, remember I'm brand new to this. Depending on your level of experience, it may be quicker for you. In total the project took about 250 hours. I spent about 125 hours reading the <u>Electrical Systems 101</u> topics, previous project write-ups, and started my own thread <u>1987 MK1 Electrical System Upgrade – Feedback Requested</u> to ask questions on the C34IA website. The outcome of this effort was a complete wiring diagram, a cable planner to identify each wire/cable and associated details, and a parts list. These are each available as part of this write-up in Sections 14 and 15 respectively for you to use as reference. There are both an Excel and a PDF formatted version. A jpg file of the schematic is shown here. If you click on the graphic it will enlarge like the photos do. Another couple of clicks on the image should give you a magnifying glass to zoom in further.

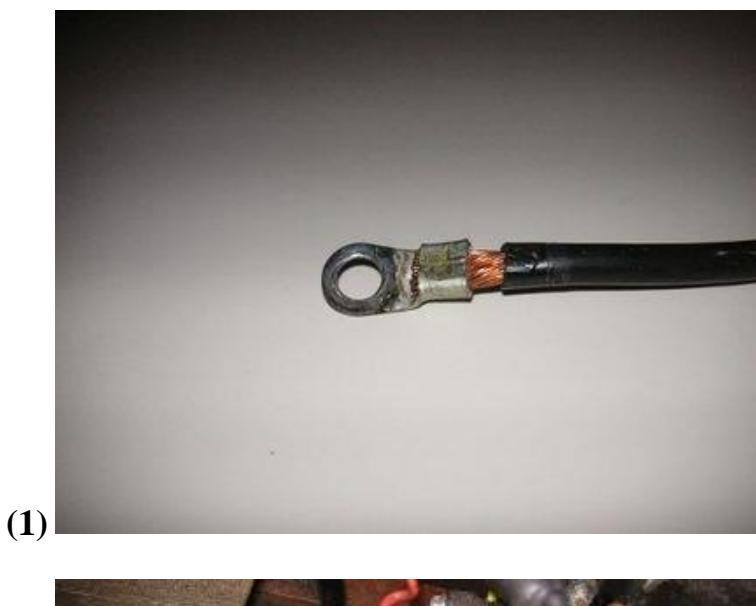
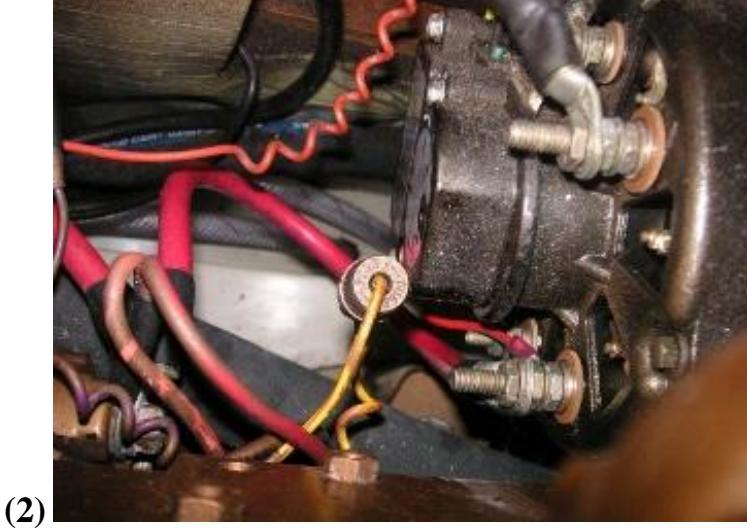
Photo (1) is one example of a negative battery cable and lug with electrical tape removed. Notice the crimp terminal and the exposed wire end by the ring. Photo (2) is looking down at the original red 4 AWG cable from the 105A alternator output to the starter. The other red 4 AWG cable runs from the starter, ~ 20 cable feet to the 1-2-Both switch at the Navigation Station. From there it ran another 15 cable feet to the battery in the battery compartment.

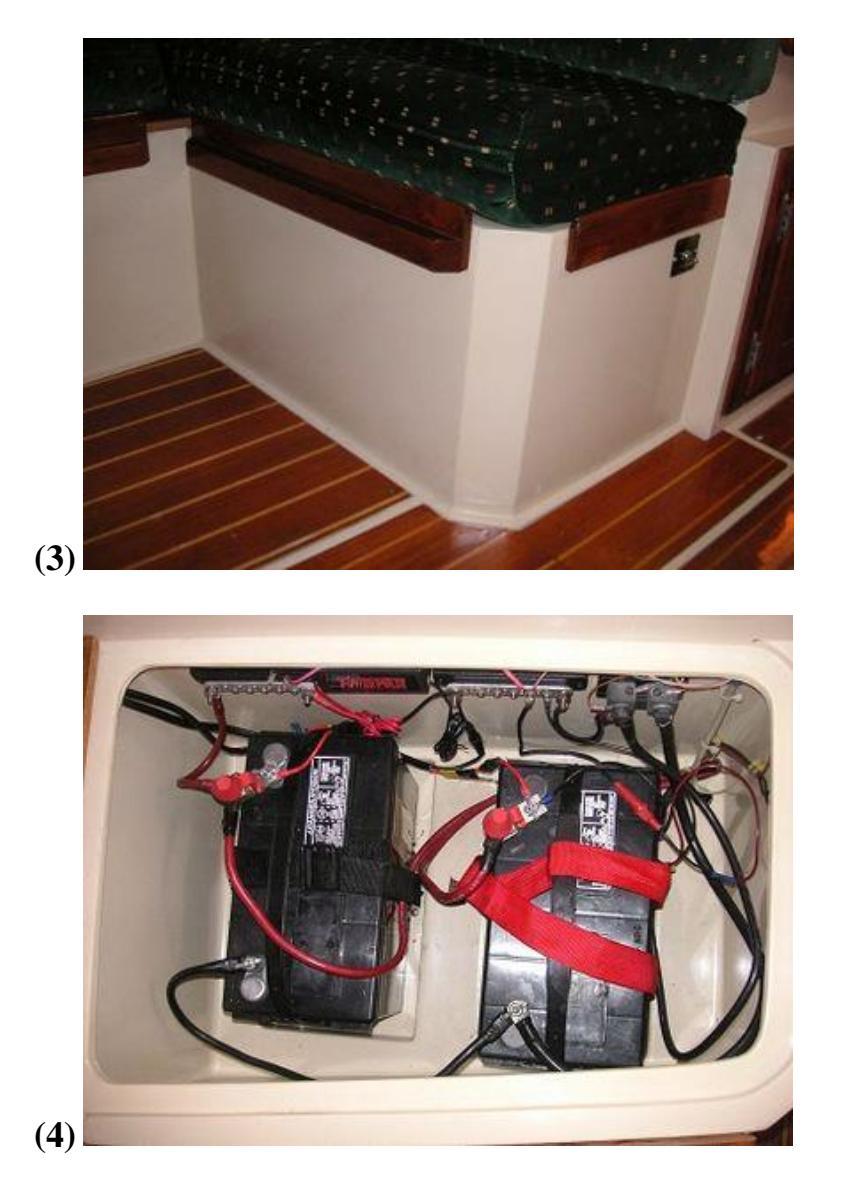
Photo (3) is the outside of the OEM battery compartment showing no ventilation openings. The switch in the upper right inboard side of the battery compartment is where the auto/on/off bilge pump switch was originally located. Photo (4) shows the original 2x Group 24 batteries, the 2 busbars, a Power Pulse battery maintenance widget, and a shunt for the Link 10 inside the battery compartment.

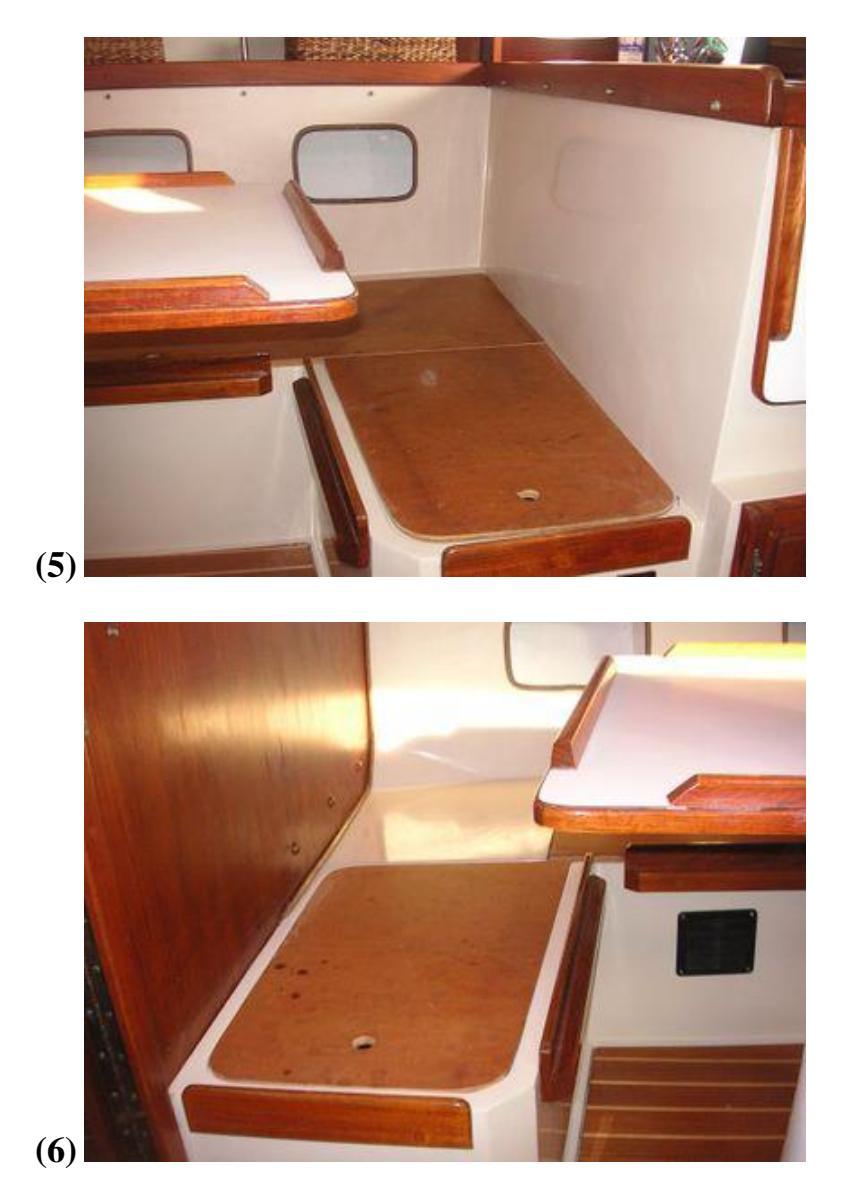
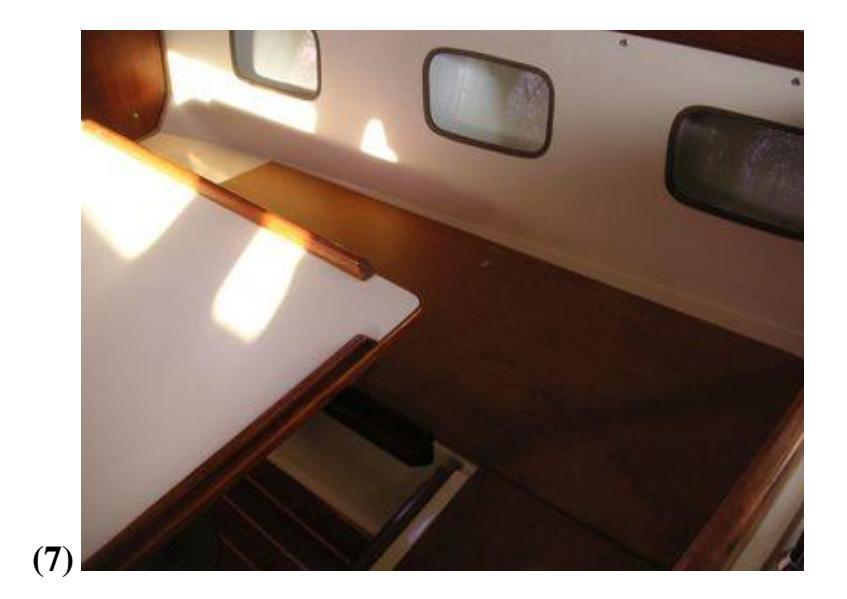
Photos (5) through (7) are of the traditional C34 salon area with all of the cushions removed. The black cover in the Photo (6) is the existing ventilation cover for the DC refrigerator compressor.

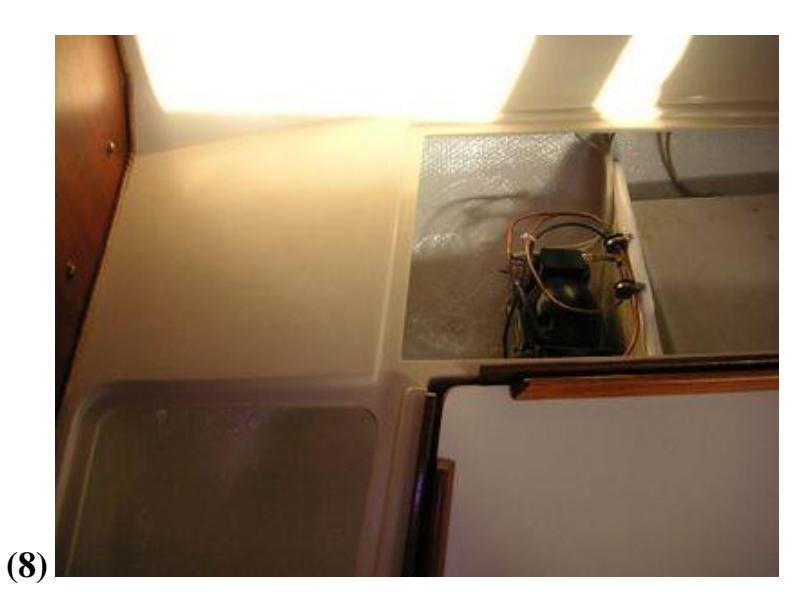
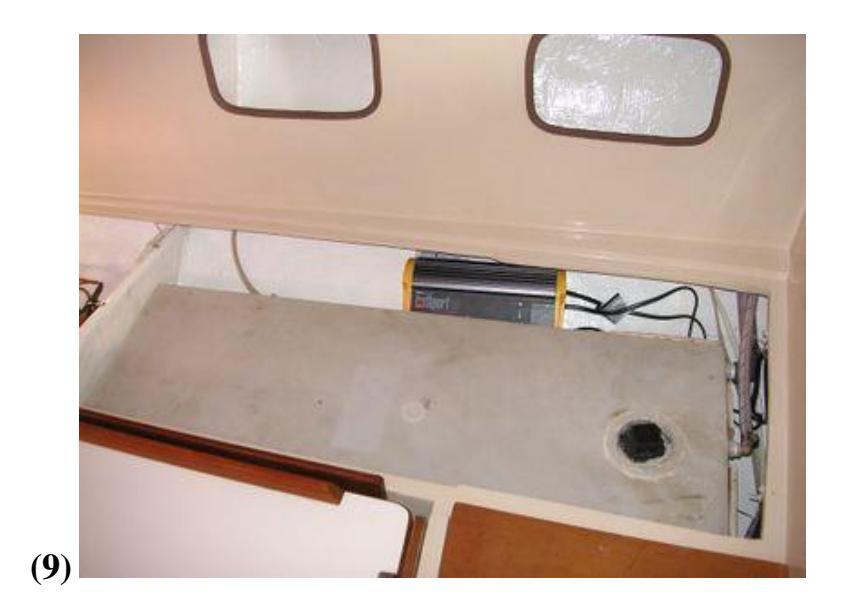
Photos (8) and (9) show the salon area with the wood covers removed. In Photo (8) you can see the fridge compressor attached to the bulkhead at the end of the starboard water tank. Photo (9) shows the water tank and ProMariner ProSport 20A AC charger which wasn't fastened to anything, just lying there waiting to flop around.

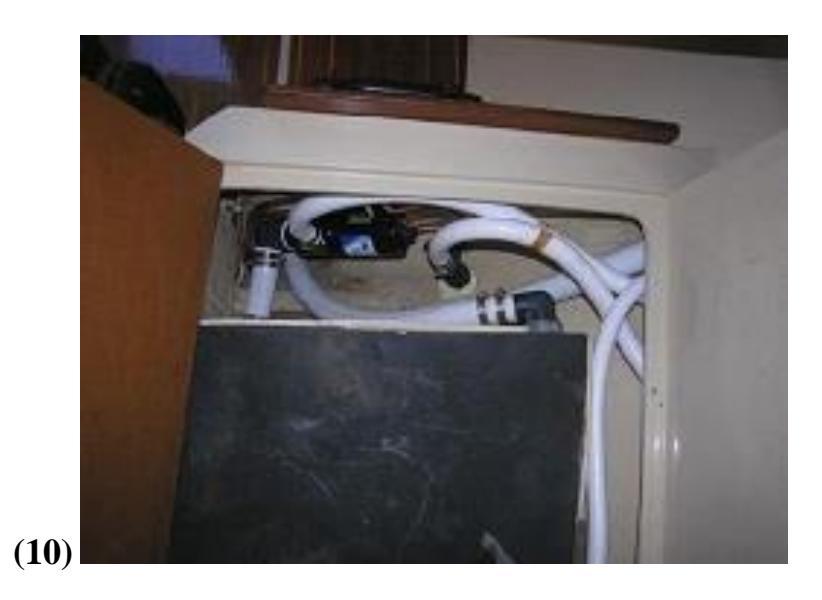
Photo (10) shows the holding tank, macerator pump, hoses, and if you look close the original wiring and cables running up to the master distribution panel at the Navigation Station.

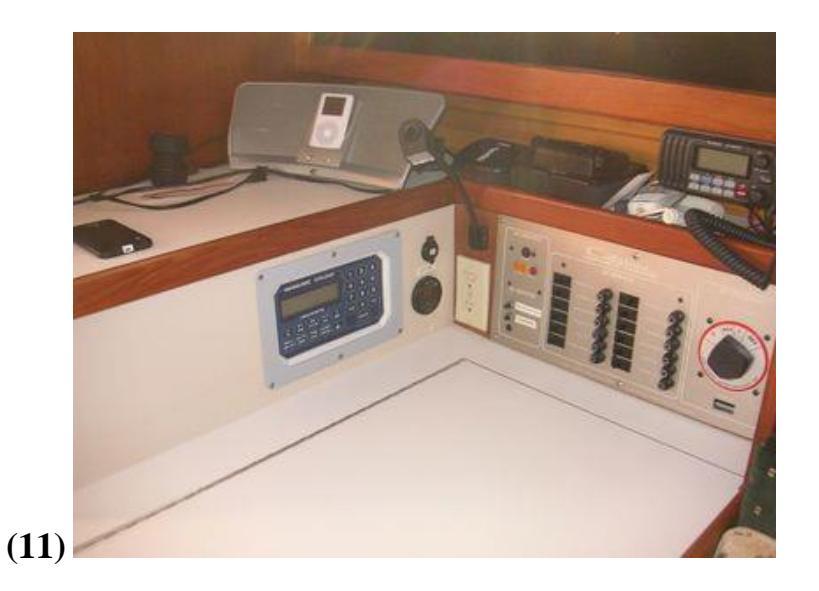
Photo (11) shows the Navigation Station with the OEM Main Panel, Link 10 battery monitor and 12VDC outlet installed by a PO. The panel has a single pole main, the polarity lights flickered, the lens for a light and the light under the battery switch were missing, the Link 10 did not operate.

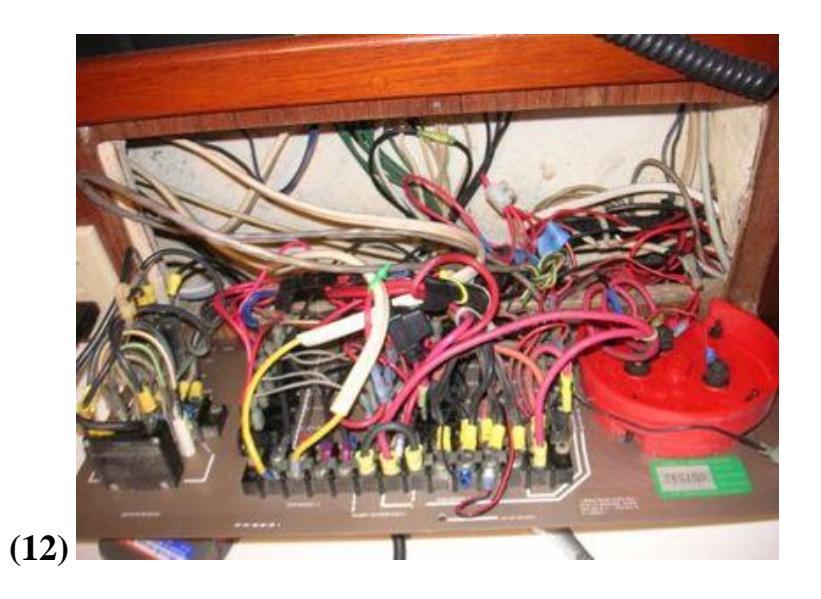
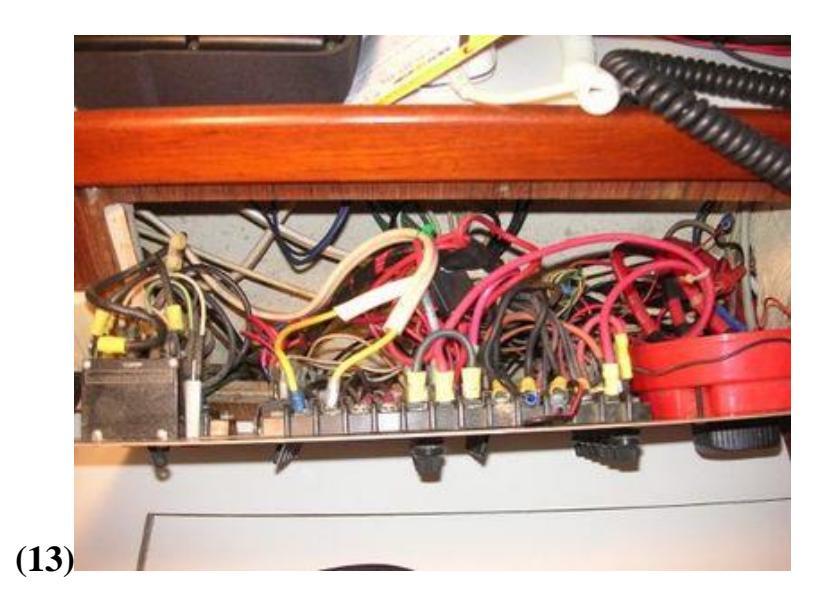
Photos (12) and (13) show the wires behind the main panel. To be polite, it was a corroded mess.

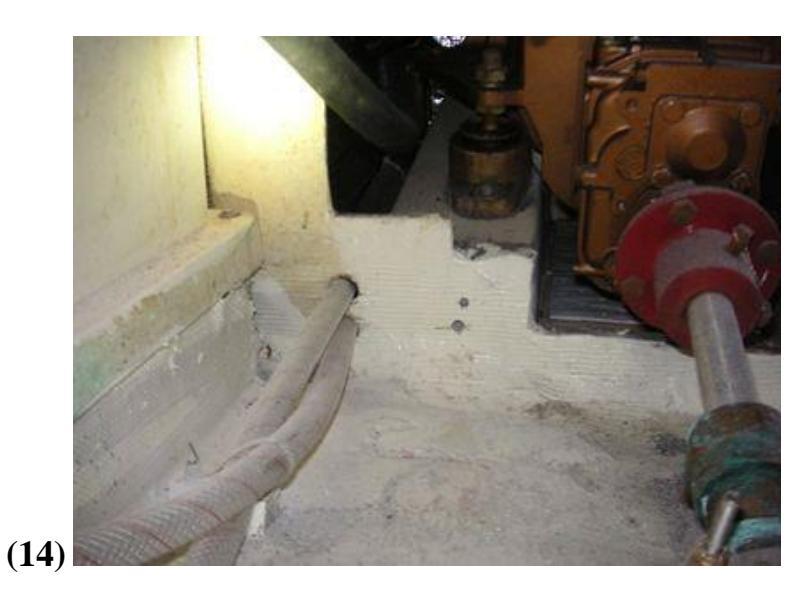
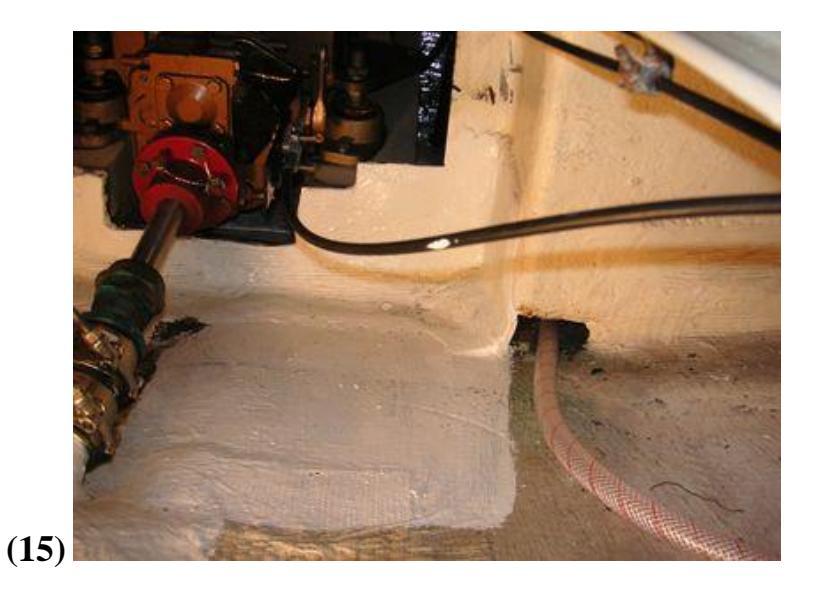
Photos (14) and (15) are taken under the aft cabin with the cushions and wood cover removed. My original plan was to run the cables from the battery compartment under the cabin floor and engine compartment through a hole in this area. (I recently painted this area with white bilgekote when I replaced all the fresh water and vent hoses). In photo (14), you can see 2 small pilot holes I drilled under the port engine mount. I drilled the pilot holes about 1" deep but did not break through. So I plugged the pilot holes with hardwood dowels and 3M 5200 and changed plans. My fall back plan was to run the cables through the opening shown in Photo (15) where the water hose from the aft tank went under the cabin floor to the sink area.

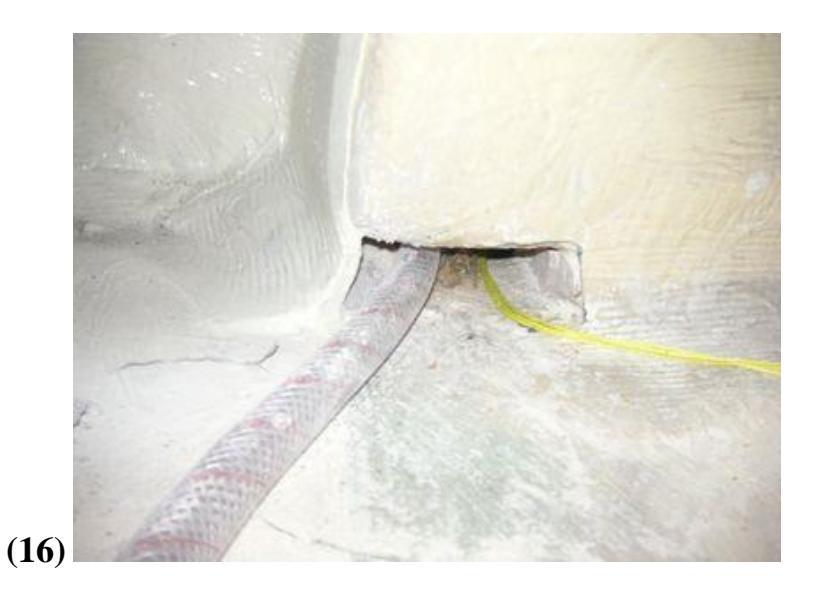
Barely visible in photo (16) is a dark clump of old adhesive sitting in the opening to the right of the aft tank water supply hose. It appeared to be excess adhesive for the conduit from the original build of the boat. A light tap with a screwdriver removed it, and now the path is clear to pass the 1 AWG cables through. The yellow strings are messenger lines to pull new cable.
