1987 MK 1 Catalina 34 Manuals and Paper Charts Storage

By Jon Windt; s/v Della Jean

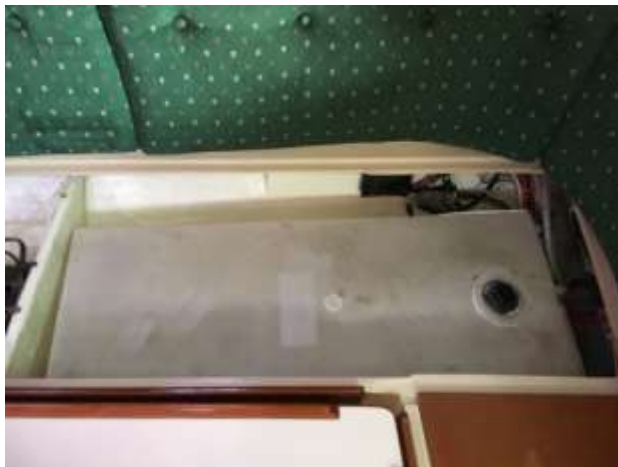
(1)

I purchased my 1987 MK 1 Catalina 34, hull #493 in April 2015. A great boat, but usable storage from the factory is limited. I have parts manuals I want to keep on the boat, but needed a place to store them. The top of the starboard water tank under the settee, has enough empty space. Putting them here they would be easy to get to, but out of the way of day to day activities. See Photo (1).

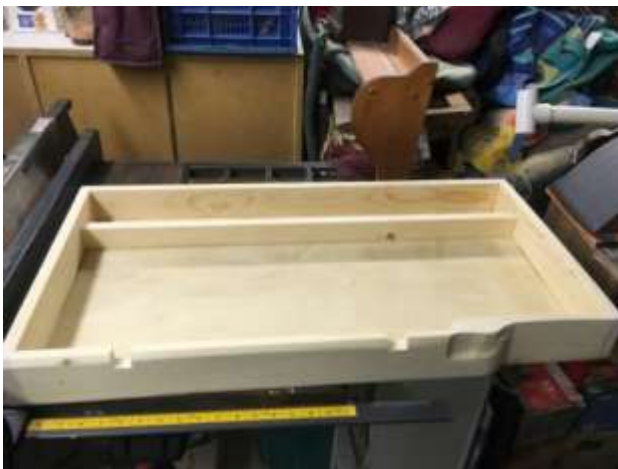
In Photo (2) of the inboard edge of the storage bin where you can see two notches, a shaped recess area, and a jog. The notches are to give clearance to the screws holding the Teak trim the table rests in when lowered into a double berth. The shaped recess area is to give clearance to uneven surfaces in the fiberglass, and the jog is to step around the battery compartment. A lot more creative sanding and shaping than I originally thought.

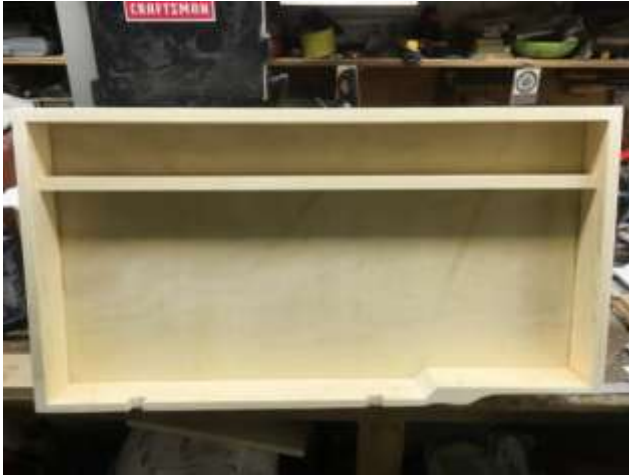
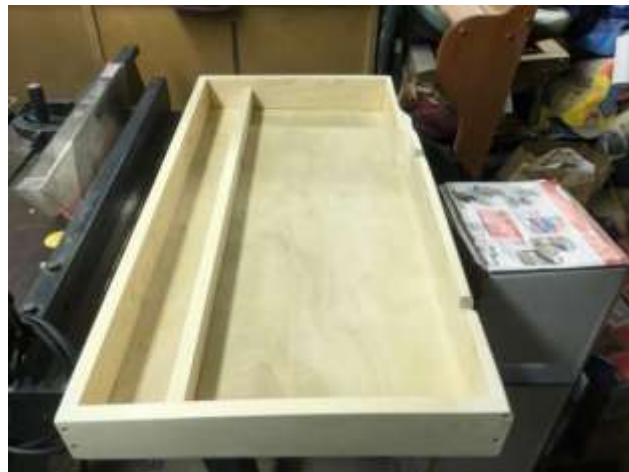
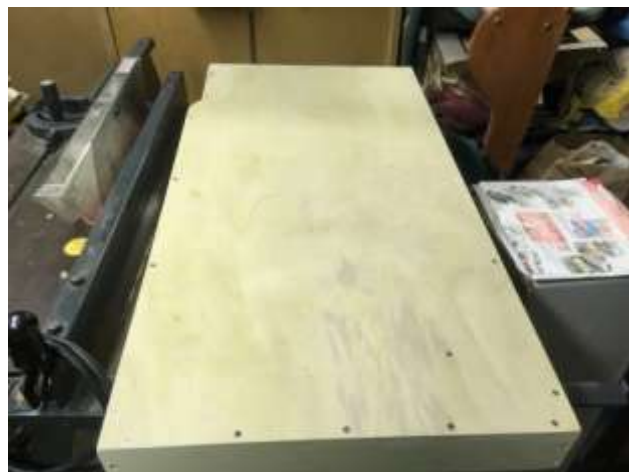
Photos (3), (4), and (5) show the different views of the unpainted storage bin.

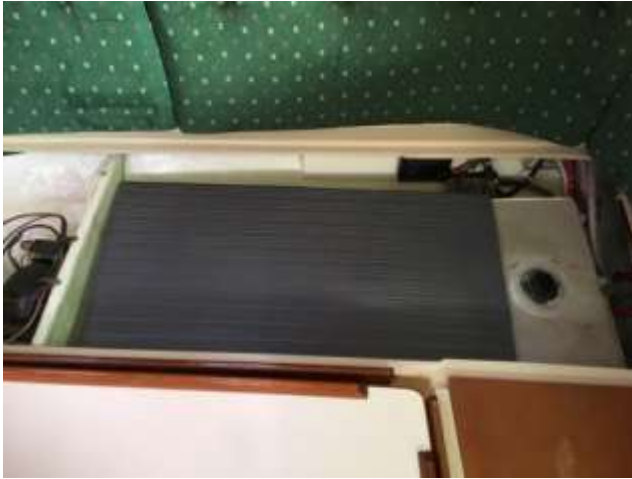
Mounting the storage shelf was straight forward. To avoid chafe wearing a hole in the top of the water tank over time, I put a gray foam pad between the tank and the storage bin. See Photo (6)

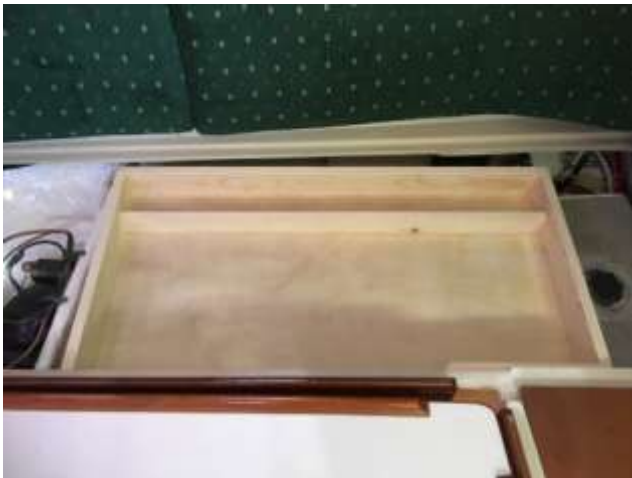
Photo (7) shows the storage bin installed on top of the foam pad and water tank. The top surface of the storage bin is below the recessed lip the cover for the water tank access lid rests on. The black circle on the right of the storage bin is the access plug into the water tank.

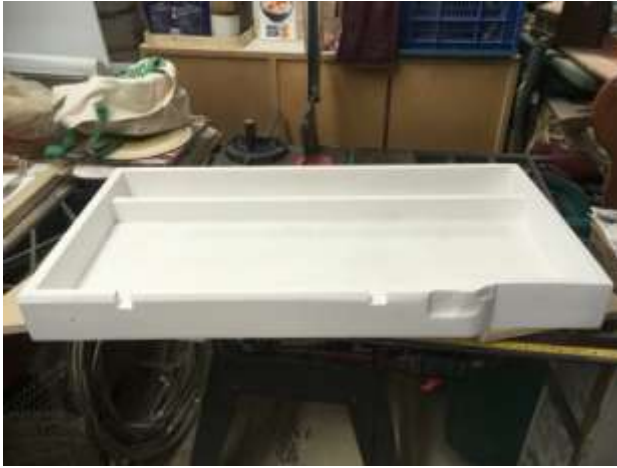
(8)

With the test fit complete and adjustments made, I applied a coat of Kilz brand white primer. See Photo (8).

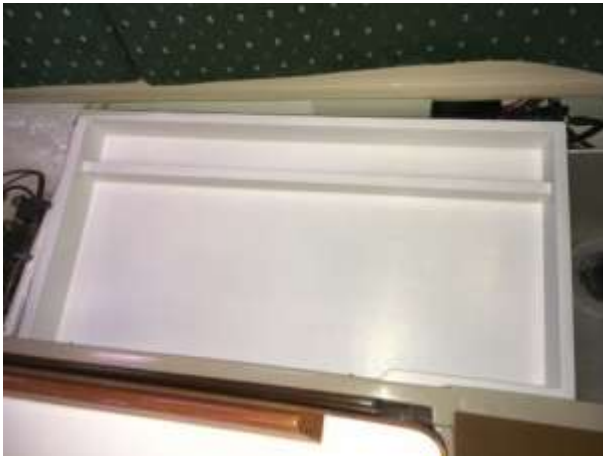
Photo (9) shows the final assembly painted with interior/exterior semi gloss enamel paint and installed on top of the water tank with the foam pad in between the tank and the storage bin. The storage bin is fastened to the boat using two #10-24 x 1 ½ long Truss head SST screws, washers and Nyloc nuts through the sette's vertical bulkhead just below the Teak trim.

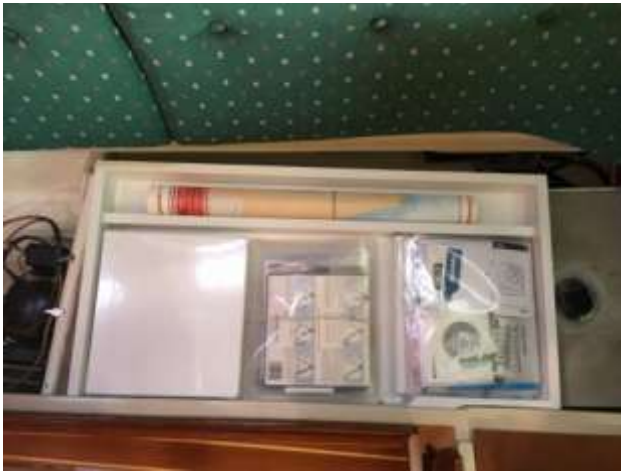
Photo (10) shows the final assembly filled with one large and one standard size 3 ring notebook, two clear 8 ½ x 11” folders full of more parts manuals, and a rolled up paper chart.

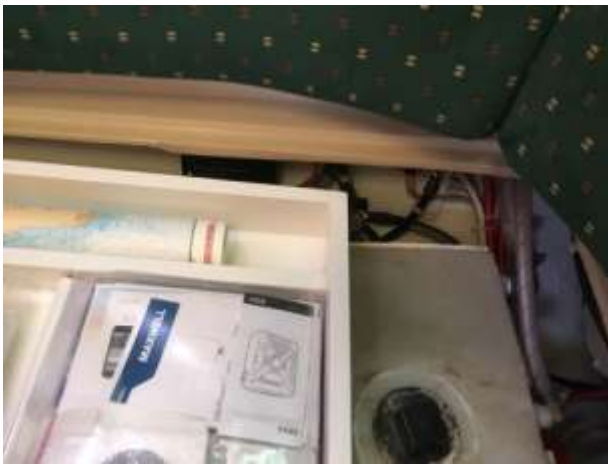
(11)

A couple of years ago I did a major project upgrading the electrical system on my boat. One of the upgrades was adding a Digital Echo Charger on a breadboard in the area under the sette and outboard of the water tank. When I do routine system checks, I check that this light is on so it's important that it continues to be visible without moving or removing anything. In photo (12) you can barely see the green status light of the Digital Echo Charger is visible above the top edge of the storage bin with the storage bin fastened in place.

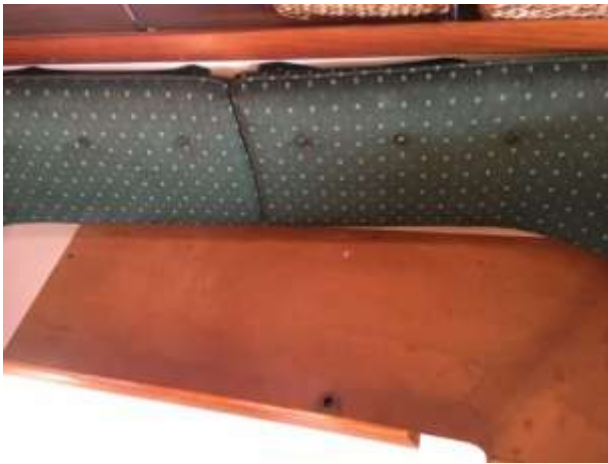
The last photo of this project is photo (12) showing the original lid reinstalled before putting the cushions back in place.
