# 1987 MK 1 Catalina 34 Electrical System Upgrade

By Jon Windt; s/v Della Jean

**REVISION A – 7-31-2016** Section 11 was revised due to re-routing of the #1, 5, and 14 1 AWG cables directly to the engine compartment from the house bank. The Cable Planner Excel and pdf files, and the pdf file of this write up have been updated and attached to this write up to reflect the current routing. The schematic and cable ID #'s are unchanged, only the routing is different.

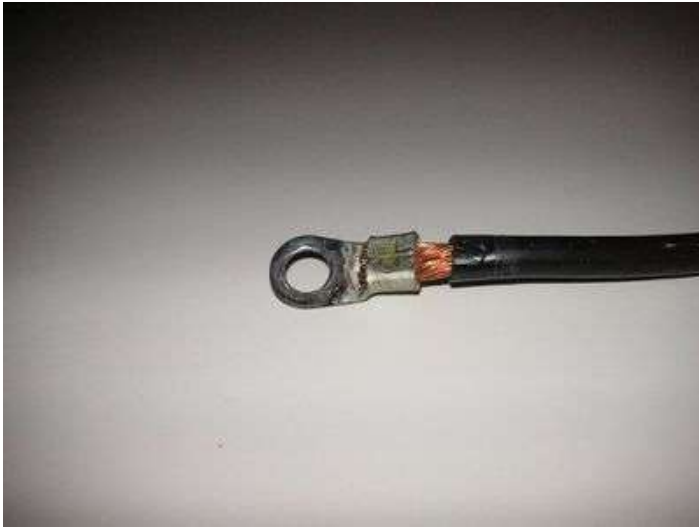
Photo (1) is one example of a negative battery cable and lug with electrical tape removed. Notice the crimp terminal and the exposed wire end by the ring. Photo (2) is looking down at the original red 4 AWG cable from the 105A alternator output to the starter. The other red 4 AWG cable runs from the starter, ~ 20 cable feet to the 1-2-Both switch at the Navigation Station. From there it ran another 15 cable feet to the battery in the battery compartment.

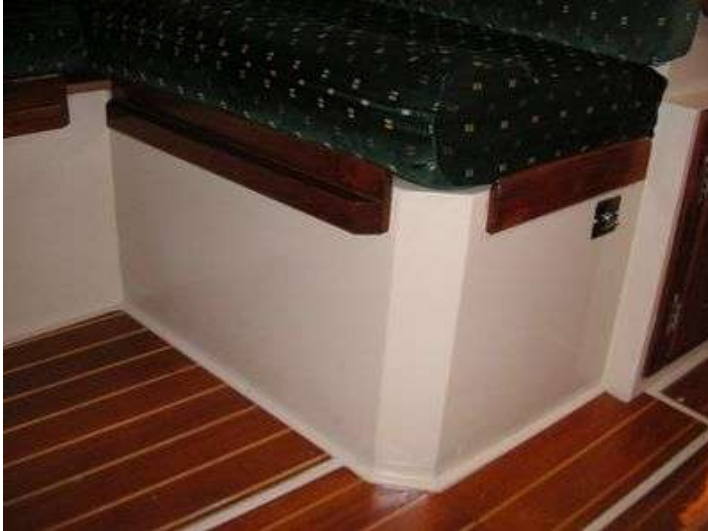
Photo (3) is the outside of the OEM battery compartment showing no ventilation openings. The switch in the upper right inboard side of the battery compartment is where the auto/on/off bilge pump switch was originally located. Photo (4) shows the original 2x Group 24 batteries, the 2 busbars, a Power Pulse battery maintenance widget, and a shunt for the Link 10 inside the battery compartment.

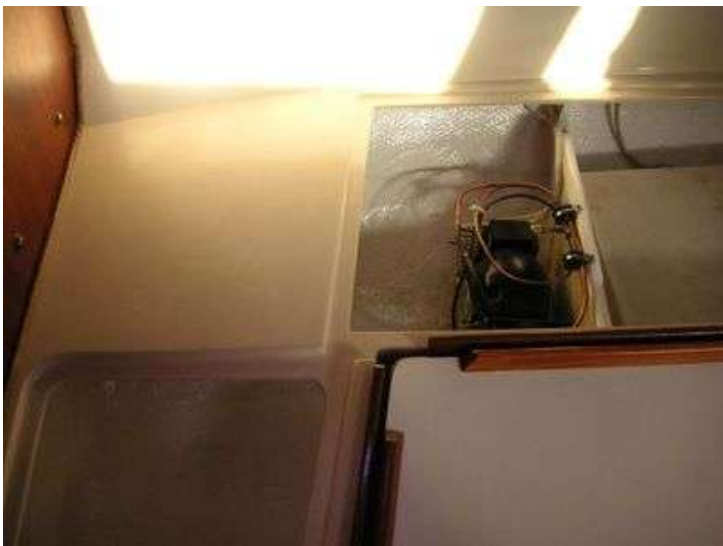
Photos (8) and (9) show the salon area with the wood covers removed. In Photo (8) you can see the fridge compressor attached to the bulkhead at the end of the starboard water tank. Photo (9) shows the water tank and ProMariner ProSport 20A AC charger. The wire from the breaker to the charger had a 3 prong plug connection (like an extension cord) at the charger, and the charger wasn't fastened to anything, just lying there on the hull waiting to flop around. Not very robust.

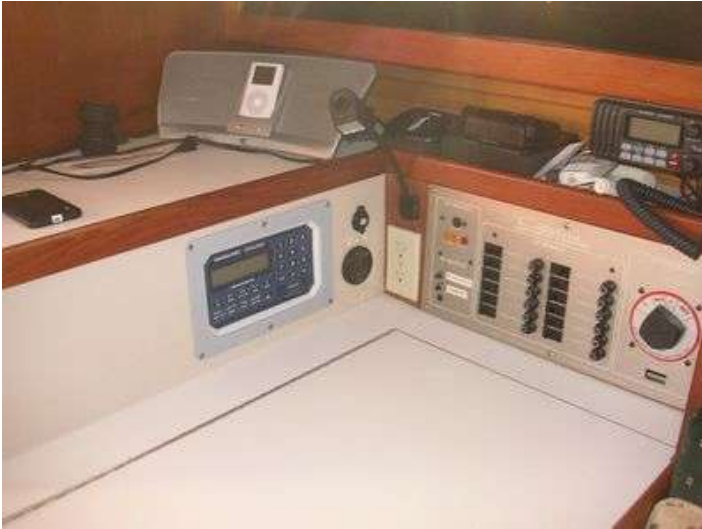
Photo (11) shows the Navigation Station with the OEM Main Panel, Link 10 battery monitor and 12VDC outlet installed by a PO. The panel has a single pole main, the polarity lights flickered, the lens for a light and the light under the battery switch were missing, the Link 10 did not operate.

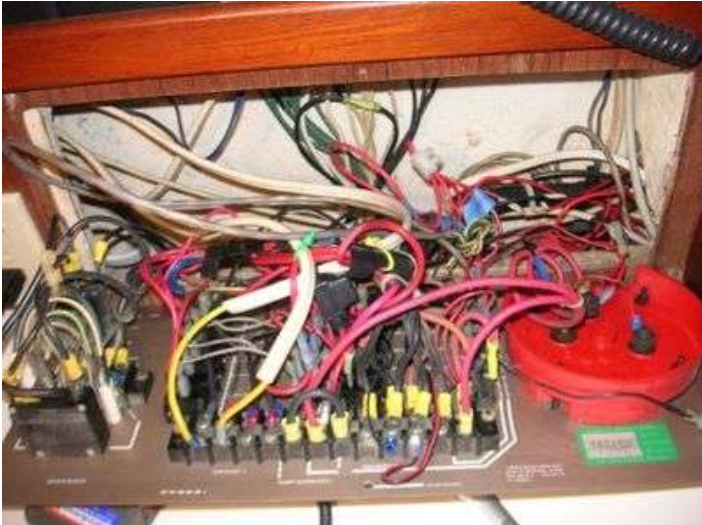
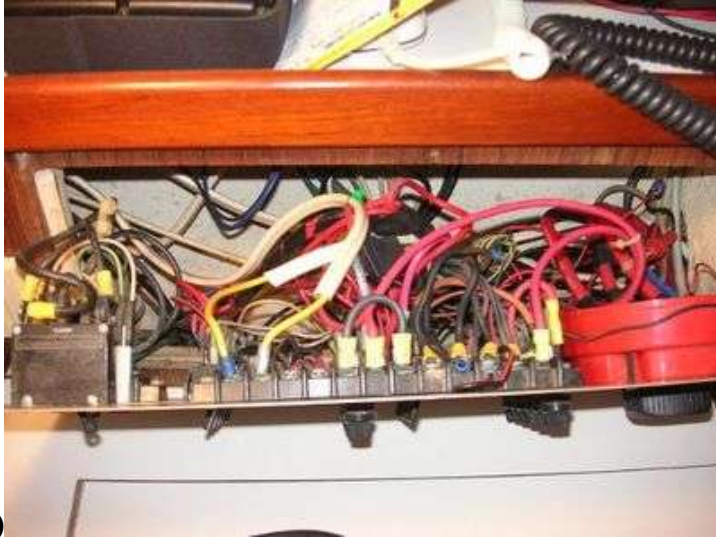
Photos (12) and (13) show the wires behind the main panel. To be polite, it was a corroded mess.

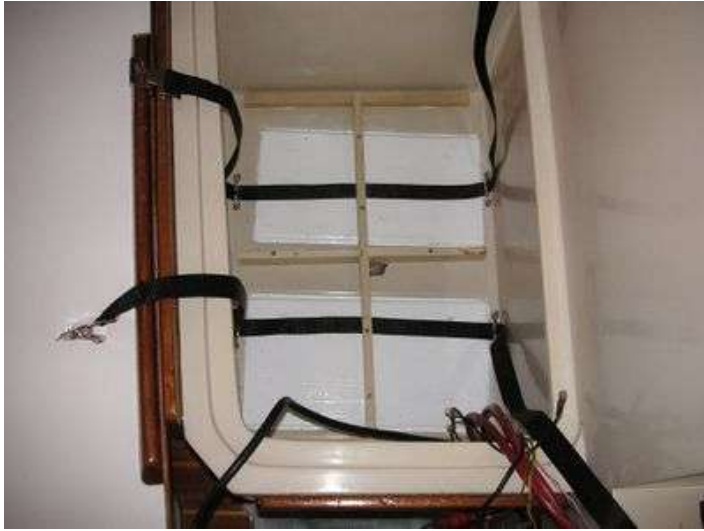
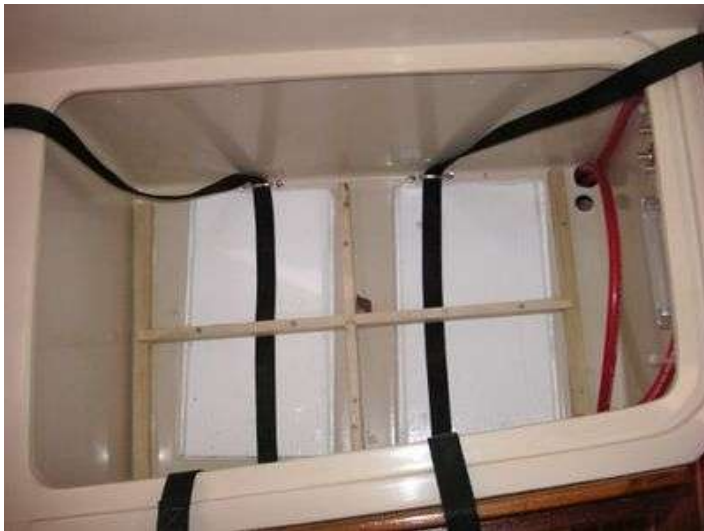
Photos (17) and (18) show the 2x8 painted wood fillers, the “egg crate” made from  $\frac{3}{4}$ ” x  $\frac{3}{4}$ ” hardwood strips screwed and countersunk to the bottom, and the battery straps all to keep the batteries in place while underway. Photo (18) shows 2 existing holes in the bottom of the box with new cables passing through. (I was later glad to have 2 entry holes). I drilled holes for #8 screws for wire ties along the upper battery box wall, and 2 thru holes for #8 screws in the radius at the bottom of the box on the water heater side. These are to attach wire ties outside of the box near the water heater for the cables that will run in that area. The 2 thru holes were covered with the same silicone caulk used earlier to seal them from a possible battery leak. Be sure the screws do not extend into the battery box or you’ll damage the batteries.

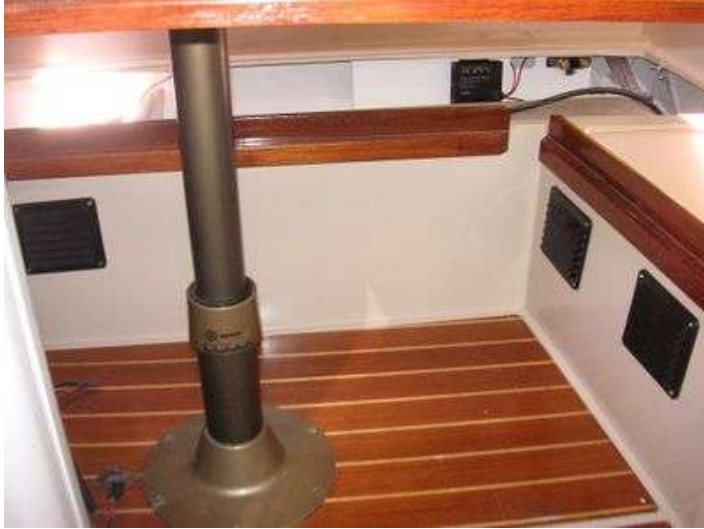
Photos (20 and (21) show the 2 new black ventilation covers installed in the battery box and the 1-2-Both battery switch installed where the bilge pump auto/on/off switch used to be. (In the background of photos you can see the breadboard for the Xantrex Digital Echo charge, house negative busbar, and BMV-700 shunt, but more on that later). The battery switch is a Blue Sea 6007 installed with the front panel mounted option. I used a 2 5/8" Milwaukee Dozer hole saw to drill the hole for the battery switch. It was tricky since I was using the hole saw to enlarge the existing smaller bilge switch hole. The battery box is two walls that are hollow in between. I wedged a piece of wood into the hollow section to give the hole saw pilot bit something to grab on to. I lined up the hole saw with the top of the existing bilge switch hole and went for it. It worked, but maybe not the safest couple of minutes I spent on this project.

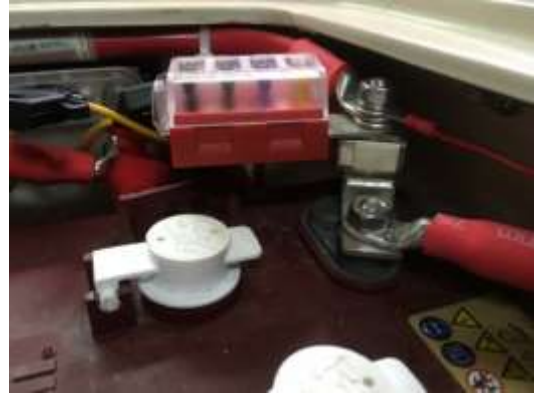
Photos (23), and (23A) show the Blue Sea 5024 fuse block I used to combine 4 fused runs into one small space with one connection point directly on the battery. The battery posts are short allowing connection of only 2 lugs comfortably. Photo (23A) shows the stack sequence on the battery terminal as the Blue Sea terminal block 5191, positive cable #7, then the nut. On the Blue Sea terminal block 5191, the stack sequence is 250A MRBF, Blue Sea 5024 fuse block, positive cable #2, positive cable #1, then the nut. (The cable #'s are shown in the schematic included with this write-up). Many devices require connecting directly to the battery or as close as possible for best results, and is preferred by ABYC code. This does that neatly.

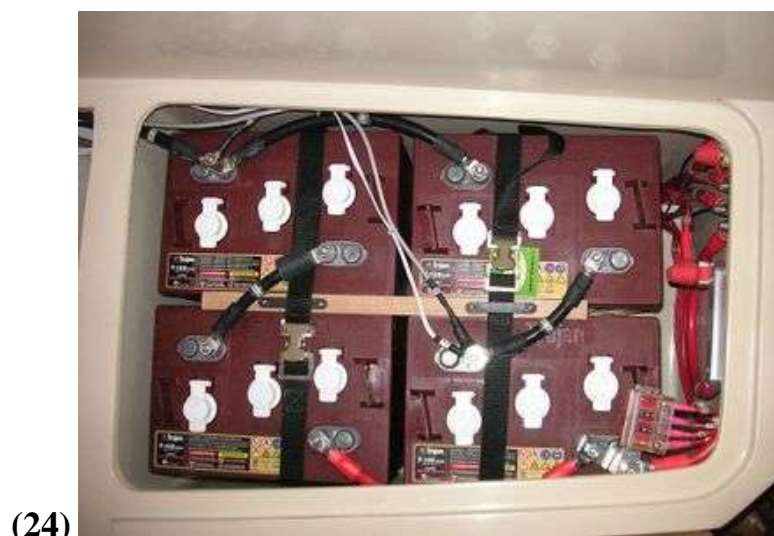
Photo (24) shows the Trojan T105's installed waiting for inspection. I cut a piece of red oak into a "T" shape to fit between the batteries to avoid them tipping together when the battery strap is tightened. The black plastic clips came with the NAPA battery box for the reserve battery. I'm using a higher quality battery strap and stainless steel clips to hold the reserve battery to the shelf, so I decided to use the plastic clips here to keep the wood from sliding. The house bank connects to position 1 on the 1-2-Both battery selector switch. In photo (24), the schematic battery ID #'s starting from the bottom right are #1, bottom left is #2, upper right is #3, and upper left is #4. See the schematic attached in Section 14 of this write-up for the details.

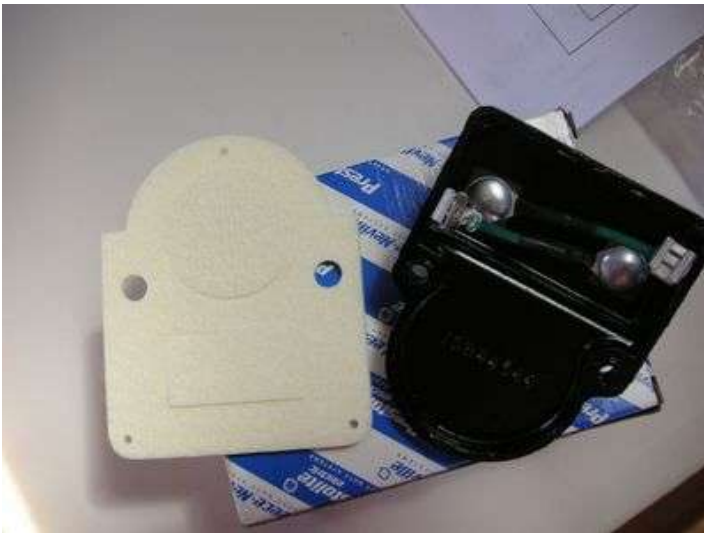
Photo (32) shows an inside view of the same assembled kit before installation.

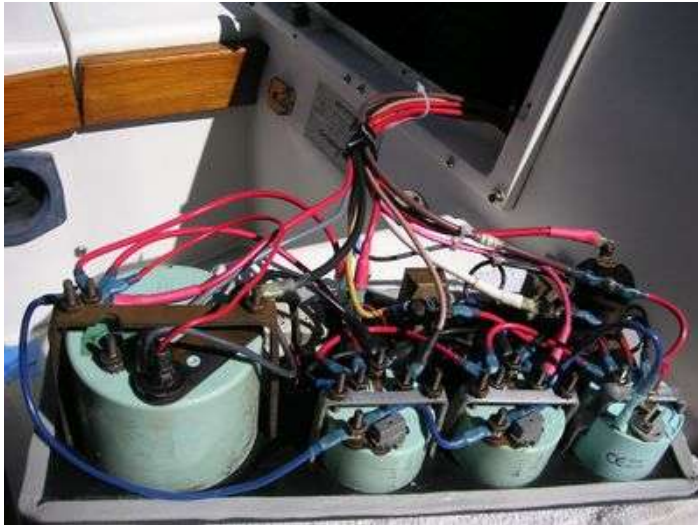
(35)

In photo (35), the brown ignition wire, ID # 50, connects to the ignition switch in the cockpit. The gray material around the perimeter of the cockpit panel is foam tape for weather protection when installed. FYI –I set the belt manager to level 4. The engine was started and run at 1500 rpm. The alternator was charging the house at 80 Amps, the alternator was at 32°C and the house bank was at 18°C. Just like advertised!

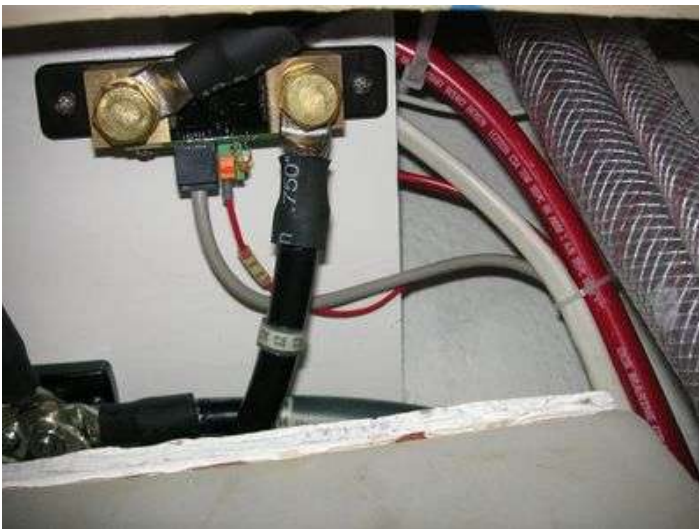
In photo (41) you see the shunt for the BMV-700. The house bank negative is connecting to the brass bolt on the left. This orientation of the shunt was used to have the battery monitor connections pointing down to reduce stress on the wires, and avoid condensation from humidity seeping into the connection points.

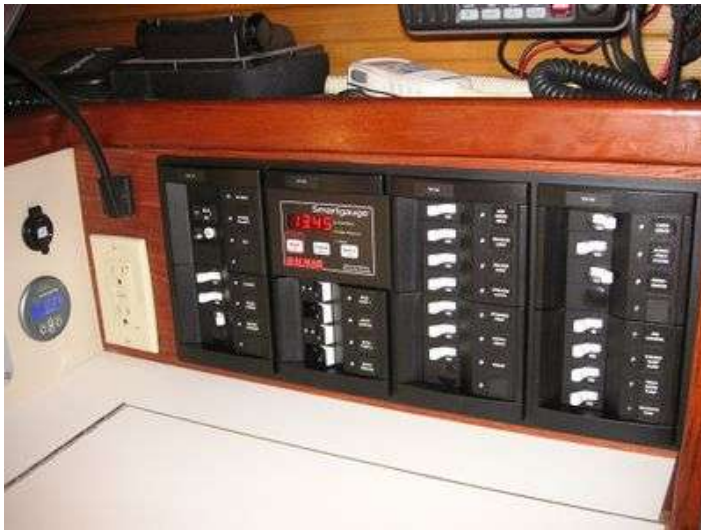
Photo (45) shows the Navigation Station with the new Blue Sea 360 Main Distribution Panel installed. The AC power is on the left side of the panel with a new ELCI 30A double pole main breaker, separate outlet, water heater, and AC battery charger breakers, plus two spares. Moving to the right is the SmartGauge battery monitor located above the bilge pump restricted off and manual on breakers, the right two columns are the 14 DC breakers plus 2 spares. One of the spares will be used for the future auto-pilot. Photo (46) shows the BMV-700 battery monitor and the 12VDC outlet that are installed on the bulkhead shared with the hanging locker, and to the left of the GFCI outlet.

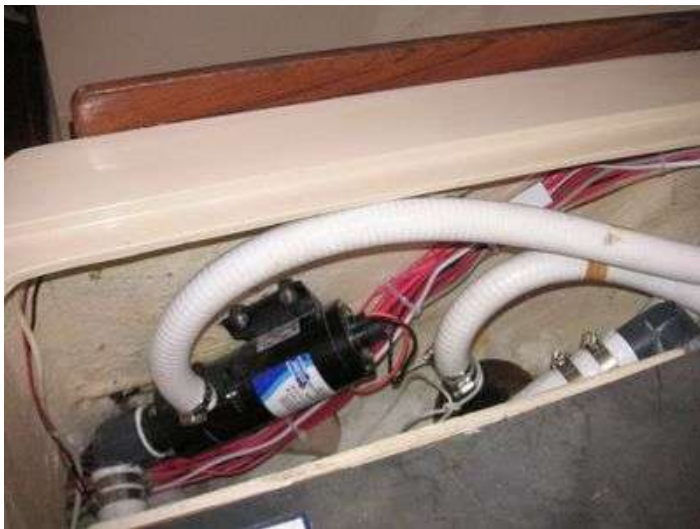
Here in photo (50) you see the wire bundle going by the macerator pump and motor up to the main distribution panel higher than before to get them off the hull and out of the way.

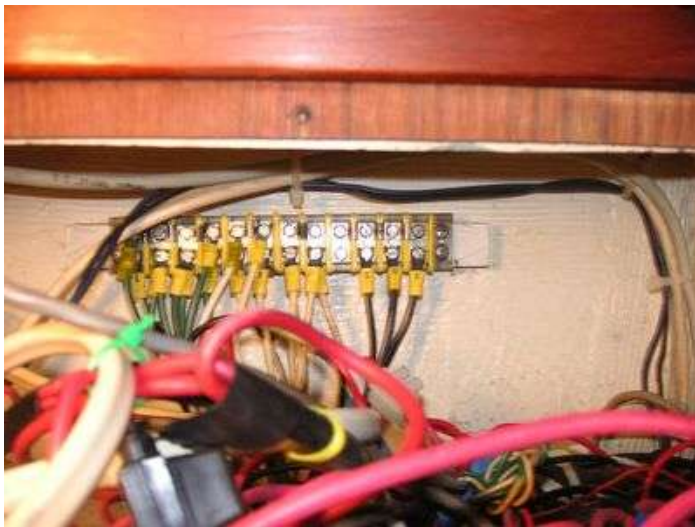
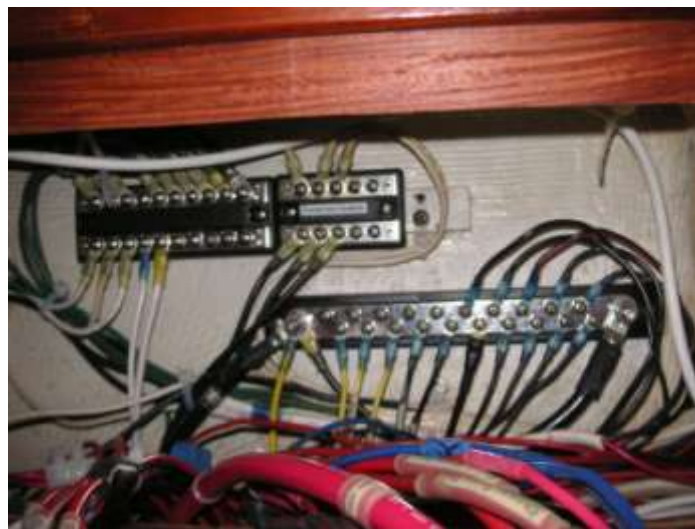
**AC Busbar Replacement:** I removed the original terminal strip in photo (53) and replaced it with a 10 screw dual busbar and a 5 screw dual busbar as shown in photo (54). In photo (53) you can see dark spots under the screw at the end of each wire. Those are corroded spade fittings with open crimps at both ends. I removed and replaced all with heat shrink adhesive lined ring terminals. They are now all nice and shiny new in photo (54). The 10 screw dual busbar is for most AC neutrals and all grounds. The smaller 5 screw dual busbar is dedicated to line and neutrals for the cabin, galley, and head protected AC outlets. The AC outlet power leaves the panel breaker and connects to the GFCI outlet at the Navigation Station. From there it connects to the 5 screw dual busbar for the downstream AC outlets, and is labeled "Protected Outlets". In this arrangement the cabin, galley, and head outlets are all protected by the Navigation Station GFCI outlet. The down side to this arrangement is the AC outlets are limited to a combined total of 30A. This may or may not be a nuisance item. I plan to wait and see if it is an issue before changing anything.

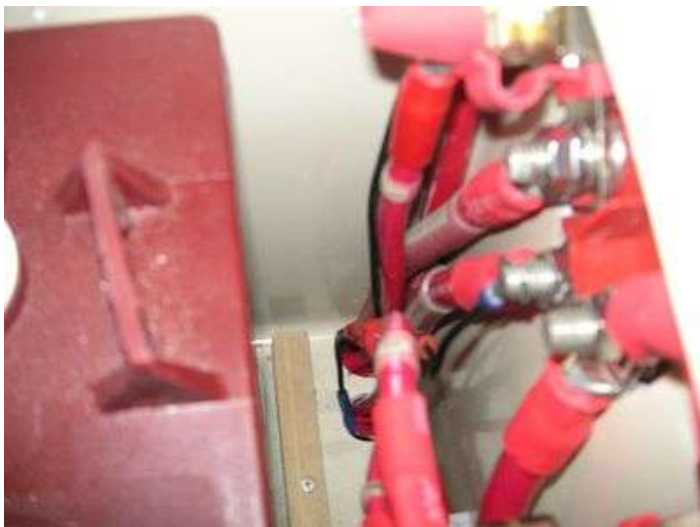
Photo (61) shows the cables entering the bottom of the battery box thru the larger of the two existing holes and connecting to the back of the 1-2-Both battery selector switch in the battery box, the “always on” busbar, and the house battery bank. Remember I said I was glad there were two holes? This is why, it is big stuff. *NOTE: although the battery selector switch posts extended into the battery compartment, the back of the switch was slightly recessed so I was not able to tighten down the cables. Adding a SST washer to each post allowed me to tighten each post and get full contact as required.*

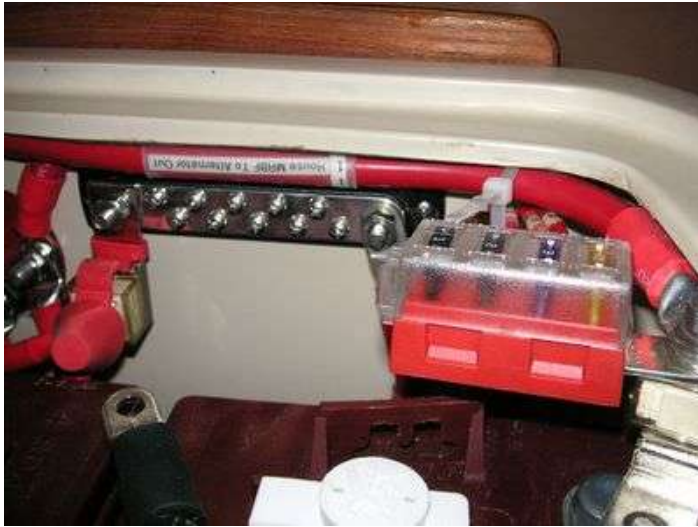
(64)

In photo (64), you see the end of the Blue Sea 5024 fuse block discussed in the House Battery section.

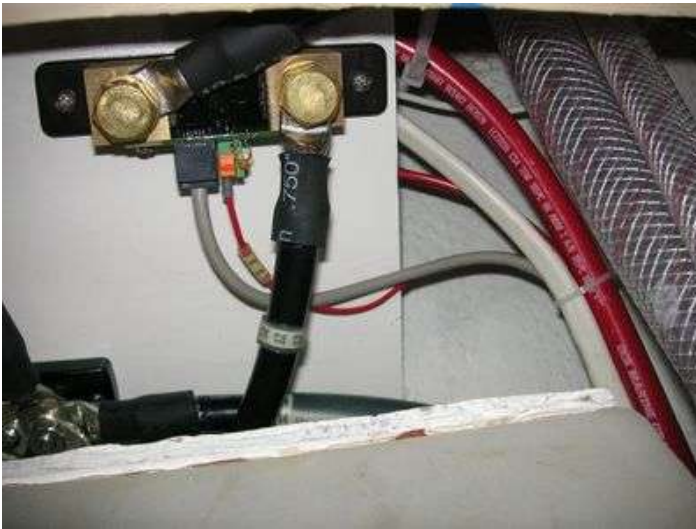
(67)

That same cable then connects to the left bolt on the BMV-700 shunt attached to the breadboard as shown in photo (67).

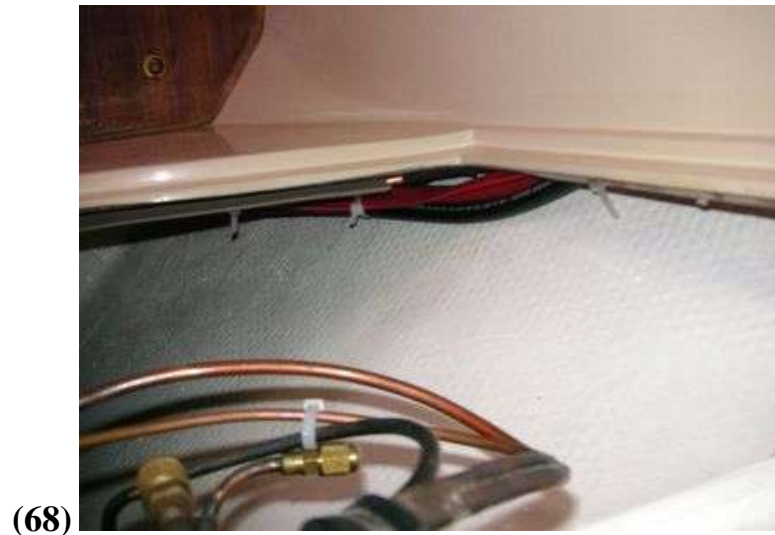
Photo (68) shows the positive and negative cables running to the reserve battery from the Digital Echo Charge, the SmartGauge, the 1-2-Both battery selector switch position #2, and from the house bank negative busbar. The shiny bit you see is the refrigeration line. To protect the refrigeration lines in case there is a gas leak from the maintenance free battery, I covered it with the material used to cover wires on the floor so you don't trip. Photo (69) shows the wires and cables from the reserve battery, Digital Echo Charge, and the SmartGauge running underneath the storage cubby holes behind the outboard salon seat cushion. The white Nomex is the existing DC wiring for the refrigerator compressor and fan. The wood you see is glassed in and is part of the boat. It wasn't added by me for this project.

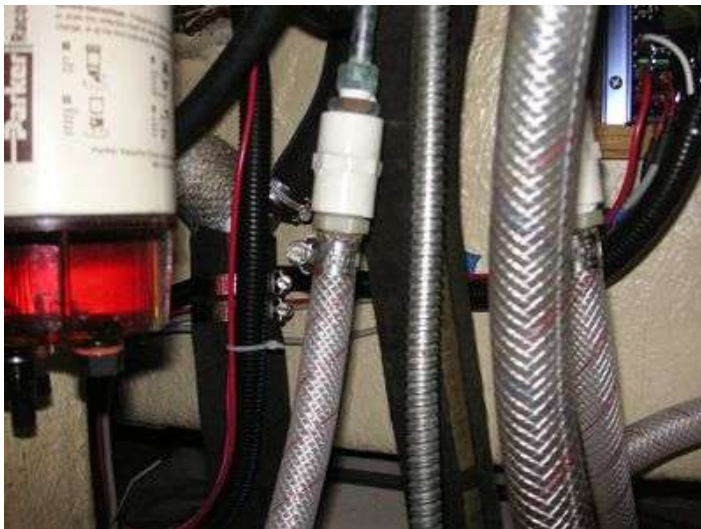
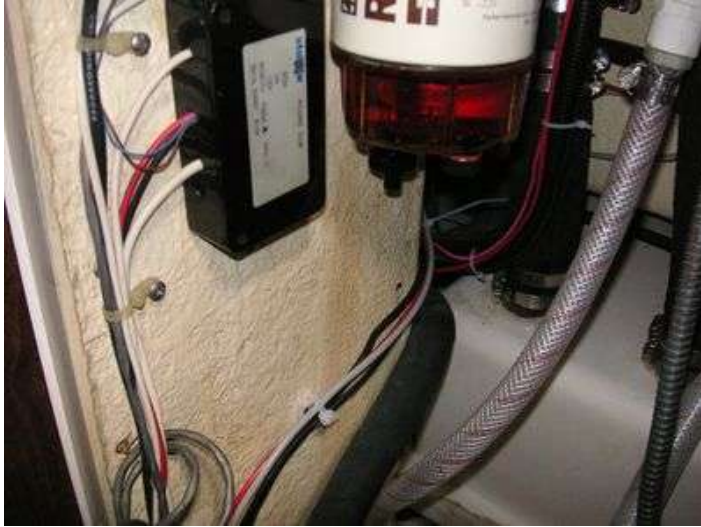
Photos (71) and (72) show the external regulator wiring under the head sink in the split loom, then is runs along the engine compartment bulkhead under the Racor filter.

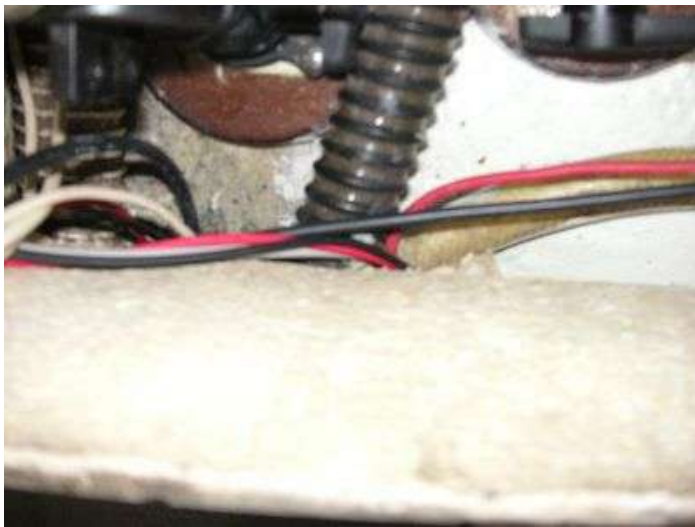
Photo (73) the external regulator wires enter the 3/4" conduit under the shower pan. They exit the conduit by the macerator pump/motor in photo (75) of the next photo group. The black box by the Racor is part of my non-working depth/temp/speed system.

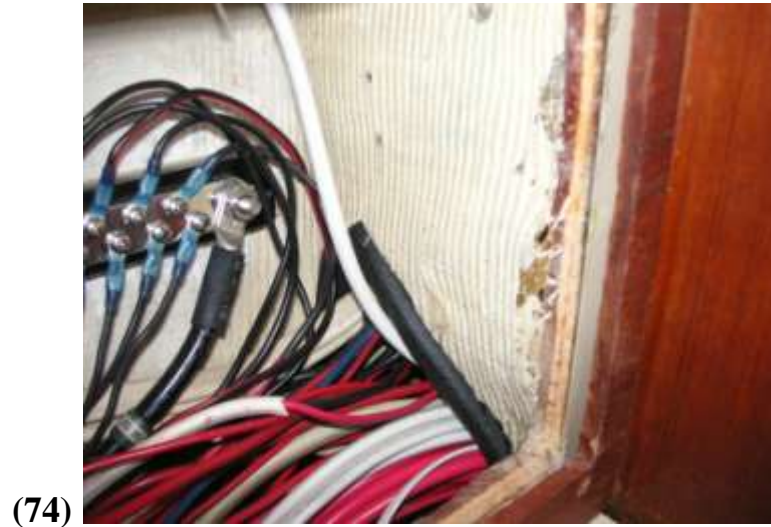
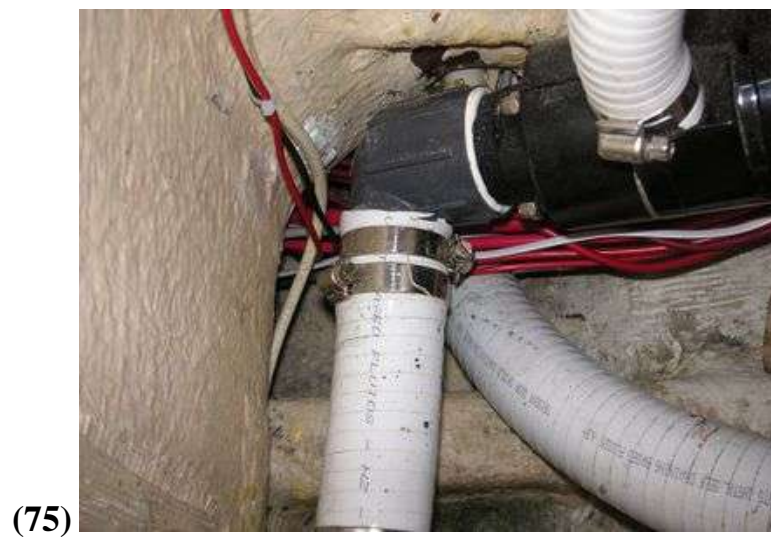
Finally photos of the wires running from behind the Main Distribution Panel, to the battery box area. Photo (74) shows the bundle exiting from behind the Main Distribution Panel with a chafe guard I made from some extra fuel hose, and photo (75) shows where they pass under the macerator pump/motor and pick up the external regulator wires.

Photo (76) is where they cross over above the bilge. The hoses lying on the hull are for the hot and cold water to the head and the existing manual and electric bilge pumps.
