# 1987 MK 1 Catalina 34 Electrical System Upgrade

By Jon Windt; s/v Della Jean

**REVISION A – 7-31-2016 Section 11 was revised due to re-routing of the #1, 5, and 14 1 AWG cables directly to the engine compartment from the house bank**

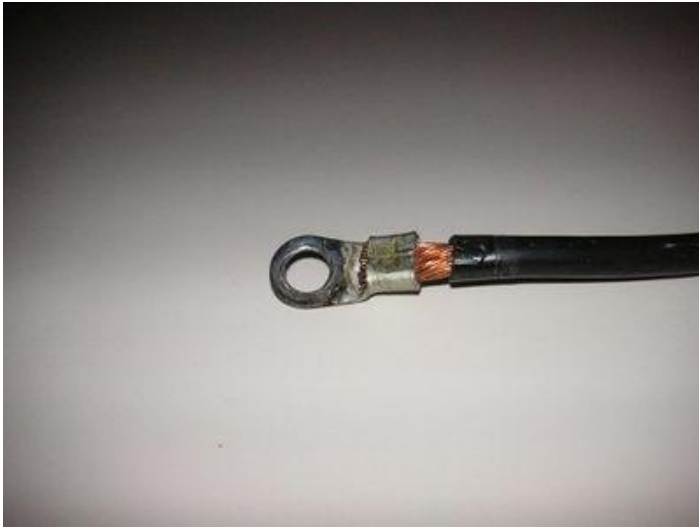
Photo (1) is one example of a negative battery cable and lug with electrical tape removed. Notice the crimp terminal and the exposed wire end by the ring. Photo (2) is looking down at the original red 4 AWG cable from the 105A alternator output to the starter. The other red 4 AWG cable runs from the starter, ~ 20 cable feet to the 1-2-Both switch at the Navigation Station. From there it ran another 15 cable feet to the battery in the battery compartment.

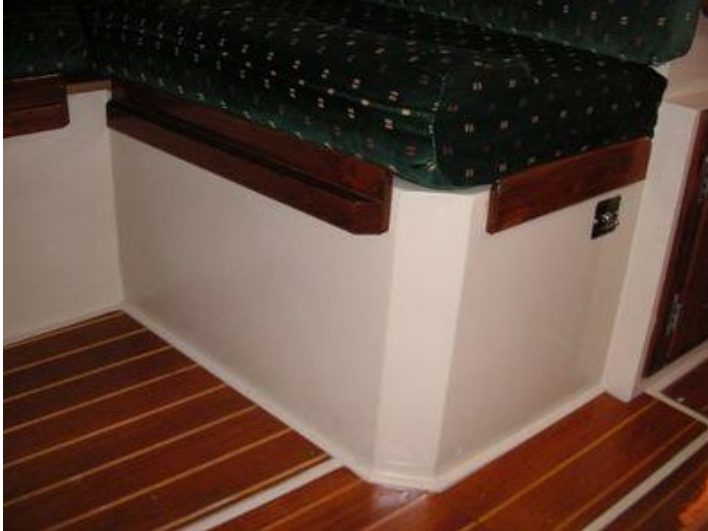
Photo (3) is the outside of the OEM battery compartment showing no ventilation openings. The switch in the upper right inboard side of the battery compartment is where the auto/on/off bilge pump switch was originally located. Photo (4) shows the original 2x Group 24 batteries, the 2 busbars, a Power Pulse battery maintenance widget, and a shunt for the Link 10 inside the battery compartment.

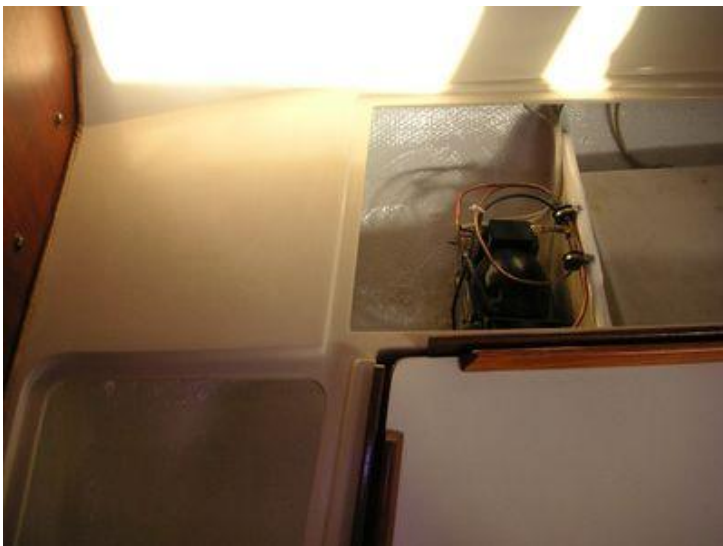
Photos (8) and (9) show the salon area with the wood covers removed. In Photo (8) you can see the fridge compressor attached to the bulkhead at the end of the starboard water tank. Photo (9) shows the water tank and ProMariner ProSport 20A AC charger. The wire from the breaker to the charger had a 3 prong plug connection (like an extension cord) at the charger, and the charger wasn't fastened to anything, just lying there on the hull waiting to flop around. Not very robust.

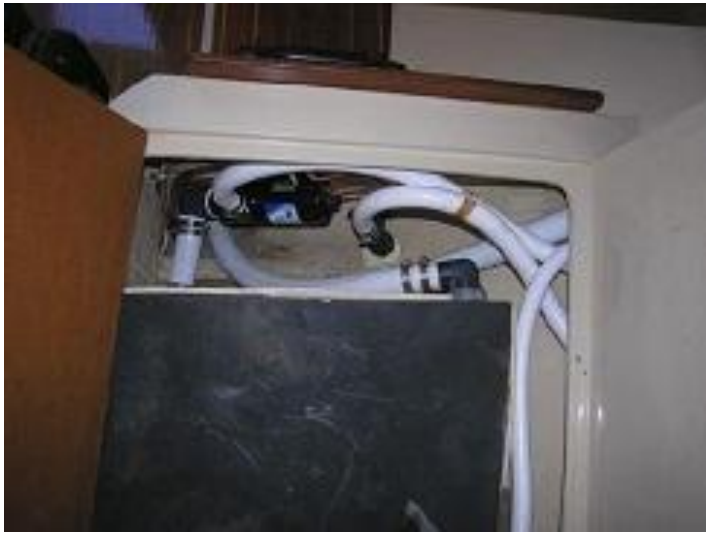
**(10)**

Photo (10) shows the holding tank, macerator pump, hoses, and if you look close the original wiring and cables running up to the master distribution panel at the Navigation Station.

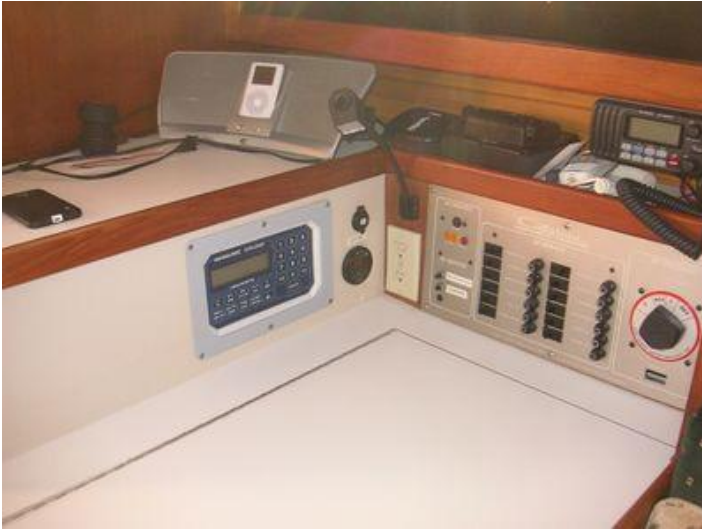
Photo (11) shows the Navigation Station with the OEM Main Panel, Link 10 battery monitor and 12VDC outlet installed by a PO. The panel has a single pole main, the polarity lights flickered, the lens for a light and the light under the battery switch were missing, the Link 10 did not operate.

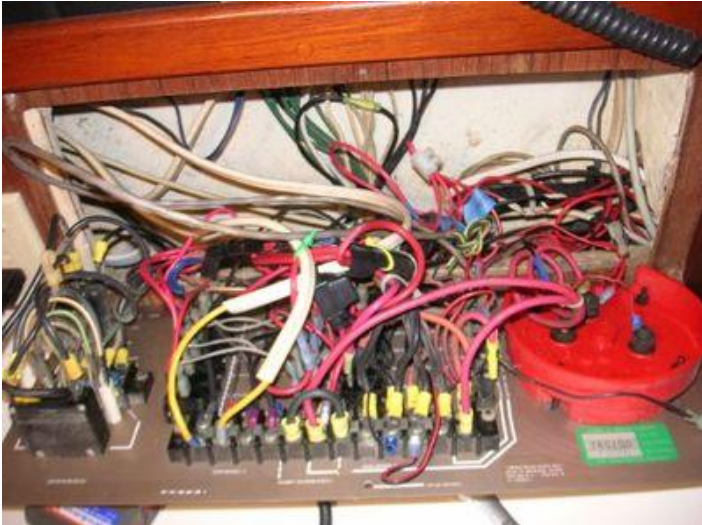
Photos (12) and (13) show the wires behind the main panel. To be polite, it was a corroded mess.

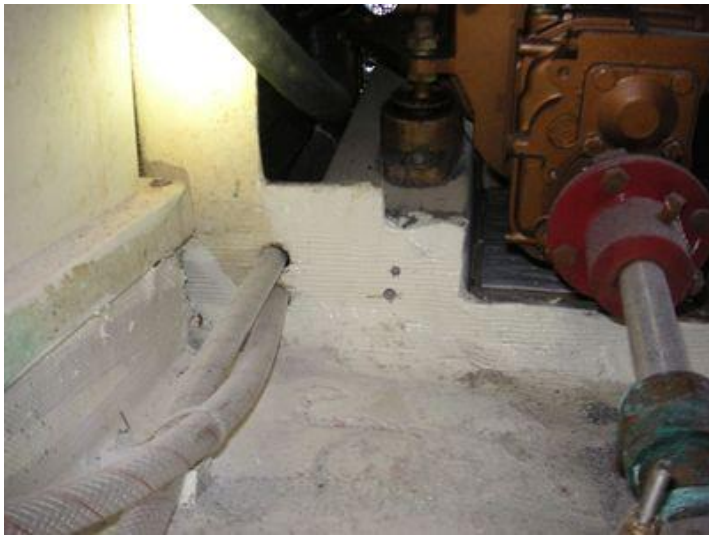
Photos (14) and (15) are taken under the aft cabin with the cushions and wood cover removed. My original plan was to run the cables from the battery compartment under the cabin floor and engine compartment through a hole in this area. (I recently painted this area with white bilgekote when I replaced all the fresh water and vent hoses). In photo (14), you can see 2 small pilot holes I drilled under the port engine mount. I drilled the pilot holes about 1" deep but did not break through. So I plugged the pilot holes with hardwood dowels and 3M 5200 and changed plans. My fall back plan was to run the cables through the opening shown in Photo (15) where the water hose from the aft tank went under the cabin floor to the sink area.

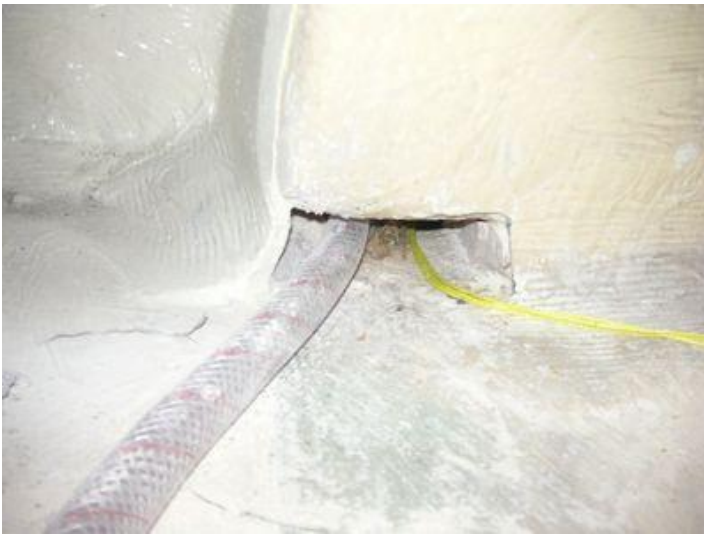
Barely visible in photo (16) is a dark clump of old adhesive sitting in the opening to the right of the aft tank water supply hose. It appeared to be excess adhesive for the conduit from the original build of the boat. A light tap with a screwdriver removed it, and now the path is clear to pass the 1 AWG cables through. The yellow strings are messenger lines to pull new cable. **However**, I found that I could reroute the hot and cold water hoses to the head sink between the manual bilge pump hose and the shower drain hose and reuse the now unused holes in the engine compartment to run the #1, 5, and 14 cables. See photos 55-57 for more clarity. This pass through from under the aft cabin to the galley will be used for my electric 1 1/8" bilge pump hose.

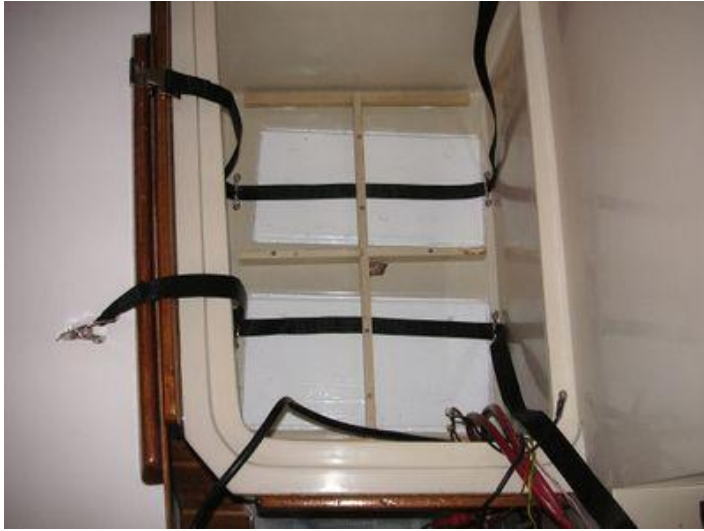
Photos (17) and (18) show the 2x8 painted wood fillers, the “egg crate” made from  $\frac{3}{4}$ ” x  $\frac{3}{4}$ ” hardwood strips screwed and countersunk to the bottom, and the battery straps all to keep the batteries in place while underway. Photo (18) shows 2 existing holes in the bottom of the box with new cables passing through. (I was later glad to have 2 entry holes). I drilled holes for #8 screws for wire ties along the upper battery box wall, and 2 thru holes for #8 screws in the radius at the bottom of the box on the water heater side. These are to attach wire ties outside of the box near the water heater for the cables that will run in that area. The 2 thru holes were covered with the same silicone caulk used earlier to seal them from a possible battery leak. Be sure the screws do not extend into the battery box or you’ll damage the batteries.

**House Battery Box Issues:** The OEM battery box has 2 recessed pans for the original batteries to sit in. In order to convert the battery box from a 2 battery arrangement to using 4 6V golf cart batteries, these recessed pans need to be filled or covered to make a flush surface for the batteries to sit on. The entire surface must be flush so they don't "rock" or have a point load that may cause a battery failure.

To keep the batteries as low as possible in the battery box I elected to fill the recess using a 2x8 piece of wood. I cut it into 2  $\sim 14\frac{1}{4}$ " long by  $\sim 1\frac{9}{16}$ " thick pieces and chamfered the bottom to fit the recessed pan radius and painted them with white bilgekote. I countersunk screws to fasten them to the bottom of the recessed pan, then used a white silicone caulk to fill the gap between the wood edges and the pan. CAUTION - In my case each pan size was slightly different, so I had to customize each to fit and have a flush surface. Measure yours to get your dimensions before cutting anything. An alternative to filling the recess is to use a plywood cover with a support underneath in each recessed pan. The down side to this method is reduced height.

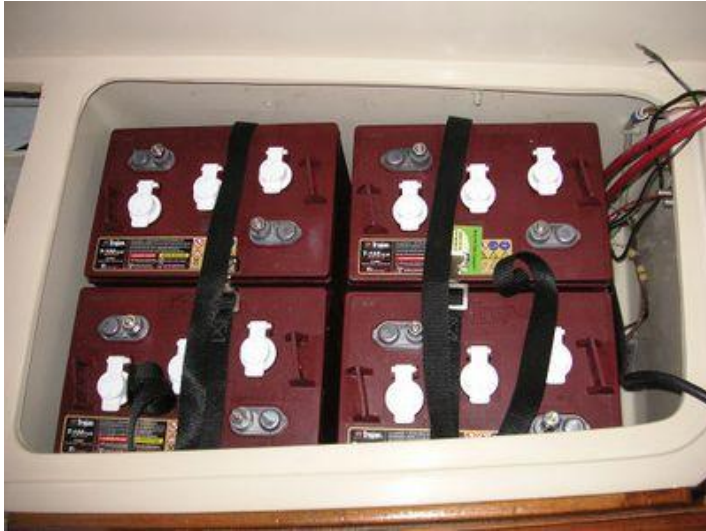
(19)

I didn't want to make the final attachments, and then find out the tie down straps interfered with the fill caps on the batteries. So I temporarily installed all of the house batteries to ensure the eggcrate matched up as intended, and the battery straps didn't interfere with the battery fill caps as shown in photo (19).

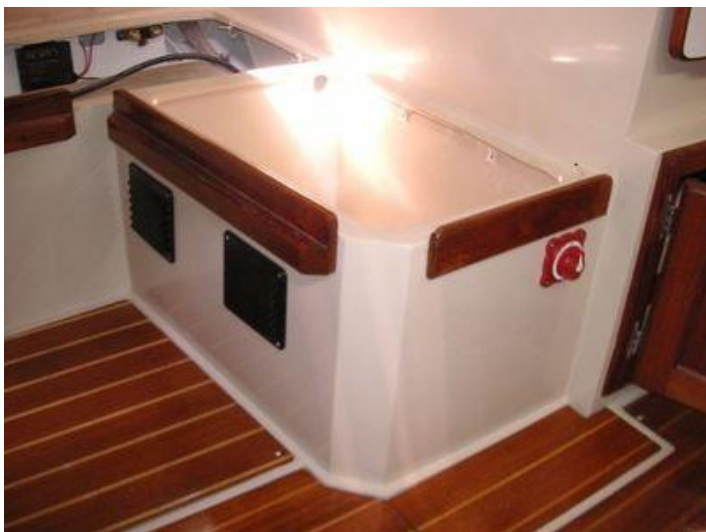
(20)

Photos (20 and (21) show the 2 new black ventilation covers installed in the battery box and the 1-2-Both battery switch installed where the bilge pump auto/on/off switch used to be. (In the background of photos you can see the breadboard for the Xantrex Digital Echo charge, house negative busbar, and BMV-700 shunt, but more on that later). The battery switch is a Blue Sea 6007 installed with the front panel mounted option. I used a 2 5/8" Milwaukee Dozer hole saw to drill the hole for the battery switch. It was tricky since I was using the hole saw to enlarge the existing smaller bilge switch hole. The battery box is two walls that are hollow in between. I wedged a piece of wood into the hollow section to give the hole saw pilot bit something to grab on to. I lined up the hole saw with the top of the existing bilge switch hole and went for it. It worked, but maybe not the safest couple of minutes I spent on this project.

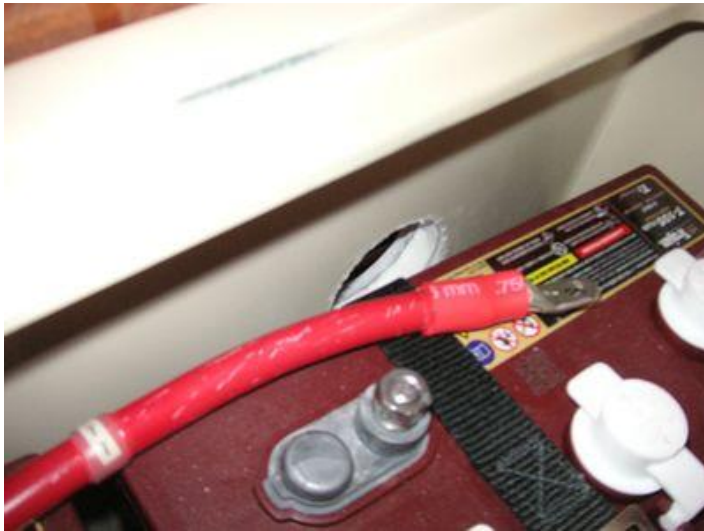
(22)

I used the same 2 5/8" hole saw for the vent covers along the forward side of the battery compartment instead of buying a larger hole saw for two holes. This surface is also two walls and hollow in between. To avoid gases collecting, I rolled up paper towels and stuffed them inside just below the edge of the hole to act as a backing for the caulk I used. The caulk provided a seal with a nice finished appearance as can be seen in photo (22).

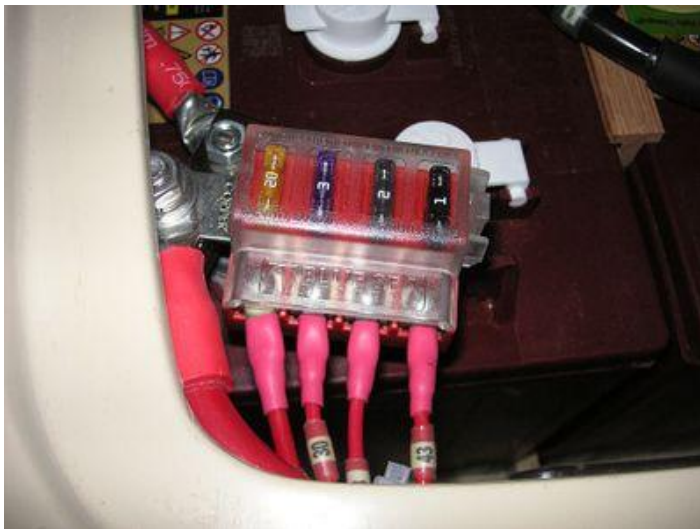
Photos (23) and (24) show the Trojan T105's installed waiting for inspection. I used the Blue Sea 5024 fuse block in the photo (23) to combine 4 fused runs into one small space with one connection point directly on the battery. The battery posts are short allowing connection of only 2 lugs comfortably. Many devices require connecting directly to the battery or as close as possible for best results, and is preferred by ABYC code. This does that neatly. In photo (24) I cut a piece of red oak into a "T" shape to fit between the batteries to avoid them tipping together when the battery strap is tightened. The black plastic clips came with the NAPA battery box for the reserve battery. I'm using a higher quality battery strap and stainless steel clips to hold the reserve battery to the shelf, so I decided to use the plastic clips here to keep the wood from sliding. The house bank connects to position 1 on the 1-2-Both battery selector switch. In photo (24), the schematic battery ID #'s starting from the bottom right are #1, bottom left is #2, upper right is #3, and upper left is #4. See the schematic attached in Section 14 of this write-up for the details.

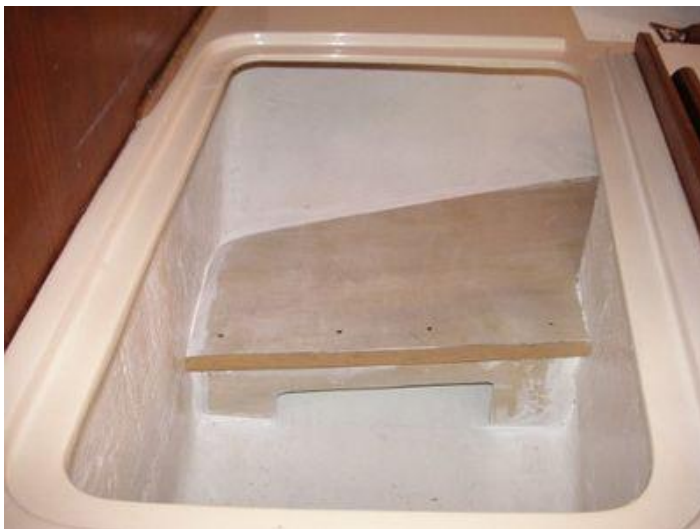
(25)

The most common location others install a reserve/start battery on a C34 is under the aft cabin. When I looked at under aft cabin installations, although done well, it was cramped, dark, wet, and hard to service. I chose to add a shelf under the forward outboard starboard corner section of the salon shown in work in photo (25). A loss of storage area, but my storage is limited here due to the refrigerator compressor anyway which you can see in phot (26). Using ½" birch plywood I fabricated a shelf to match the hull, bulkheads, and refrigerator compressor shelf. I cut an opening in the vertical leg of the new shelf for water drainage and access. The underside was painted in the non-bonding areas with white bilgekote before final installation. The hull and bulkheads were sanded for good adhesion, I then used 3M 5200 to bond the shelf to the hull and countersunk screws to bond the top and vertical leg of the shelf together. The screws were covered with a ½" cove molding for looks and a little additional ledge surface to help when removing the battery. The reserve battery was used as a weight to apply pressure while the 3M 5200 cured. The exterior is finished with white bilgekote.

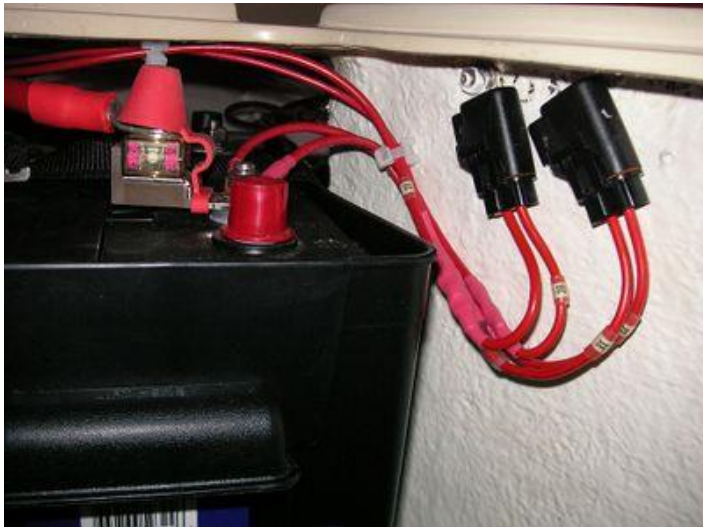
I added hardwood strips, and the same type battery strap as the house bank to keep the battery box from moving while underway. The terminal posts and all fuses are shown in photo (27) are easily accessible by removing a cushion and the wood cover. The SmartGauge and Digital Echo charge in-line fuses are shown mounted on the bulkhead. I also have space to stow a small tool bag as shown in photo (28).

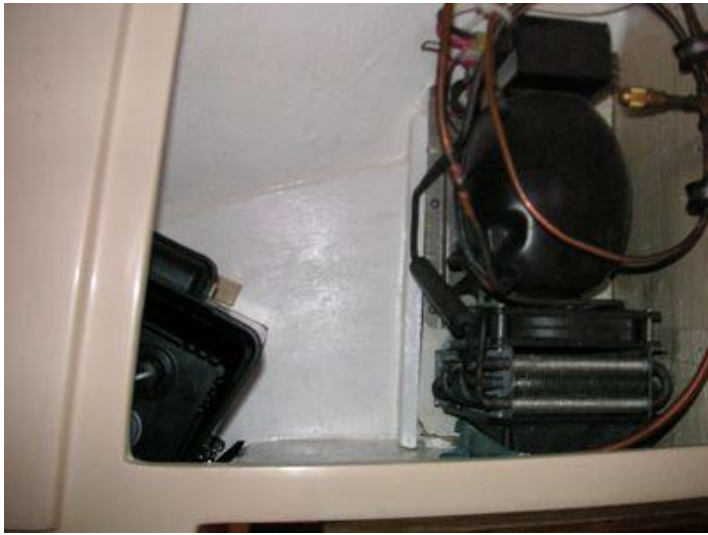
In photo (29) you can see that this arrangement also provides space for a future electric windlass breaker to fit between the battery and fridge compressor.

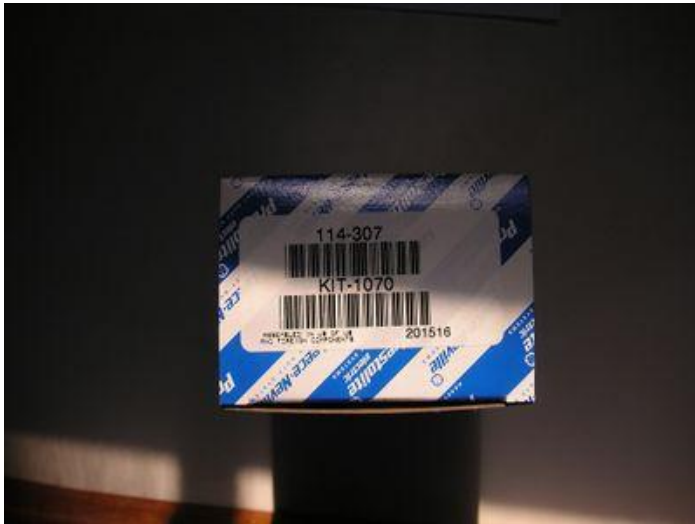
Internally regulated alternators are not designed to periodically recharge a large discharged battery bank rapidly. Technical details and graphs on this subject are discussed at length in my posting [1987 MK1 Electrical System Upgrade – Feedback Requested](#), and in [Electrical Systems 101](#). To take advantage of my existing 105A alternator, I installed an external regulator. This requires a conversion kit for Leece-Neville I purchased from ASE Supply Inc. Photo (30) shows the part # 114-307, Kit 1070. Photo (31) shows an outside view of the assembled kit before installation.

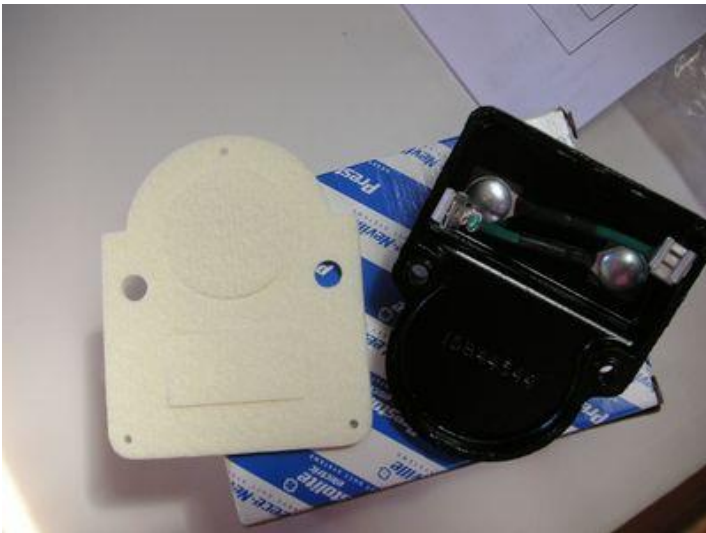
Photo (32) shows an inside view of the same assembled kit before installation.

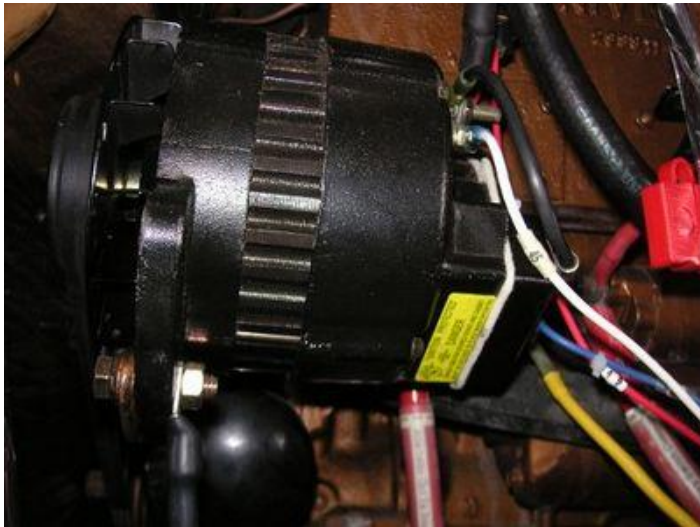
(33)

I used the Balmar MC-614H external regulator with the 54" long harness, and installed both battery and alternator temperature sensing. To attach the alternator temperature sense wire to the alternator I replaced the original 1" long alternator bracket screw with a 1 1/4" long grade 8 screw as shown in photo (33). The MC-614H is installed under the head sink attached to a piece of 3/4" plywood bonded to the bulkhead. It is easy to read the display and use the reed switch for adjustments as shown in photo (34). The regulator wires run to the engine compartment in the split loom. The existing 3/4" conduit under the shower pan is used to connect the positive sense wire to the house bank, and the regulator negative to the house negative busbar after the shunt.

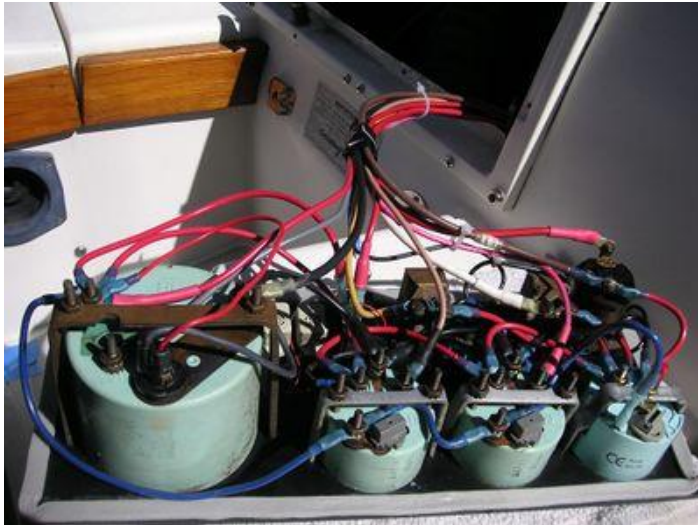
(35)

In photo (35), the brown ignition wire, ID # 50, connects to the ignition switch in the cockpit. The gray material around the perimeter of the cockpit panel is foam tape for weather protection when installed. FYI –I set the belt manager to level 4. The engine was started and run at 1500 rpm. The alternator was charging the house at 80 Amps, the alternator was at 32°C and the house bank was at 18°C. Just like advertised!

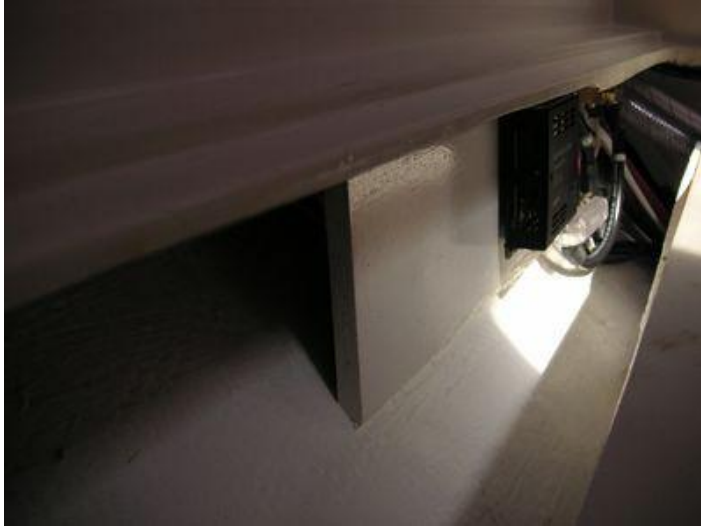
Photo (38) shows the bottom of the breadboard matched and bonded to the hull. After drying, it was repainted with white bilgekote before installing the components as shown in the next group of photos.

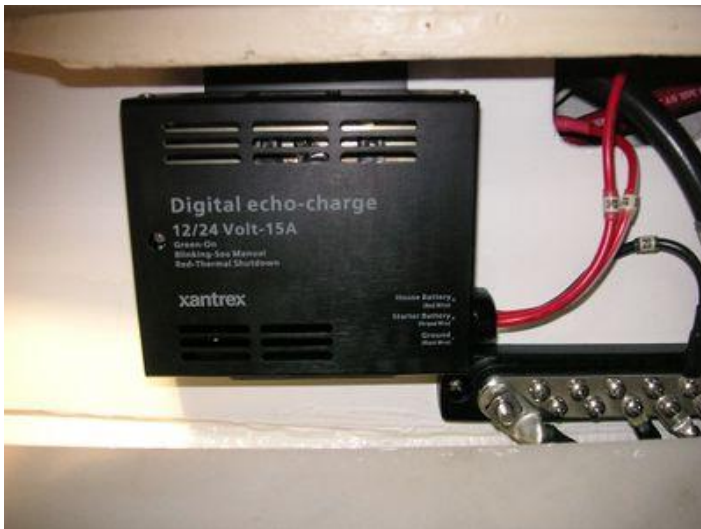
(39)

In photo (39), the Digital Echo Charge is shown installed and wired. The busbar comes with a cover that is removed for clarity. Installing the busbar and the wires connecting to it requires a stubby screwdriver due to limited space between it and the water tank. Photo (40) shows the house negative busbar with negative wires connected and labeled. The 1AWG negative cable to the main engine ground is on the right. The 1AWG negative from the shunt crosses over to the far left post on the busbar.

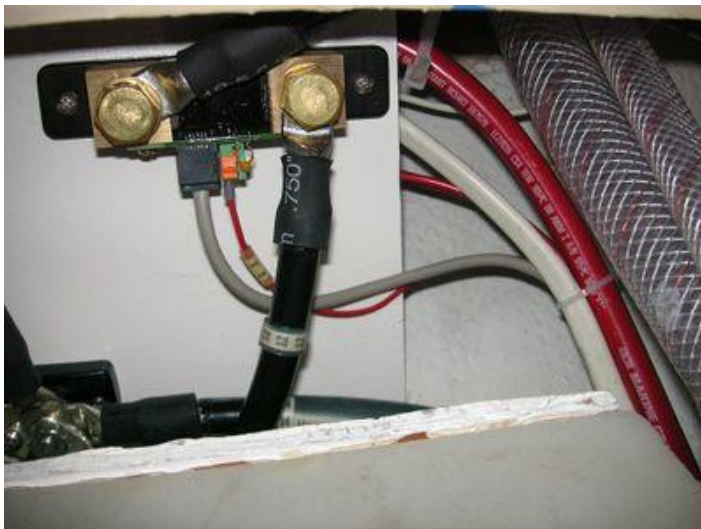
In photo (41) you see the shunt for the BMV-700. The house bank negative is connecting to the brass bolt on the left. This orientation of the shunt was used to have the battery monitor connections pointing down to reduce stress on the wires, and avoid condensation from humidity seeping into the connection points.

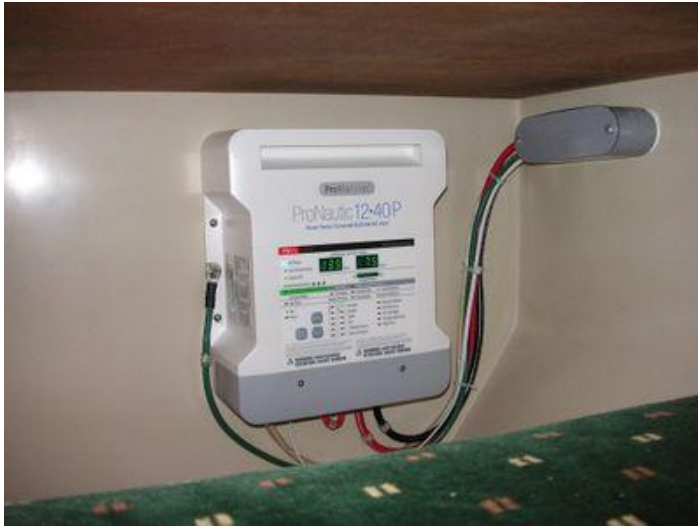
I removed the original ProMariner ProSport 20A AC battery charger that was lying on the hull **unattached** to anything, and replaced it with a ProNautic 40A multistage smart charger. The ProNautic uses battery temperature sensing, and can be programmed for several battery types and profiles for safe and efficient charging. I installed it with 4 screws on the common hanging locker bulkhead underneath the Navigation Station desk, see photos (42) and (43). This allows vertical mounting with plenty of ventilation in a relatively cool dry area. The location does not interfere with my knees when sitting at the desk, but is close enough to get at and change programming if needed. The AC charger wires run through the outboard bulkhead through a conduit LB under the Navigation Station desk. This reduces wires running in the hanging *wet* locker, provides a shorter run to the back of the Main Distribution Panel which is directly above it, and the conduit LB hides the hole.

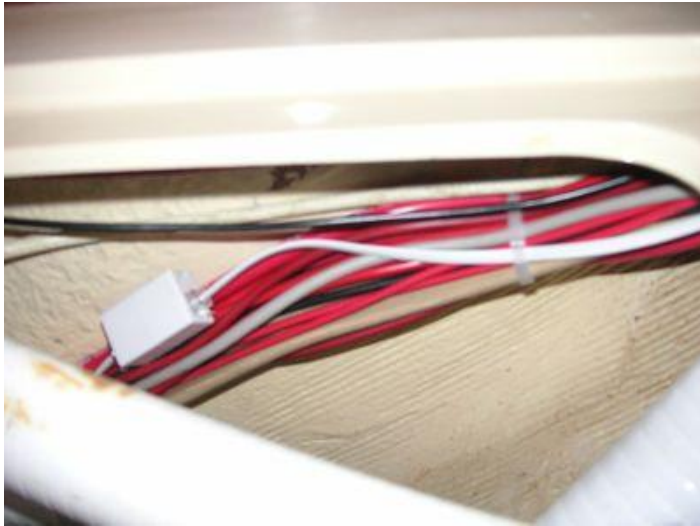
Unfortunately the temperature sense wire provided with the charger is only 10 feet long and will not reach the house bank from here. To solve this, ProMariner suggested using an RJ6 phone coupler and an RJ6 telephone line the length needed. Photo (44) shows the RJ6 phone coupler and the added 12 foot RJ6 wire tied to the main wire bundle just before the macerator pump/motor. Not sure yet if I'll plug the open RJ6 phone coupler ends with butyl tape and rescue tape to seal it from moisture.

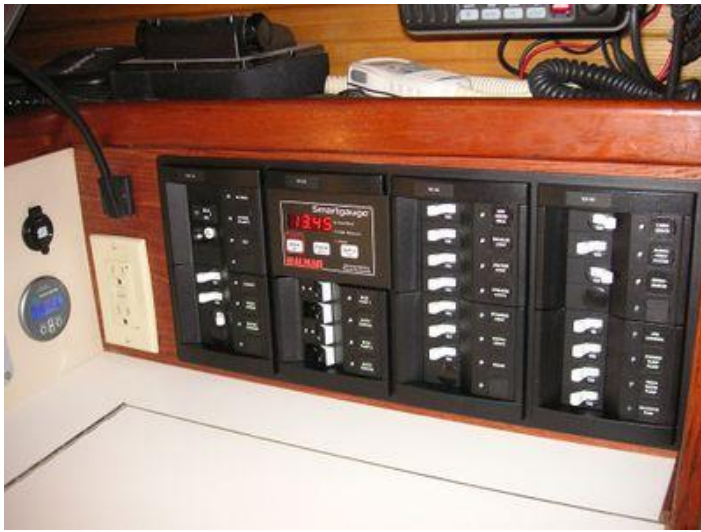
Photo (45) shows the Navigation Station with the new Blue Sea 360 Main Distribution Panel installed. The AC power is on the left side of the panel with a new ELCI 30A double pole main breaker, separate outlet, water heater, and AC battery charger breakers, plus two spares. Moving to the right is the SmartGauge battery monitor located above the bilge pump restricted off and manual on breakers, the right two columns are the 14 DC breakers plus 2 spares. One of the spares will be used for the future auto-pilot. Photo (46) shows the BMV-700 battery monitor and the 12VDC outlet that are installed on the bulkhead shared with the hanging locker, and to the left of the GFCI outlet.

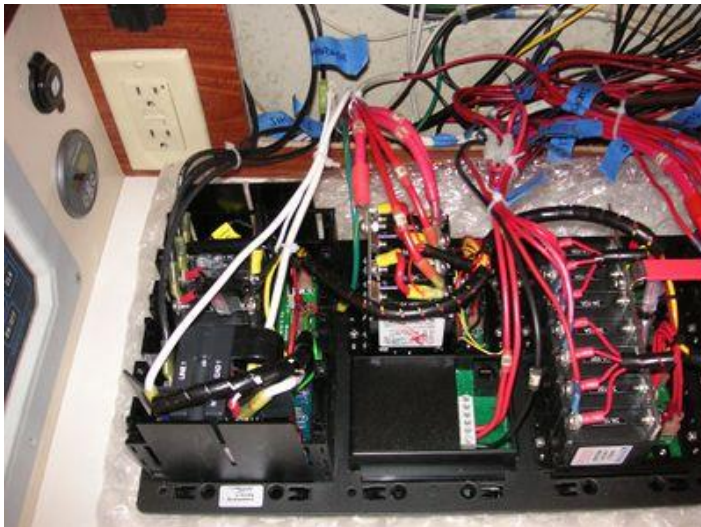
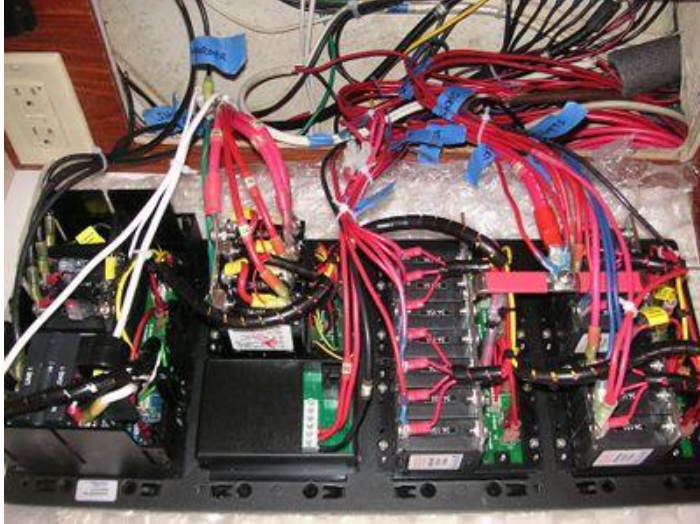
In photos (48) and (49), more breakers means more wires connecting to the main panel, but the organization of the wiring has been improved from the original.

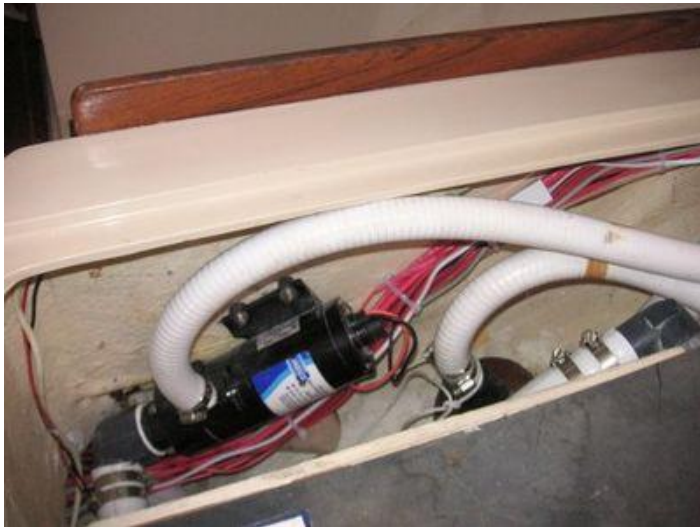
Here in photo (50) you see the wire bundle going by the macerator pump and motor up to the main distribution panel higher than before to get them off the hull and out of the way.

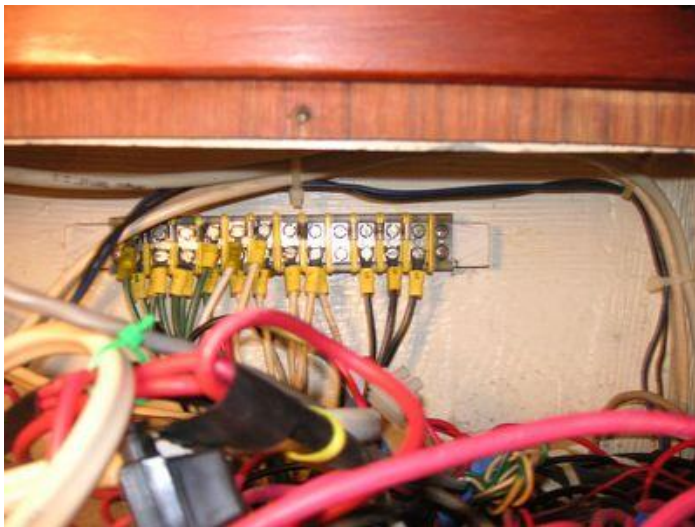
**AC Busbar Replacement:** I removed the original terminal strip in photo (53) and replaced it with a 10 screw dual busbar and a 5 screw dual busbar as shown in photo (54). In photo (53) you can see dark spots under the screw at the end of each wire. Those are corroded spade fittings with open crimps at both ends. I removed and replaced all with heat shrink adhesive lined ring terminals. They are now all nice and shiny new in photo (54). The 10 screw dual busbar is for most AC neutrals and all grounds. The smaller 5 screw dual busbar is dedicated to line and neutrals for the cabin, galley, and head protected AC outlets. The AC outlet power leaves the panel breaker and connects to the GFCI outlet at the Navigation Station. From there it connects to the 5 screw dual busbar for the downstream AC outlets, and is labeled "Protected Outlets". In this arrangement the cabin, galley, and head outlets are all protected by the Navigation Station GFCI outlet. The down side to this arrangement is the AC outlets are limited to a combined total of 30A. This may or may not be a nuisance item. I plan to wait and see if it is an issue before changing anything.

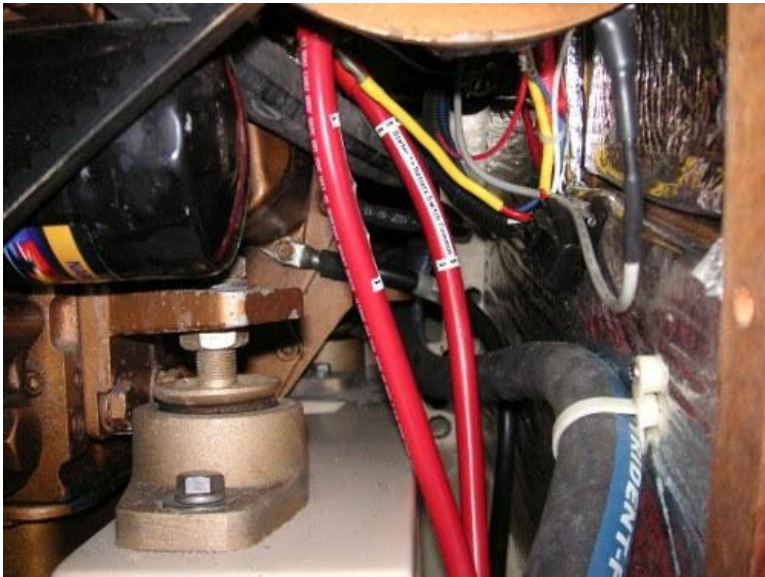
Photo (57) shows another view of the same three cables rising up to the alternator, starter, and main negative cable #14 connection on the starter motor mounting bolt.

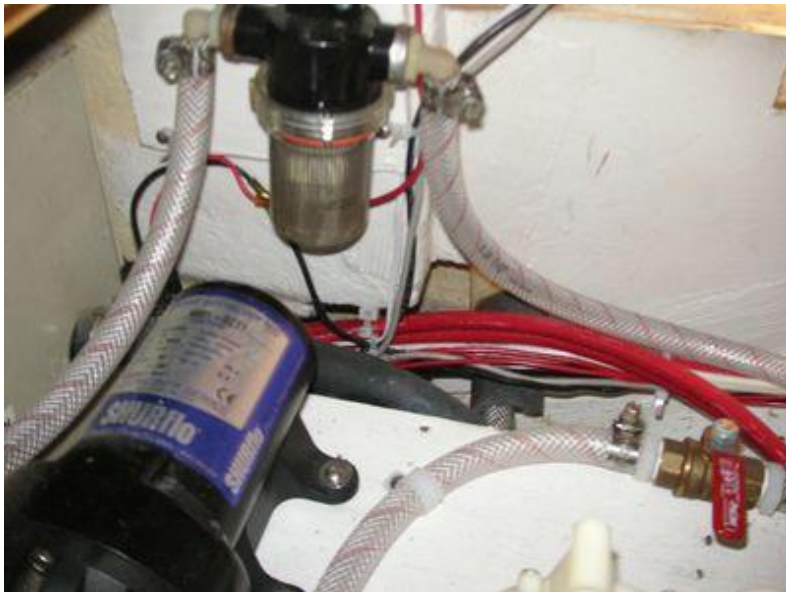
In photo (58) you can see I added insulation foam for  $\frac{3}{4}$ " pipe on the water tank hose and band clamp to protect the cables and wires from chafing.

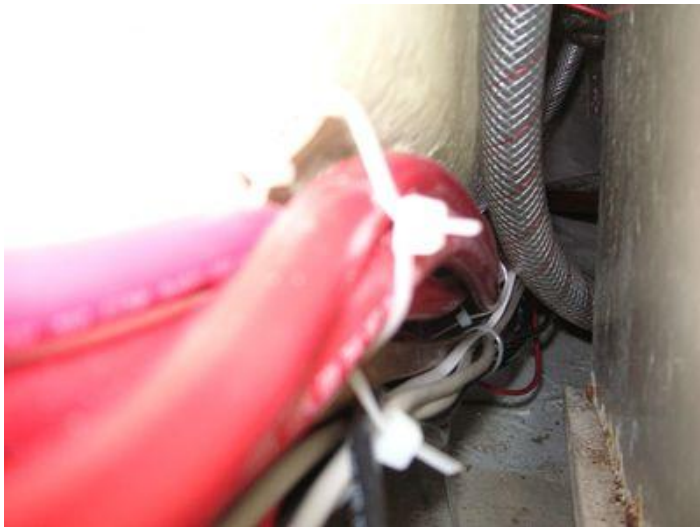
Photo (59) shows cables running between the water heater and the outside of the battery box. The wire tie mounts are attached to the thru holes I drilled in the battery box in the beginning. No other way to get in there and drill a hole. Photo (60) shows another use of the insulation material to cover the corner of the water heater support and shelf to avoid any cable or wire chafe. The insulation is attached to the heater shelf with a #8 SST screw fastened to the wood shelf so it doesn't move and leave the wires/cables exposed to the corner.

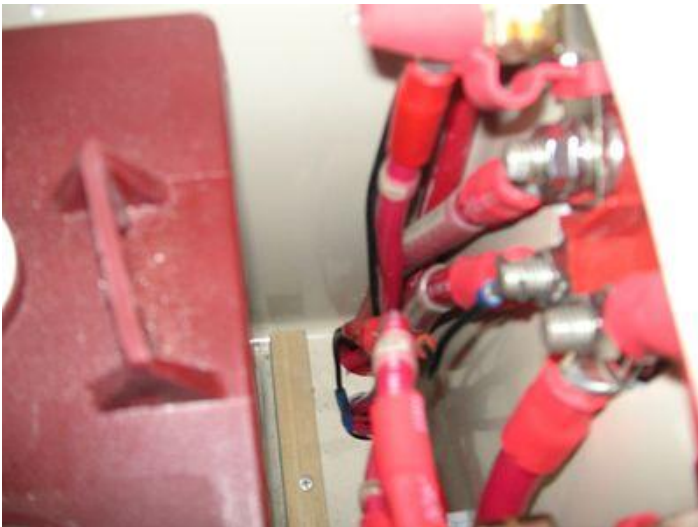
Photo (61) shows the cables entering the bottom of the battery box thru the larger of the two existing holes and connecting to the back of the 1-2-Both battery selector switch in the battery box, the “always on” busbar, and the house battery bank. Remember I said I was glad there were two holes? This is why, it is big stuff.

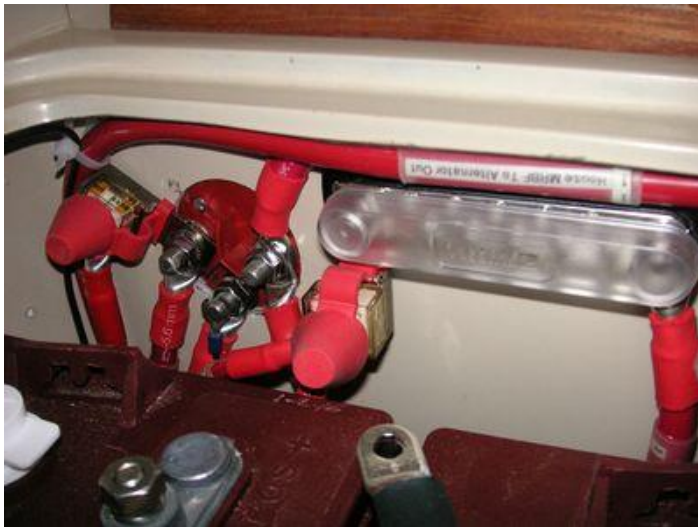
**Battery Box Busbar:** Photos (62) and (63) are looking inboard from the water tank to see inside the battery box. Photo (62) shows the primary cables inside the battery box connecting to the back of the 1-2-Both battery use switch. Position #1 (house bank) is on the right, Position #2 (reserve battery) is on the bottom, and Position C is on the left. The MRBF fuses (covered with the red caps) for the main distribution panel supply connecting to the C post, the AC battery charger, and power for the bilge pump breaker connecting to the “always on” busbar can also be seen. Photo (64) shows the alternator output cable running above the “always on” busbar. The protective cover is removed from the “always on” busbar for clarity. The alternator output cable is labeled upside down so it can be read from above when standing on the boat centerline looking down into the battery box. You can also see the jumper connecting position #1 of the 1-2-Both battery use switch to the “always on” busbar. The most critical DC item currently attached to the “always on” busbar are the bilge pumps. If the house battery bank were to fail, switching the 1-2-Both battery use switch to position #2 would not provide power to the always on busbar. To address this, I made the jumper long enough to be moved from position #1 to position #2 of the 1-2-Both battery use switch to provide temporary power. This failure mode is a remote possibility, but it could occur so I added this no cost redundancy feature.

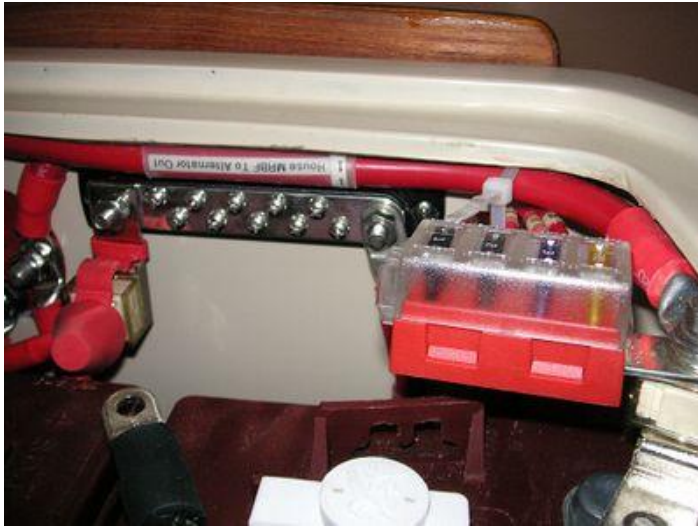
(64)

In photo (64), you see the end of the Blue Sea 5024 fuse block discussed in the House Battery section.

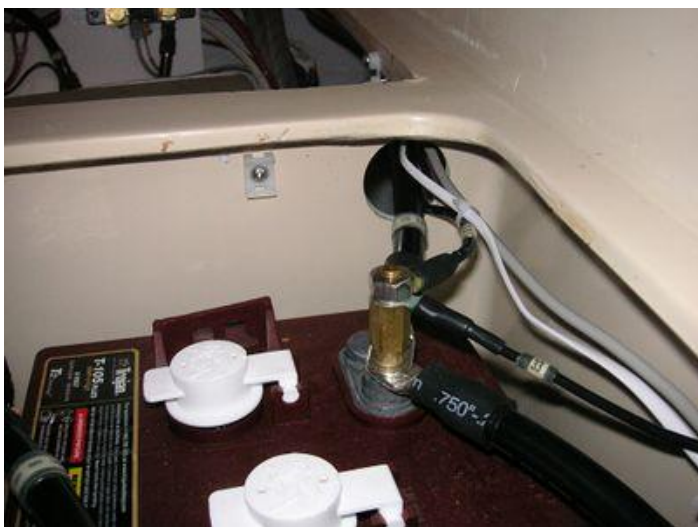
(65)

Looking at the bulkhead between the battery box and water tank in photo (65), you see the 1 AWG negative leaving battery #4 and going to the shunt through the hole in the battery box. Also visible are the temperature sense wires from the AC battery charger, and from the Balmar external voltage regulator. I separated most of the positive wires from the negative wires by running the positive's into the battery box through the two bottom holes shown earlier, and the negatives and temperature sense wires running through this hole at the top of the other end of the battery box near the water tank. I was only comfortable connecting two wires or cables to a battery post, so I purchased the extension from the battery supply house for ~ \$5. In photo (66), the 1AWG negative leaves the battery box and runs under the lip that the outboard salon cushion wood cover sits on.

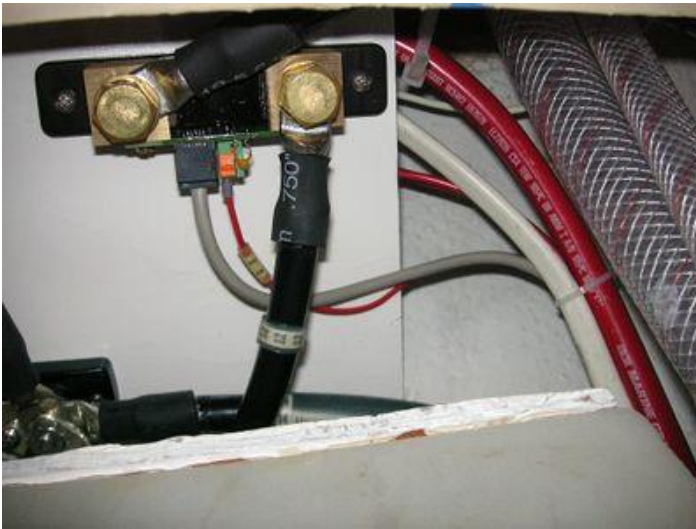
(67)

That same cable then connects to the left bolt on the BMV-700 shunt attached to the breadboard as shown in photo (67).

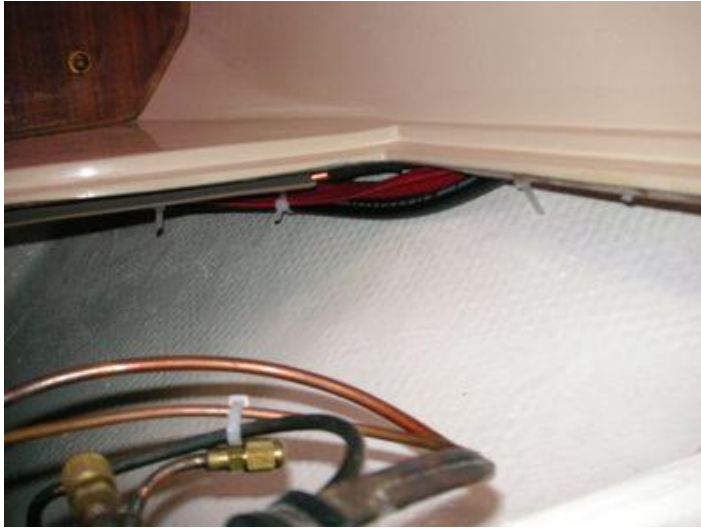
Photo (68) shows the positive and negative cables running to the reserve battery from the Digital Echo Charge, the SmartGauge, the 1-2-Both battery selector switch position #2, and from the house bank negative busbar. The shiny bit you see is the refrigeration line. To protect the refrigeration lines in case there is a gas leak from the maintenance free battery, I covered it with the material used to cover wires on the floor so you don't trip. Photo (69) shows the wires and cables from the reserve battery, Digital Echo Charge, and the SmartGauge running underneath the storage cubby holes behind the outboard salon seat cushion. The white Nomex is the existing DC wiring for the refrigerator compressor and fan. The wood you see is glassed in and is part of the boat. It wasn't added by me for this project.

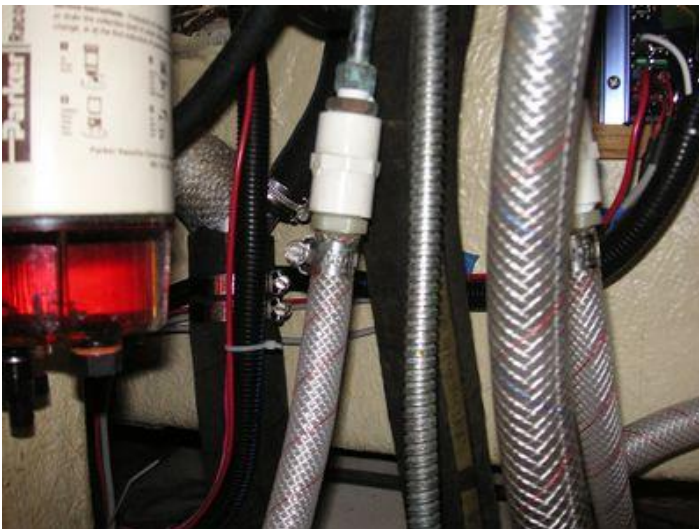
Photos (71) and (72) show the external regulator wiring under the head sink in the split loom, then is runs along the engine compartment bulkhead under the Racor filter.

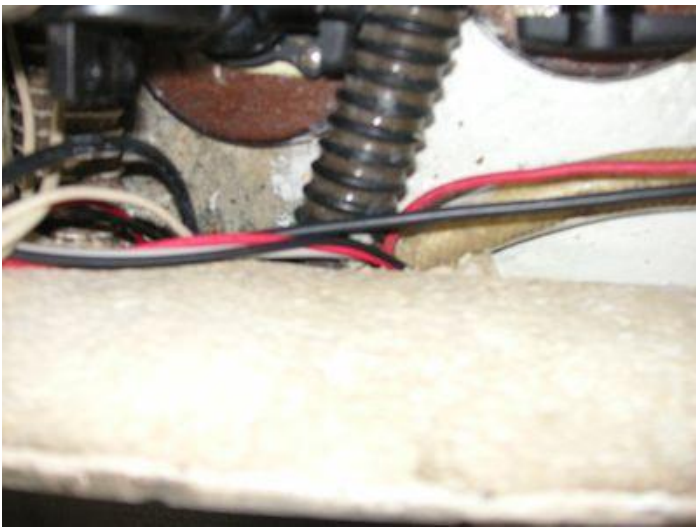
Photo (73) the external regulator wires enter the 3/4" conduit under the shower pan. They exit the conduit by the macerator pump/motor in photo (75) of the next photo group. The black box by the Racor is part of my non-working depth/temp/speed system.

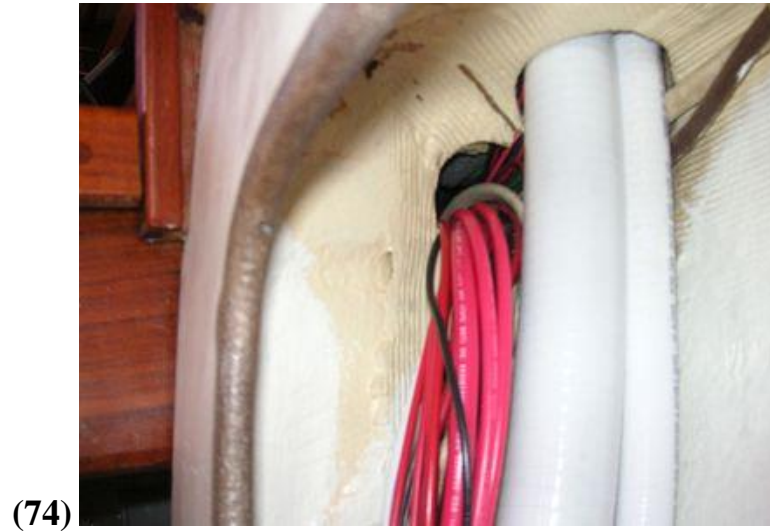
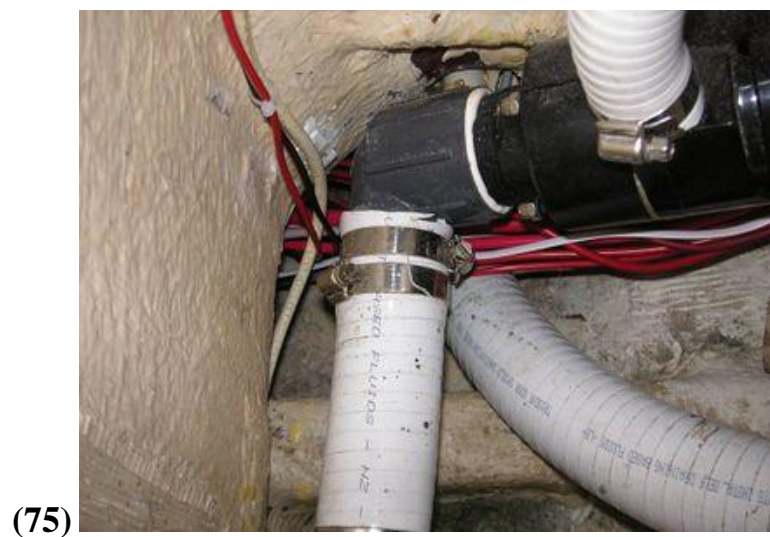
Finally photos of the wires running from behind the Main Distribution Panel, to the battery box area. Photo (74) shows the bundle exiting from behind the Main Distribution Panel, and photo (75) shows where they pass under the macerator pump/motor and pick up the external regulator wires.
