# 1987 MK 1 Catalina 34 Electrical System Upgrade

By Jon Windt; s/v Della Jean

**REVISION A – 7-31-2016 Section 11 was revised due to re-routing of the #1, 5, and 14 1 AWG cables directly to the engine compartment from the house bank**

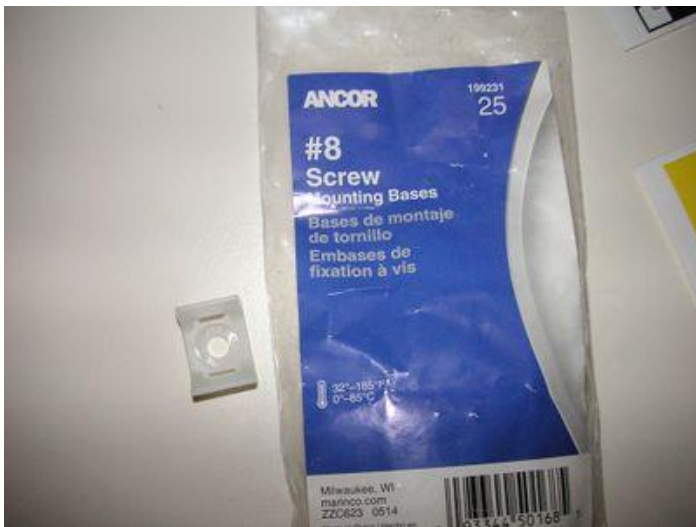
(77)

Lots of wire ties are used throughout to secure the wire and cable. A great fitting I used is #8 mounting bases; Ancor part # 199231 from West Marine shown in photo (77). Drill a hole for a #8 screw, screw it in, slip the wire tie through the slots, wrap around the wire/cable and tighten. Very secure. A valuable tool to have is a 90 degree drill. I didn't have one, so bought the 90 degree adaptor shown in photo (78) from Harbor Freight for ~\$20 before shipping and handling. It's a light duty tool, but worked well to get into tight areas to drill holes I wasn't able to without it.
