1987 MK 1 Catalina 34 Electrical System Upgrade

By Jon Windt; s/v Della Jean

REVISION A – 7-31-2016 Section 11 was revised due to re-routing of the #1, 5, and 14 1 AWG cables directly to the engine compartment from the house bank. The Cable Planner Excel and pdf files, and the pdf file of this write up have been updated and attached to this write up to reflect the current routing. The schematic and cable ID #'s are unchanged, only the routing is different.

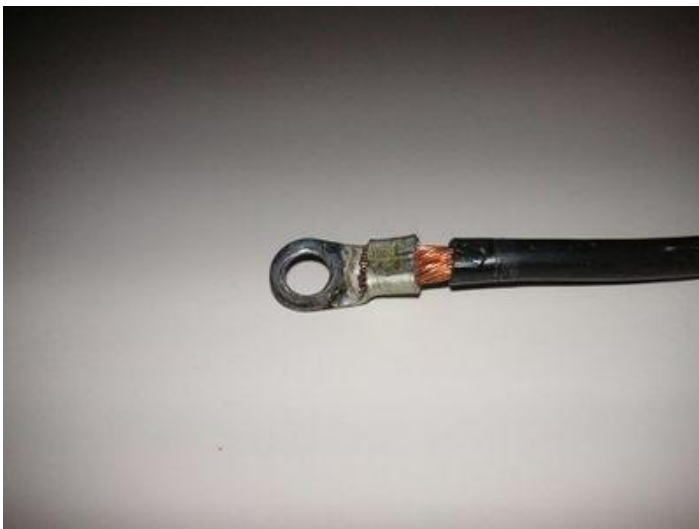
Photo (1) is one example of a negative battery cable and lug with electrical tape removed. Notice the crimp terminal and the exposed wire end by the ring. Photo (2) is looking down at the original red 4 AWG cable from the 105A alternator output to the starter. The other red 4 AWG cable runs from the starter, ~ 20 cable feet to the 1-2-Both switch at the Navigation Station. From there it ran another 15 cable feet to the battery in the battery compartment.

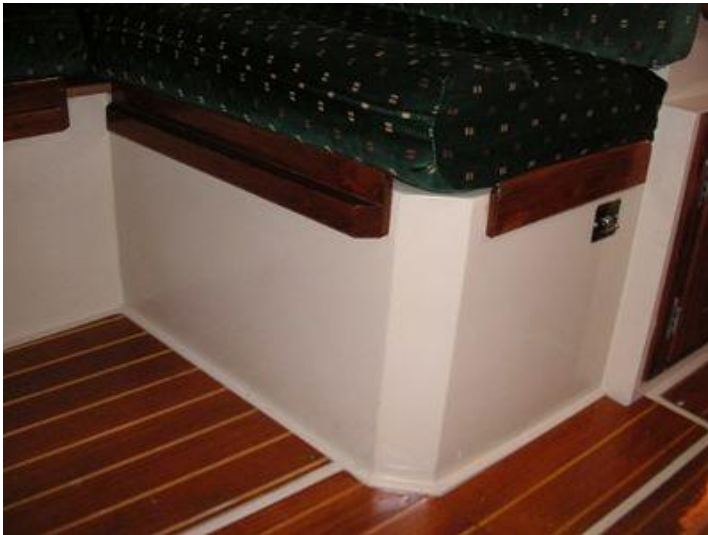
Photo (3) is the outside of the OEM battery compartment showing no ventilation openings. The switch in the upper right inboard side of the battery compartment is where the auto/on/off bilge pump switch was originally located. Photo (4) shows the original 2x Group 24 batteries, the 2 busbars, a Power Pulse battery maintenance widget, and a shunt for the Link 10 inside the battery compartment.

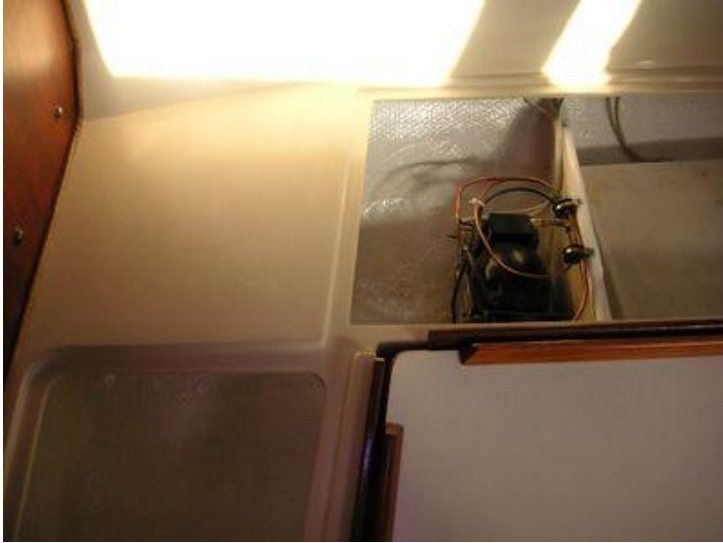
Photos (8) and (9) show the salon area with the wood covers removed. In Photo (8) you can see the fridge compressor attached to the bulkhead at the end of the starboard water tank. Photo (9) shows the water tank and ProMariner ProSport 20A AC charger. The wire from the breaker to the charger had a 3 prong plug connection (like an extension cord) at the charger, and the charger wasn't fastened to anything, just lying there on the hull waiting to flop around. Not very robust.

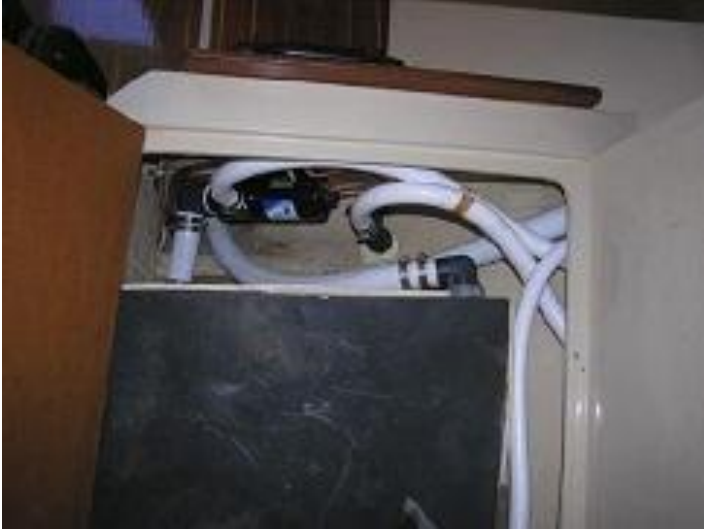
Photo (10) shows the holding tank, macerator pump, hoses, and if you look close the original wiring and cables running up to the master distribution panel at the Navigation Station.

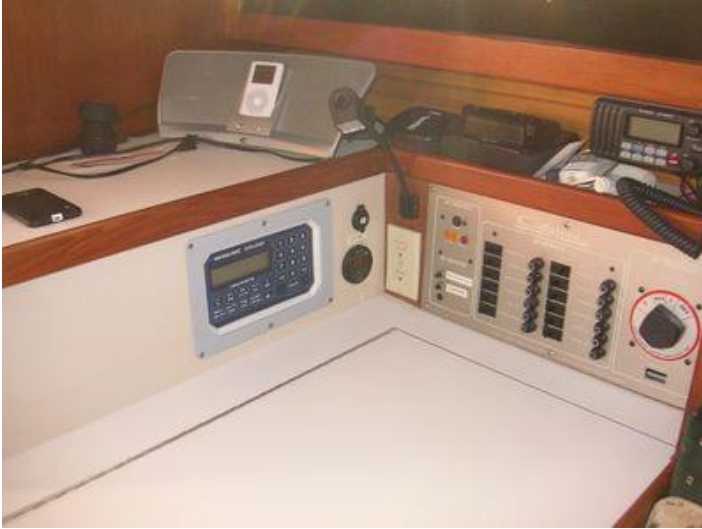
Photo (11) shows the Navigation Station with the OEM Main Panel, Link 10 battery monitor and 12VDC outlet installed by a PO. The panel has a single pole main, the polarity lights flickered, the lens for a light and the light under the battery switch were missing, the Link 10 did not operate.

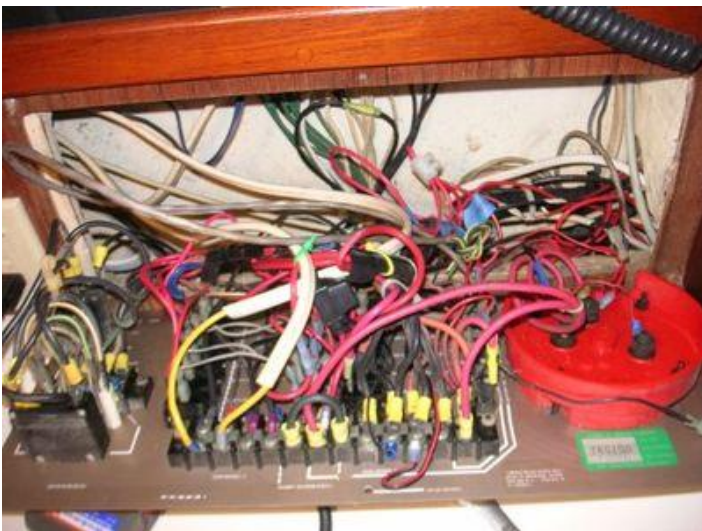
Photos (12) and (13) show the wires behind the main panel. To be polite, it was a corroded mess.

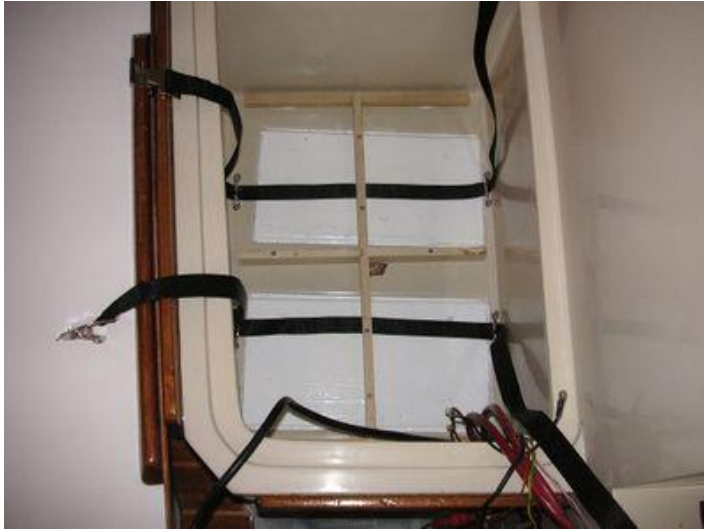
Photos (17) and (18) show the 2x8 painted wood fillers, the “egg crate” made from $\frac{3}{4}$ ” x $\frac{3}{4}$ ” hardwood strips screwed and countersunk to the bottom, and the battery straps all to keep the batteries in place while underway. Photo (18) shows 2 existing holes in the bottom of the box with new cables passing through. (I was later glad to have 2 entry holes). I drilled holes for #8 screws for wire ties along the upper battery box wall, and 2 thru holes for #8 screws in the radius at the bottom of the box on the water heater side. These are to attach wire ties outside of the box near the water heater for the cables that will run in that area. The 2 thru holes were covered with the same silicone caulk used earlier to seal them from a possible battery leak. Be sure the screws do not extend into the battery box or you’ll damage the batteries.

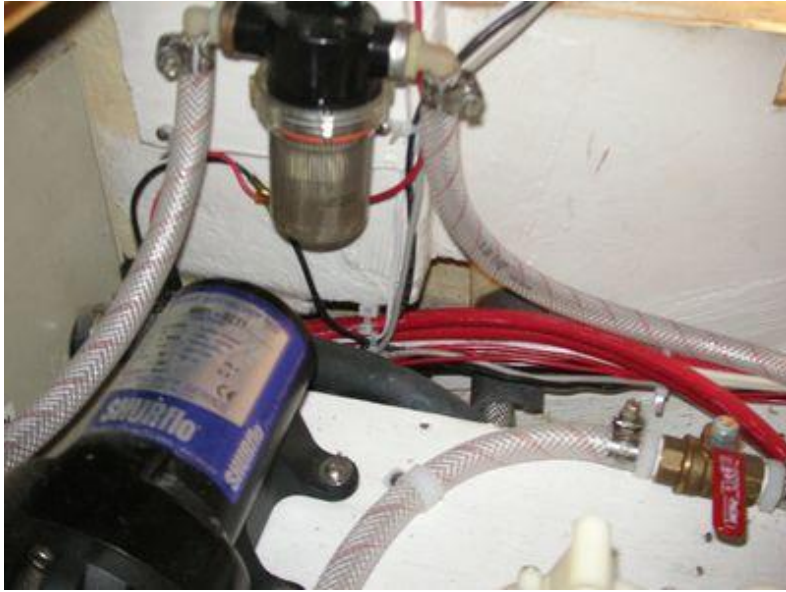
In photo (58) you can see I added insulation foam for $\frac{3}{4}$ " pipe on the water tank hose and band clamp to protect the cables and wires from chafing.

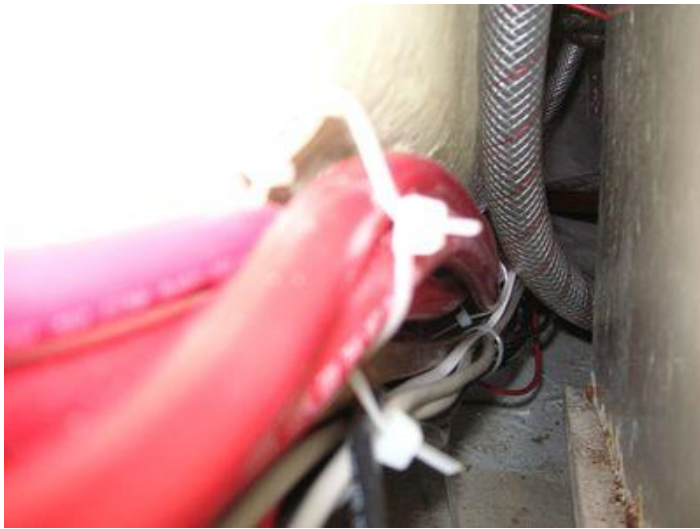
Photo (59) shows cables running between the water heater and the outside of the battery box. The wire tie mounts are attached to the thru holes I drilled in the battery box in the beginning. No other way to get in there and drill a hole. Photo (60) shows another use of the insulation material to cover the corner of the water heater support and shelf to avoid any cable or wire chafe. The insulation is attached to the heater shelf with a #8 SST screw fastened to the wood shelf so it doesn't move and leave the wires/cables exposed to the corner.

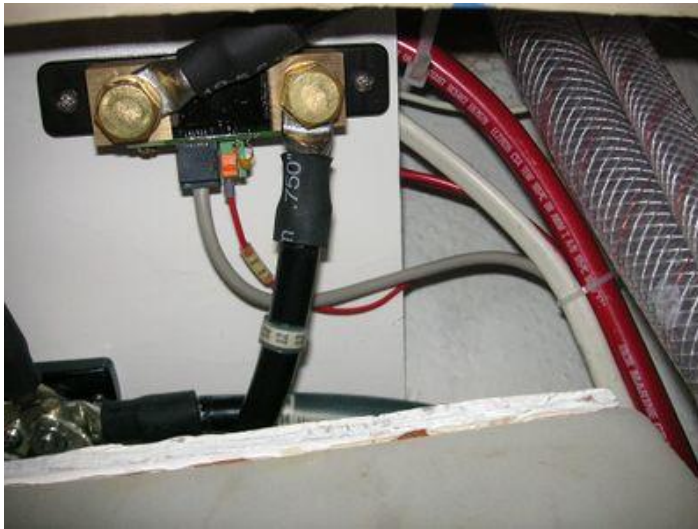
(67)

That same cable then connects to the left bolt on the BMV-700 shunt attached to the breadboard as shown in photo (67).
