1987 MK 1 Catalina 34 Electrical System Upgrade

By Jon Windt; s/v Della Jean

General Vessel Description

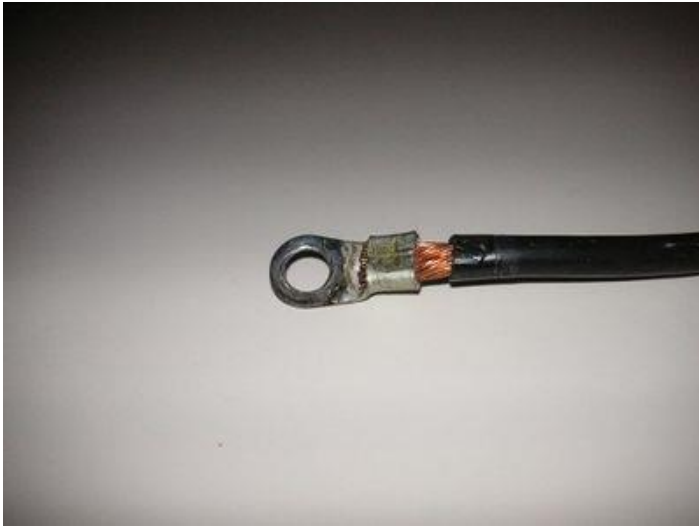
Photo (1) is one example of a negative battery cable and lug with electrical tape removed. Notice the crimp terminal and the exposed wire end by the ring. Photo (2) is looking down at the original red 4 AWG cable from the 105A alternator output to the starter. The other red 4 AWG cable runs from the starter, ~ 20 cable feet to the 1-2-Both switch at the Navigation Station. From there it ran another 15 cable feet to the battery in the battery compartment.

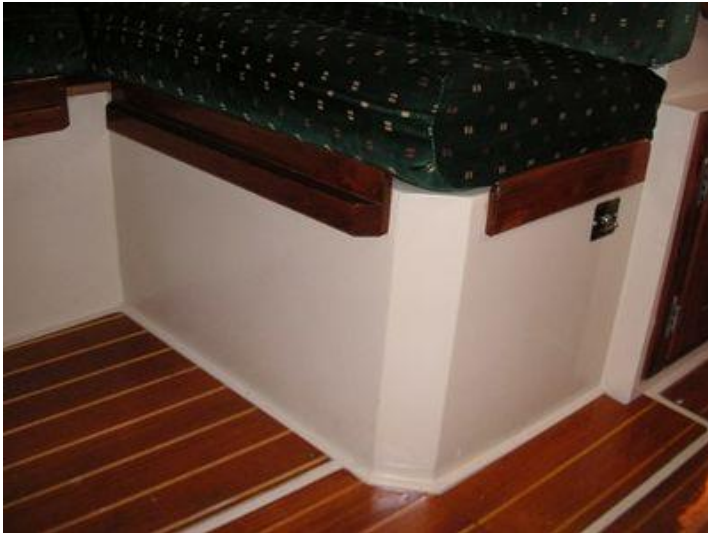
Photo (3) is the outside of the OEM battery compartment showing no ventilation openings. The switch in the upper right inboard side of the battery compartment is where the auto/on/off bilge pump switch was originally located. Photo (4) shows the original 2x Group 24 batteries, the 2 busbars, a Power Pulse battery maintenance widget, and a shunt for the Link 10 inside the battery compartment.

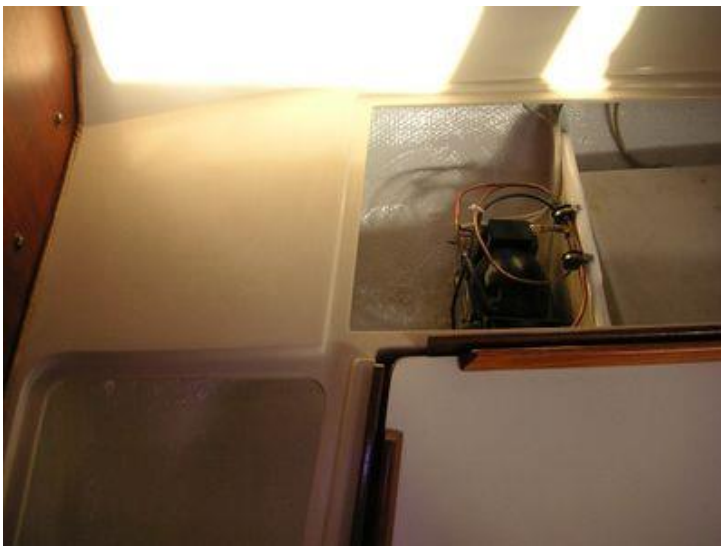
Photos (8) and (9) show the salon area with the wood covers removed. In Photo (8) you can see the fridge compressor attached to the bulkhead at the end of the starboard water tank. Photo (9) shows the water tank and ProMariner ProSport 20A AC charger. The wire from the breaker to the charger had a 3 prong plug connection (like an extension cord) at the charger, and the charger wasn't fastened to anything, just lying there on the hull waiting to flop around. Not very robust.

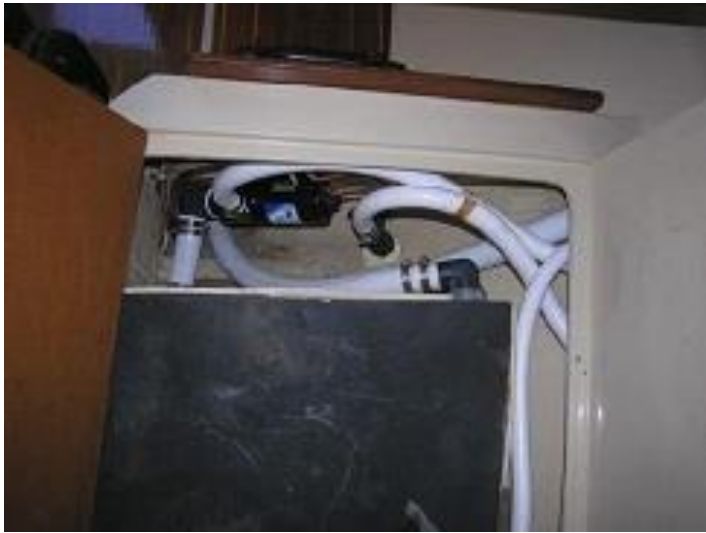
Photo (10) shows the holding tank, macerator pump, hoses, and if you look close the original wiring and cables running up to the master distribution panel at the Navigation Station.

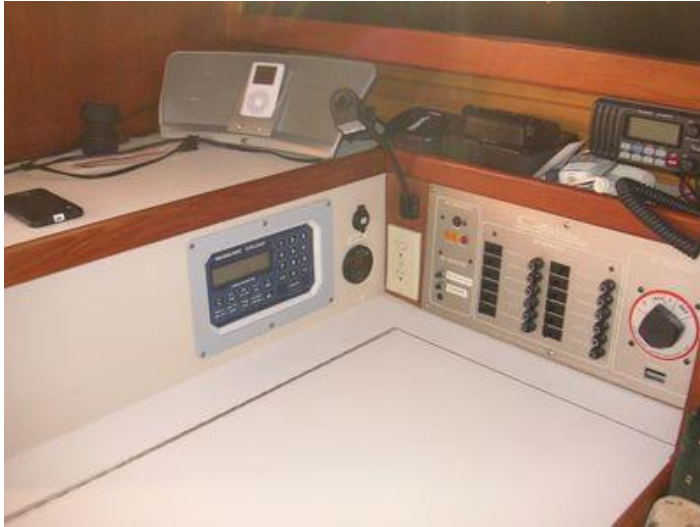
Photo (11) shows the Navigation Station with the OEM Main Panel, Link 10 battery monitor and 12VDC outlet installed by a PO. The panel has a single pole main, the polarity lights flickered, the lens for a light and the light under the battery switch were missing, the Link 10 did not operate.

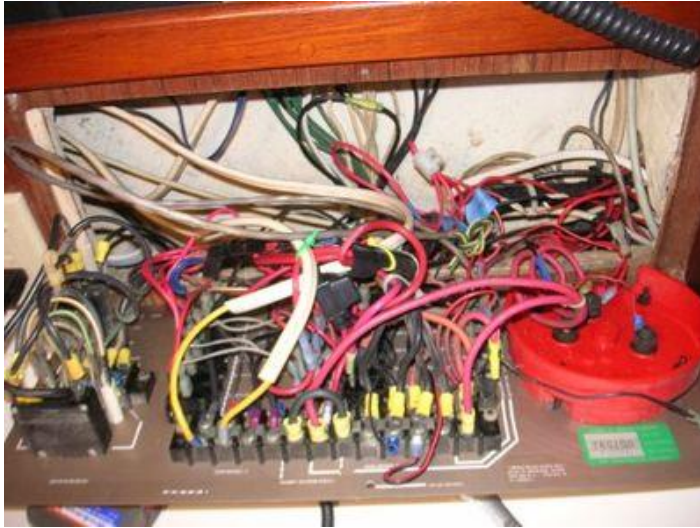
Photos (12) and (13) show the wires behind the main panel. To be polite, it was a corroded mess.

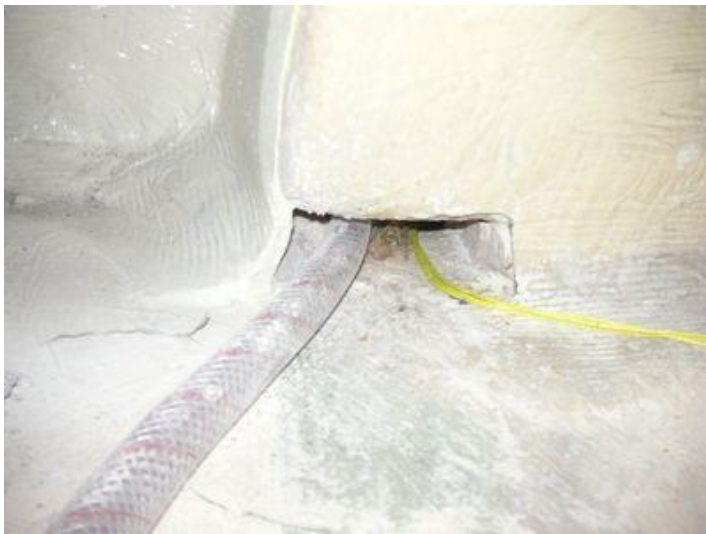
Barely visible in photo (16) is a dark clump of old adhesive sitting in the opening to the right of the aft tank water supply hose. It appeared to be excess adhesive for the conduit from the original build of the boat. A light tap with a screwdriver removed it, and now the path is clear to pass the 1 AWG cables through. The yellow strings are messenger lines to pull new cable.

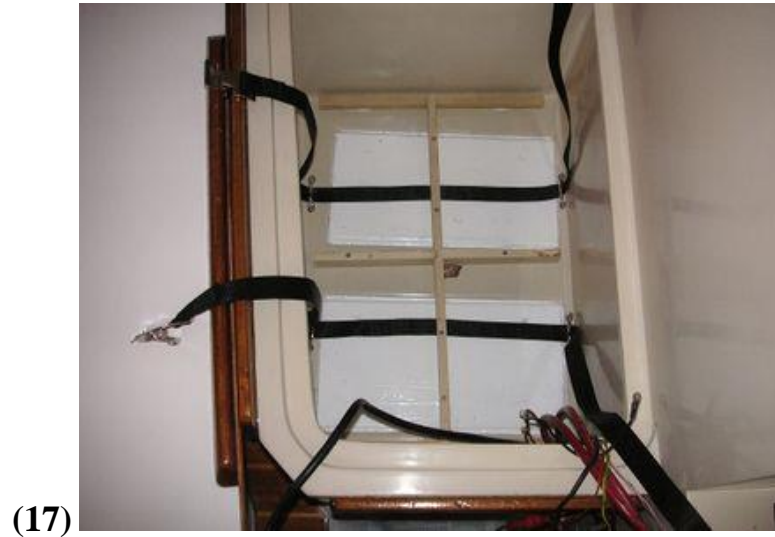
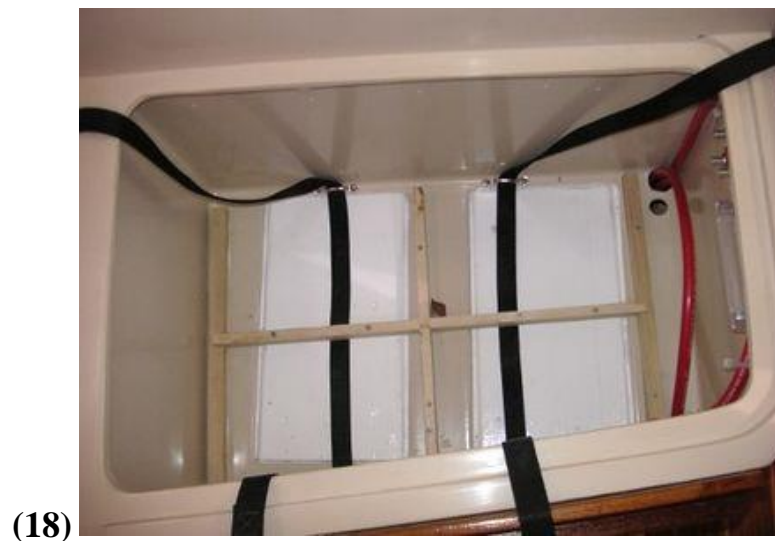
Photos (17) and (18) show the 2x8 painted wood fillers, the “egg crate” made from $\frac{3}{4}$ ” x $\frac{3}{4}$ ” hardwood strips screwed and countersunk to the bottom, and the battery straps all to keep the batteries in place while underway. Photo (18) shows 2 existing holes in the bottom of the box with new cables passing through. (I was later glad to have 2 entry holes). I drilled holes for #8 screws for wire ties along the upper battery box wall, and 2 thru holes for #8 screws in the radius at the bottom of the box on the water heater side. These are to attach wire ties outside of the box near the water heater for the cables that will run in that area. The 2 thru holes were covered with the same silicone caulk used earlier to seal them from a possible battery leak. Be sure the screws do not extend into the battery box or you’ll damage the batteries.

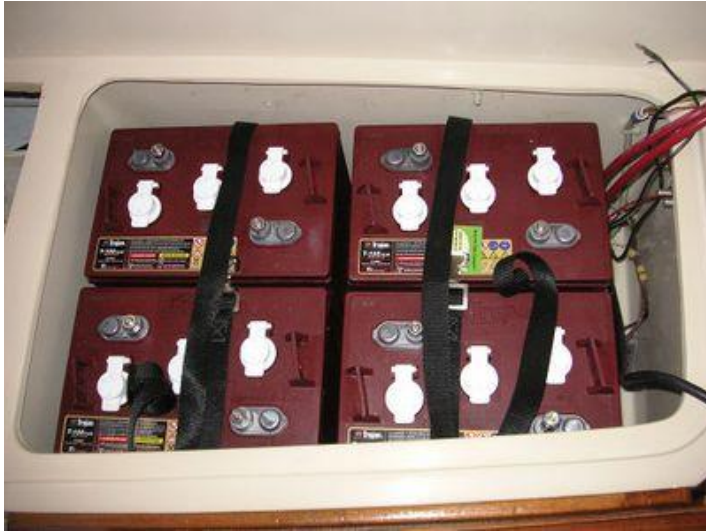
(19)

I didn't want to make the final attachments, and then find out the tie down straps interfered with the fill caps on the batteries. So I temporarily installed all of the house batteries to ensure the eggcrate matched up as intended, and the battery straps didn't interfere with the battery fill caps as shown in photo (19).

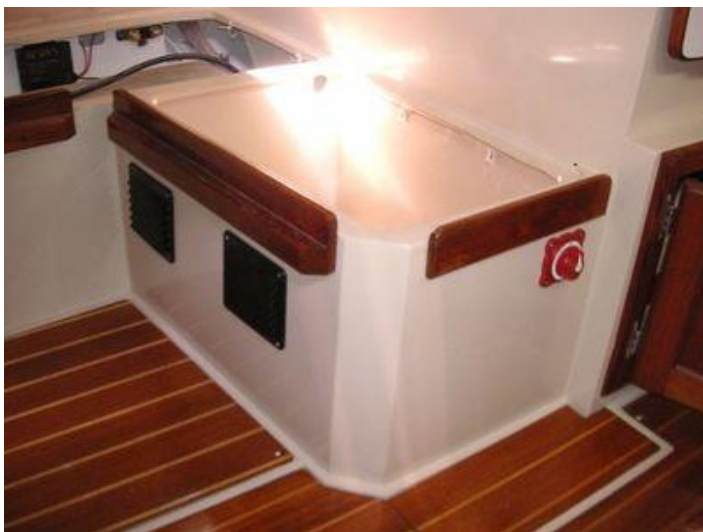
(20)

Photos (20 and (21) show the 2 new black ventilation covers installed in the battery box and the 1-2-Both battery switch installed where the bilge pump auto/on/off switch used to be. (In the background of photos you can see the breadboard for the Xantrex Digital Echo charge, house negative busbar, and BMV-700 shunt, but more on that later). The battery switch is a Blue Sea 6007 installed with the front panel mounted option. I used a 2 5/8" Milwaukee Dozer hole saw to drill the hole for the battery switch. It was tricky since I was using the hole saw to enlarge the existing smaller bilge switch hole. The battery box is two walls that are hollow in between. I wedged a piece of wood into the hollow section to give the hole saw pilot bit something to grab on to. I lined up the hole saw with the top of the existing bilge switch hole and went for it. It worked, but maybe not the safest couple of minutes I spent on this project.

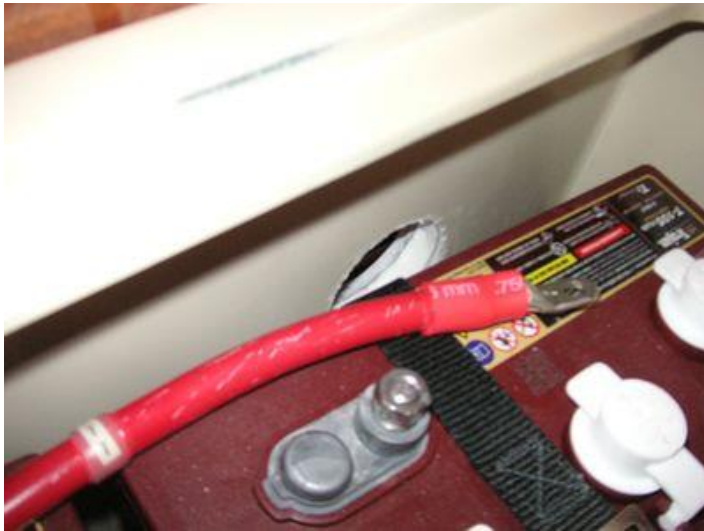
(22)

I used the same 2 5/8" hole saw for the vent covers along the forward side of the battery compartment instead of buying a larger hole saw for two holes. This surface is also two walls and hollow in between. To avoid gases collecting, I rolled up paper towels and stuffed them inside just below the edge of the hole to act as a backing for the caulk I used. The caulk provided a seal with a nice finished appearance as can be seen in photo (22).

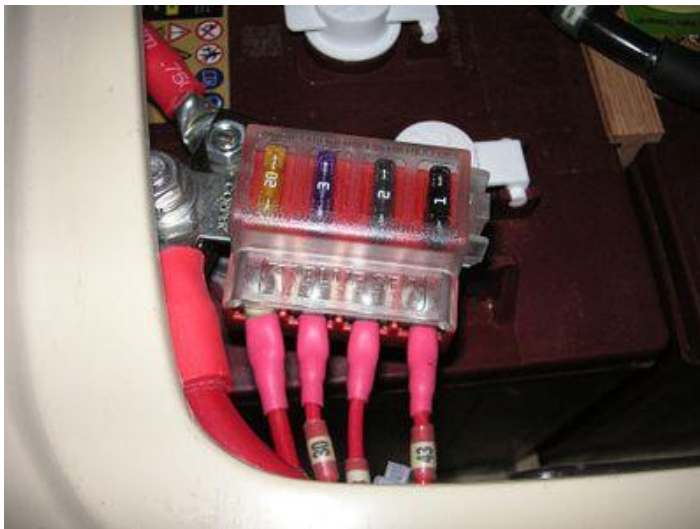
Photos (23) and (24) show the Trojan T105's installed waiting for inspection. I used the Blue Sea 5024 fuse block in the photo (23) to combine 4 fused runs into one small space with one connection point directly on the battery. The battery posts are short allowing connection of only 2 lugs comfortably. Many devices require connecting directly to the battery or as close as possible for best results, and is preferred by ABYC code. This does that neatly. In photo (24) I cut a piece of red oak into a "T" shape to fit between the batteries to avoid them tipping together when the battery strap is tightened. The black plastic clips came with the NAPA battery box for the reserve battery. I'm using a higher quality battery strap and stainless steel clips to hold the reserve battery to the shelf, so I decided to use the plastic clips here to keep the wood from sliding. The house bank connects to position 1 on the 1-2-Both battery selector switch. In photo (24), the schematic battery ID #'s starting from the bottom right are #1, bottom left is #2, upper right is #3, and upper left is #4. See the schematic attached in Section 14 of this write-up for the details.

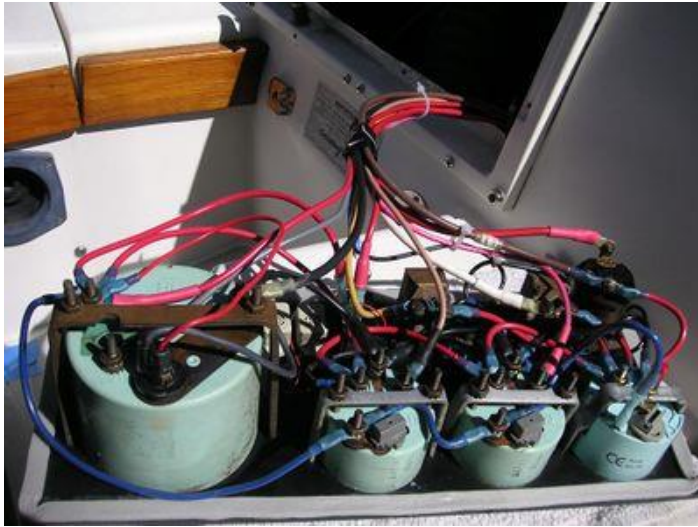
(35)

In photo (35), the brown ignition wire, ID # 50, connects to the ignition switch in the cockpit. The gray material around the perimeter of the cockpit panel is foam tape for weather protection when installed. FYI –I set the belt manager to level 4. The engine was started and run at 1500 rpm. The alternator was charging the house at 80 Amps, the alternator was at 32°C and the house bank was at 18°C. Just like advertised!

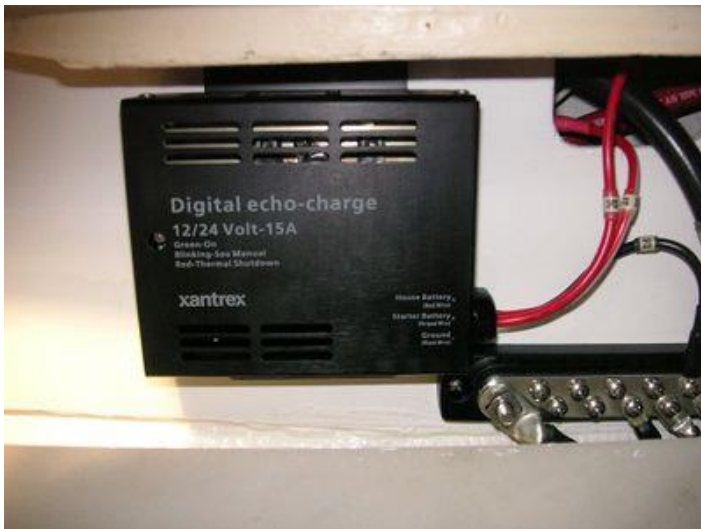
(39)

In photo (39), the Digital Echo Charge is shown installed and wired. The busbar comes with a cover that is removed for clarity. Installing the busbar and the wires connecting to it requires a stubby screwdriver due to limited space between it and the water tank. Photo (40) shows the house negative busbar with negative wires connected and labeled. The 1AWG negative cable to the main engine ground is on the right. The 1AWG negative from the shunt crosses over to the far left post on the busbar.

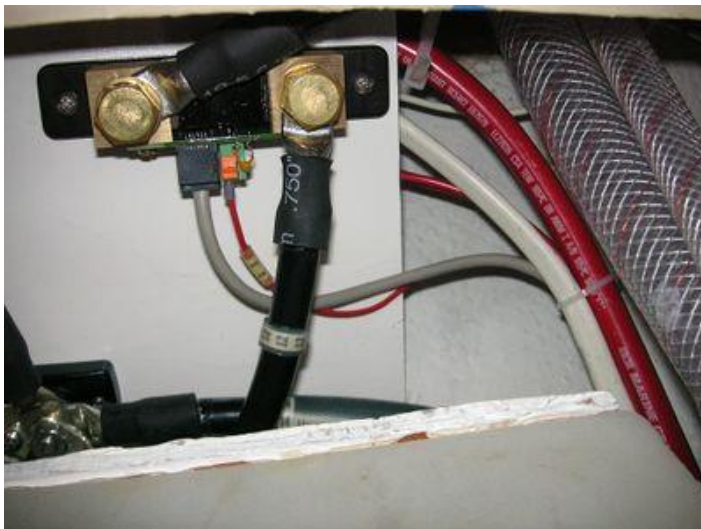
In photo (41) you see the shunt for the BMV-700. The house bank negative is connecting to the brass bolt on the left. This orientation of the shunt was used to have the battery monitor connections pointing down to reduce stress on the wires, and avoid condensation from humidity seeping into the connection points.

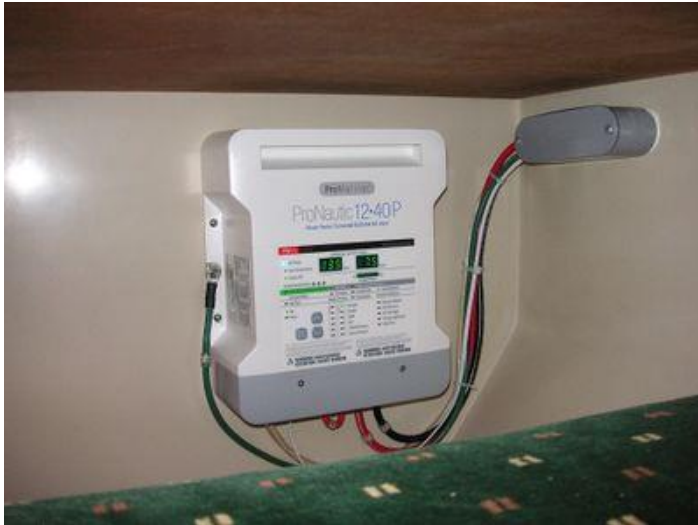
I removed the original ProMariner ProSport 20A AC battery charger that was lying on the hull **unattached** to anything, and replaced it with a ProNautic 40A multistage smart charger. The ProNautic uses battery temperature sensing, and can be programmed for several battery types and profiles for safe and efficient charging. I installed it with 4 screws on the common hanging locker bulkhead underneath the Navigation Station desk, see photos (42) and (43). This allows vertical mounting with plenty of ventilation in a relatively cool dry area. The location does not interfere with my knees when sitting at the desk, but is close enough to get at and change programming if needed. The AC charger wires run through the outboard bulkhead through a conduit LB under the Navigation Station desk. This reduces wires running in the hanging *wet* locker, provides a shorter run to the back of the Main Distribution Panel which is directly above it, and the conduit LB hides the hole.

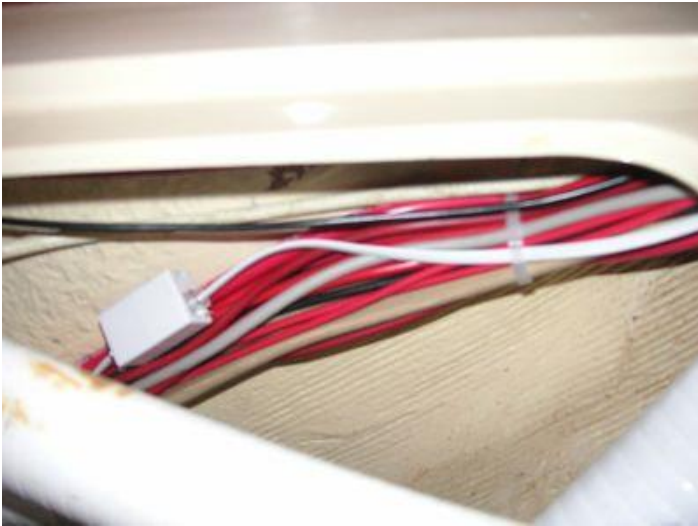
Unfortunately the temperature sense wire provided with the charger is only 10 feet long and will not reach the house bank from here. To solve this, ProMariner suggested using an RJ6 phone coupler and an RJ6 telephone line the length needed. Photo (44) shows the RJ6 phone coupler and the added 12 foot RJ6 wire tied to the main wire bundle just before the macerator pump/motor. Not sure yet if I'll plug the open RJ6 phone coupler ends with butyl tape and rescue tape to seal it from moisture.

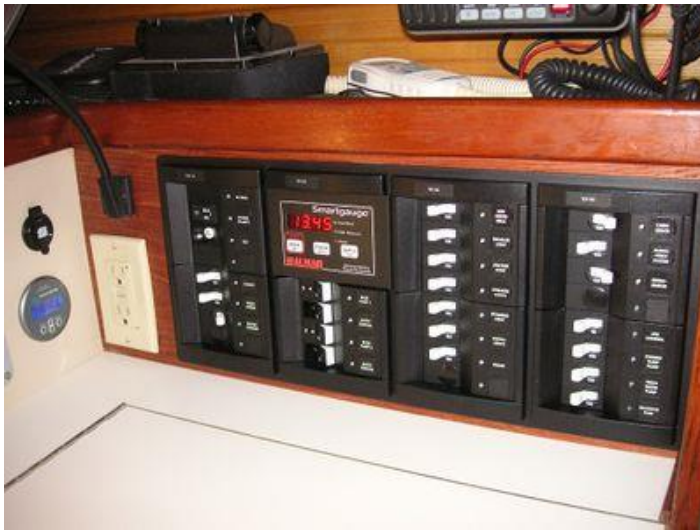
Photo (45) shows the Navigation Station with the new Blue Sea 360 Main Distribution Panel installed. The AC power is on the left side of the panel with a new ELCI 30A double pole main breaker, separate outlet, water heater, and AC battery charger breakers, plus two spares. Moving to the right is the SmartGauge battery monitor located above the bilge pump restricted off and manual on breakers, the right two columns are the 14 DC breakers plus 2 spares. One of the spares will be used for the future auto-pilot. Photo (46) shows the BMV-700 battery monitor and the 12VDC outlet that are installed on the bulkhead shared with the hanging locker, and to the left of the GFCI outlet.

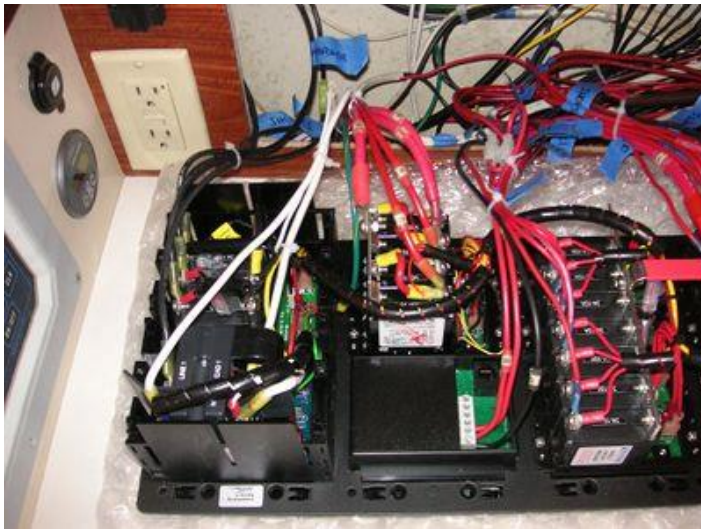
In photos (48) and (49), more breakers means more wires connecting to the main panel, but the organization of the wiring has been improved from the original.

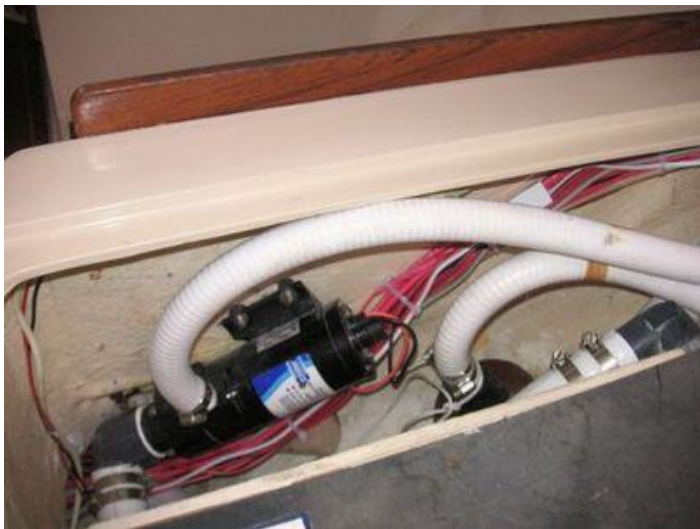
Here in photo (50) you see the wire bundle going by the macerator pump and motor up to the main distribution panel higher than before to get them off the hull and out of the way.

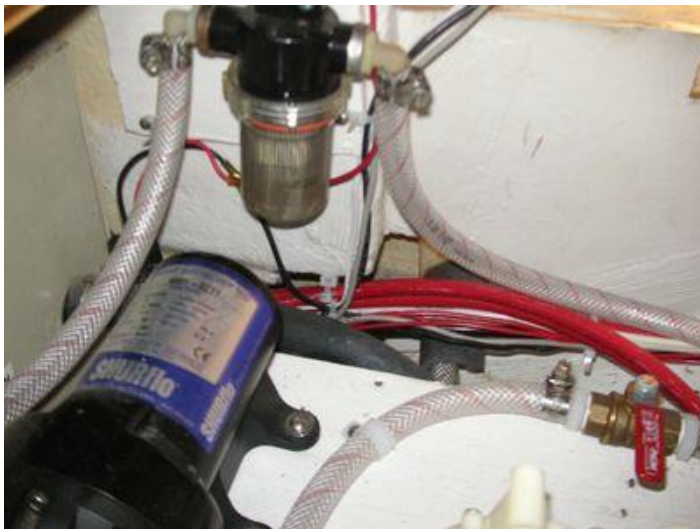
In photo (59) you can see I added insulation foam for $\frac{3}{4}$ " pipe on the water tank hose and band clamp to protect the cables and wires from chafing.

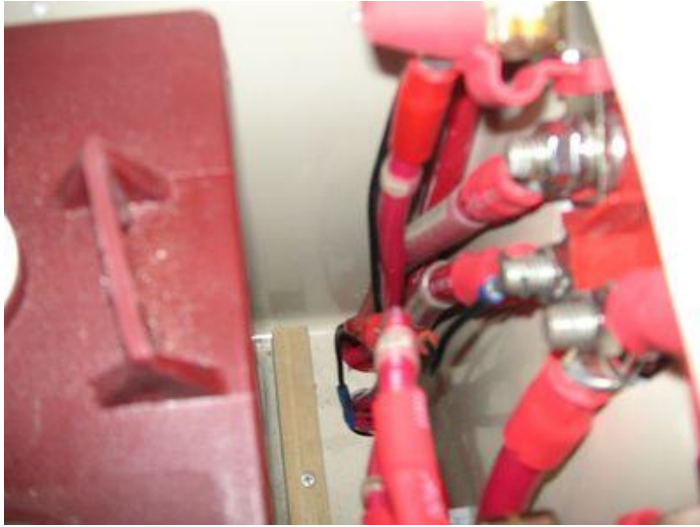
Photo (62) shows the cables entering the bottom of the battery box thru the larger of the two existing holes and connecting to the back of the 1-2-Both battery selector switch in the battery box, the “always on” busbar, and the house battery bank. Remember I said I was glad there were two holes? This is why, it is big stuff.

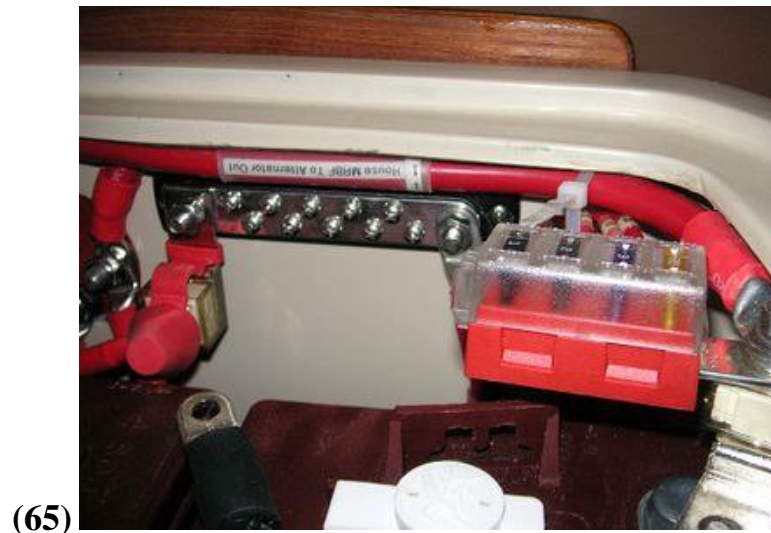
In photo (65), you see the end of the Blue Sea 5024 fuse block discussed in the House Battery section.

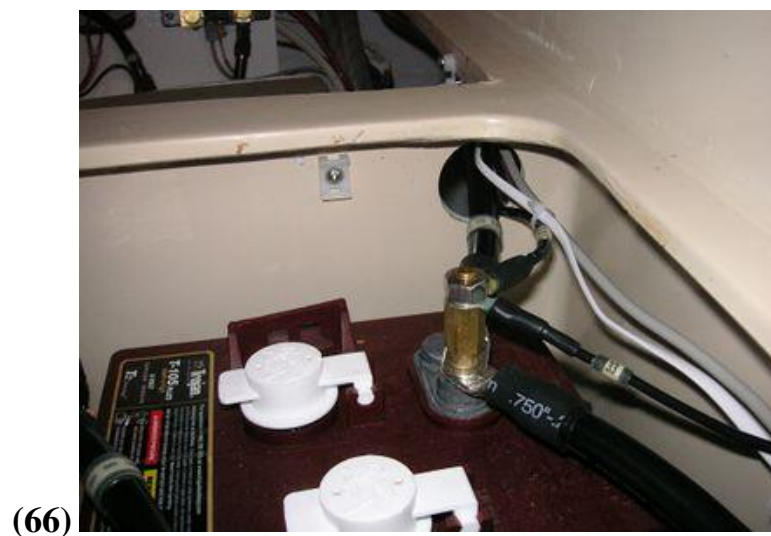
Looking at the bulkhead between the battery box and water tank in photo (66), you see the 1 AWG negative leaving battery #4 and going to the shunt through the hole in the battery box. Also visible are the temperature sense wires from the AC battery charger, and from the Balmar external voltage regulator. I separated most of the positive wires from the negative wires by running the positive's into the battery box through the two bottom holes shown earlier, and the negatives and temperature sense wires running through this hole at the top of the other end of the battery box near the water tank. I was only comfortable connecting two wires or cables to a battery post, so I purchased the extension from the battery supply house for ~ \$5. In photo (67), the 1AWG negative leaves the battery box and runs under the lip that the outboard salon cushion wood cover sits on.

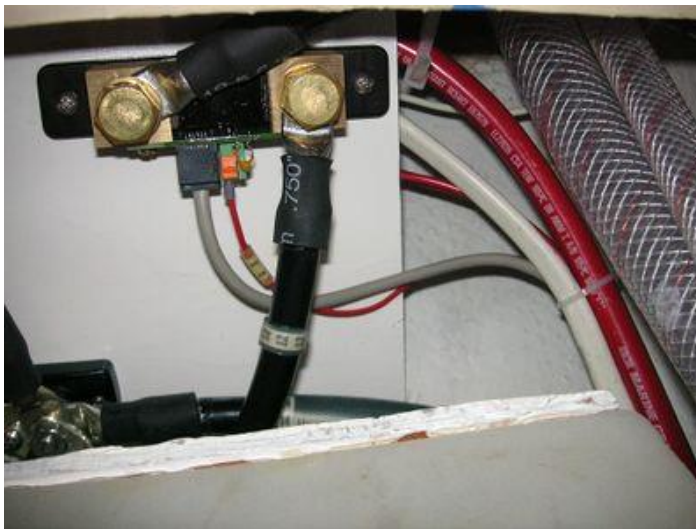
(68)

That same cable then connects to the left bolt on the BMV-700 shunt attached to the breadboard as shown in photo (68).

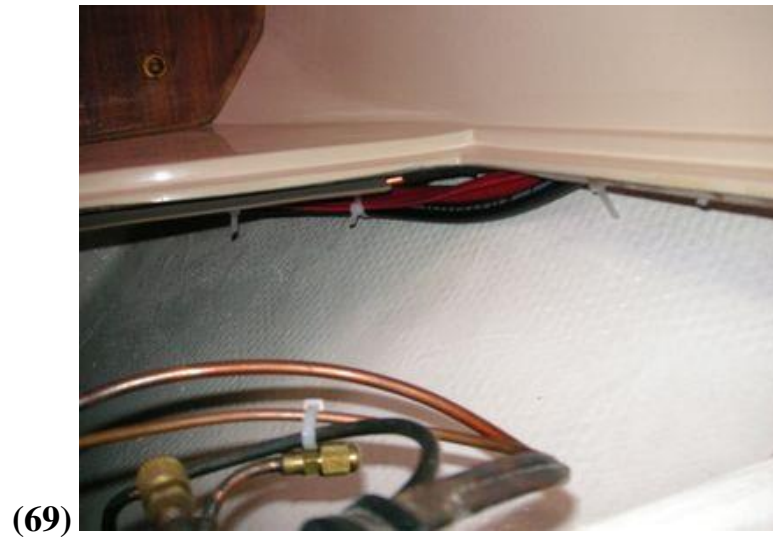
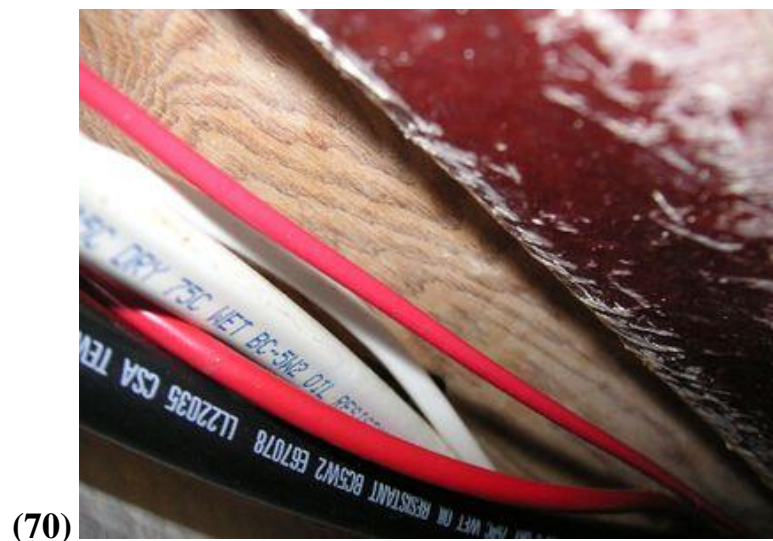
Photo (69) shows the positive and negative cables running to the reserve battery from the Digital Echo Charge, the SmartGauge, the 1-2-Both battery selector switch position #2, and from the house bank negative busbar. The shiny bit you see is the refrigeration line. To protect the refrigeration lines in case there is a gas leak from the maintenance free battery, I covered it with the material used to cover wires on the floor so you don't trip. Photo (70) shows the wires and cables from the reserve battery, Digital Echo Charge, and the SmartGauge running underneath the storage cubby holes behind the outboard salon seat cushion. The white Nomex is the existing DC wiring for the refrigerator compressor and fan. The wood you see is glassed in and is part of the boat. It wasn't added by me for this project.

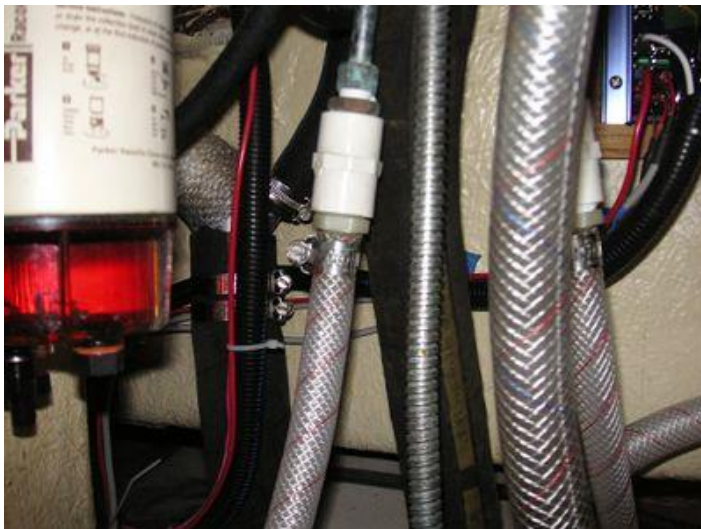
Photos (72) and (73) show the external regulator wiring under the head sink in the split loom, then is runs along the engine compartment bulkhead under the Racor filter.

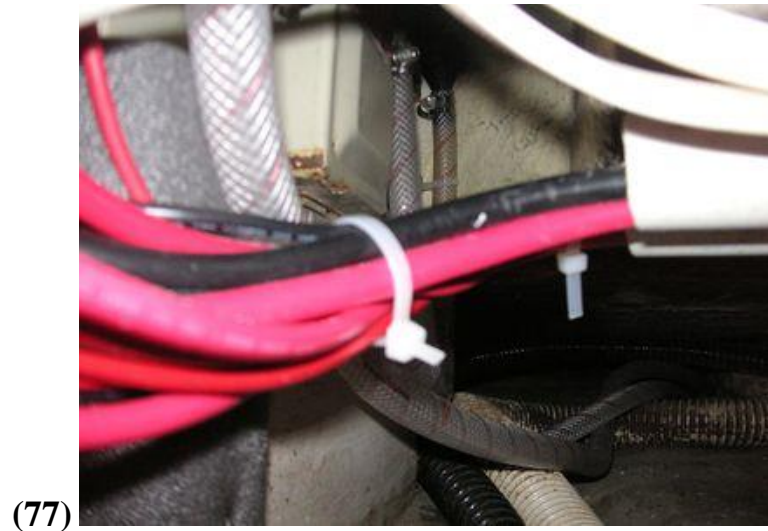
Photo (77) is where they cross over above the bilge. The hoses lying on the hull are for the hot and cold water to the head and the existing manual and electric bilge pumps.

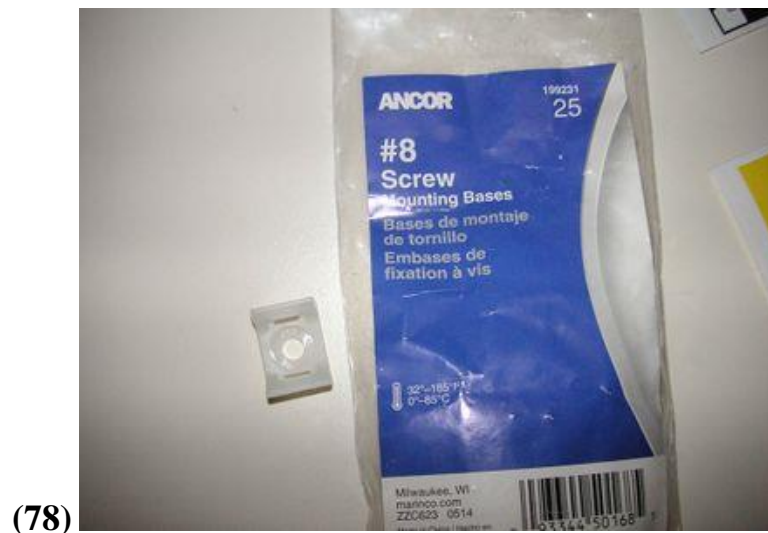
Lots of wire ties are used throughout to secure the wire and cable. A great fitting I used is #8 mounting bases; Ancor part # 199231 from West Marine shown in photo (78). Drill a hole for a #8 screw, screw it in, slip the wire tie through the slots, wrap around the wire/cable and tighten. Very secure. A valuable tool to have is a 90 degree drill. I didn't have one, so bought the 90 degree adaptor shown in photo (79) from Harbor Freight for ~\$20 before shipping and handling. It's a light duty tool, but worked well to get into tight areas to drill holes I wasn't able to without it.
