1987 MK 1 Catalina 34 Part Manual Storage

By Jon Windt; s/v Della Jean

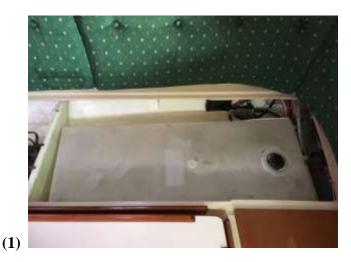
I purchased my 1987 MK 1 Catalina 34, hull #493 in April 2015. A great boat, but usable storage from the factory is limited. I have parts manuals I want to keep on the boat, but needed a place to store them. The top of the starboard water tank under the sette, has enough empty space. Putting them here they would be easy to get to, but out of the way of day to day activities. See Photo (1).

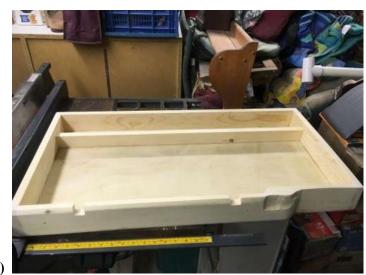
In Photo (2) of the inboard edge of the storage bin where you can see two notches, a shaped recess area, and a jog. The notches are to give clearance to the screws holding the Teak trim the table rests in when lowered into a double berth. The shaped recess area is to give clearance to uneven surfaces in the fiberglass, and the jog is to step around the battery compartment. A lot more creative sanding and shaping than I originally thought.

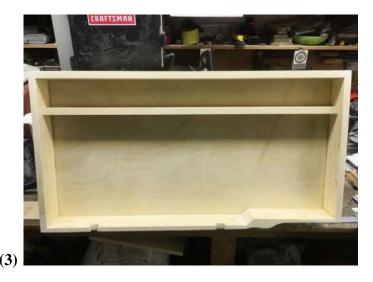
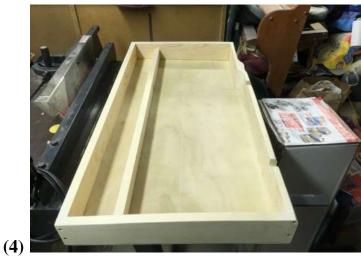
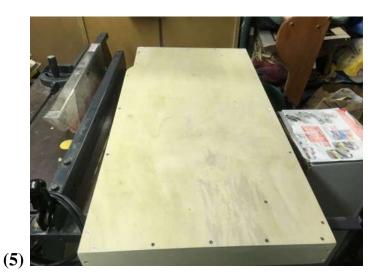
The length and width dimension of the storage are 34" length x 18" wide. The depth varies from $3\frac{1}{2}$ " on the inboard side to 3" on the outboard side to maximize storage but still fit under the lip for the lid. The small section will be for the paper charts, and is $3\frac{1}{16}$ " wide. The sides and paper chart partition are made from 1x5" pine boards. The bottom is made from the 1/4" plywood.

Photos (3), (4), and (5) show the different views of the unpainted storage bin.

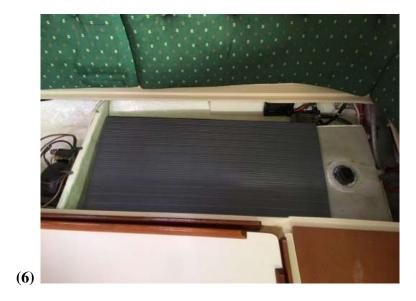
Mounting the storage shelf was straight forward. To avoid chafe wearing a hole in the top of the water tank over time, I put a gray foam pad between the tank and the storage bin. See Photo (6)

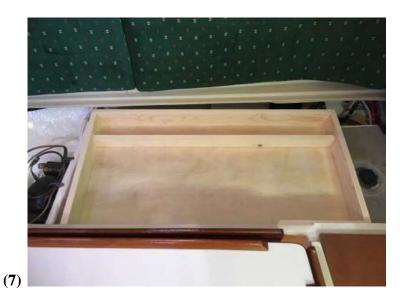
Photo (7) shows the storage bin installed on top of the foam pad and water tank. The top surface of the storage bin is below the recessed lip the cover for the water tank access lid rests on. The black circle on the right of the storage bin is the access plug into the water tank.

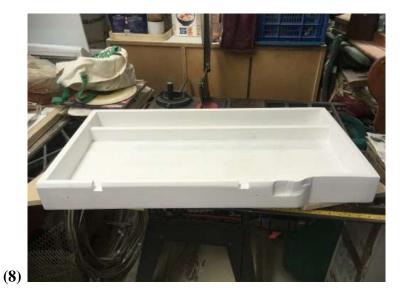
With the test fit complete and adjustments made, I applied a coat of Kilz brand white primer. See Photo (8).

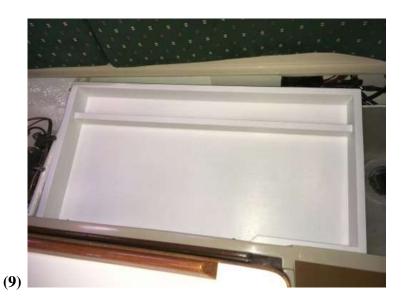
Photo (9) shows the final assembly painted with interior/exterior semi gloss enamel paint and installed on top of the water tank with the foam pad in between the tank and the storage bin. The storage bin is fastened to the boat using two #10-24 x 1 ½ long Truss head SST screws, washers and Nyloc nuts through the sette's vertical bulkhead just below the Teak trim.

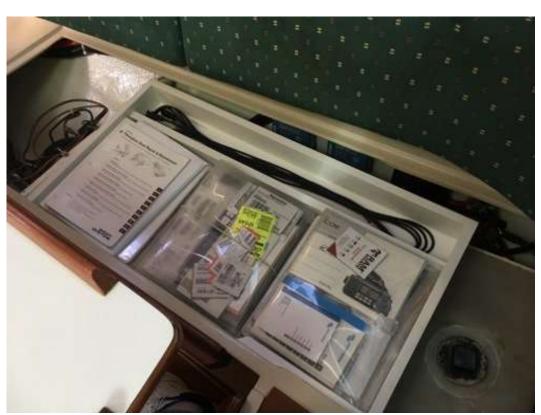
Photo (10) shows the final assembly filled with one large and one standard size 3 ring notebook, two clear 8 ½ x 11" folders full of more parts manuals, and an extension cable for my ICOM CommandMic. In the gap under the back cushion and between the new storage bin and the liner of the sette you can see a black box and two blue boxes mounted to a vertical piece of wood. The black box is the Digital Echo charger for my reserve battery, and the two blue boxes are the Victron Energy MPPT charge controllers for the two solar panels I just added in 2020. When I do routine system checks, I check that the lights are on so it's important that they continue to be visible without moving or removing anything. In the photo you can barely see that the green status light of the Digital Echo Charger is visible above the top edge of the storage bin with the storage bin fastened in place.

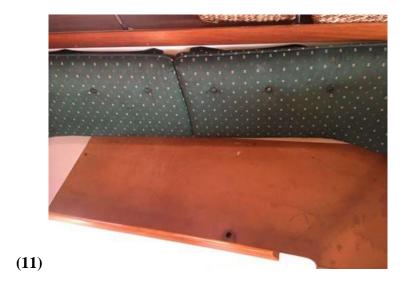
The last photo of this project is photo (11) showing the original lid reinstalled before putting the cushions back in place.
