1987 MK 1 Catalina 34 Electrical System Upgrade

By Jon Windt; s/v Della Jean

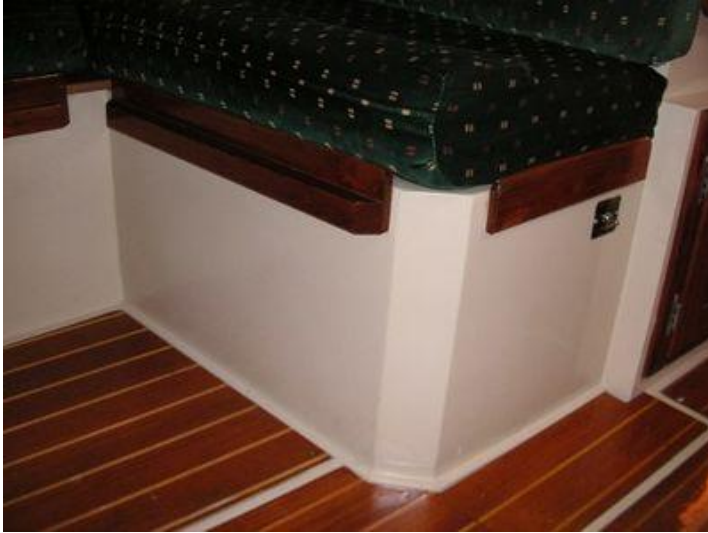
Photo (3) is the outside of the OEM battery compartment showing no ventilation openings. The switch in the upper right inboard side of the battery compartment is where the auto/on/off bilge pump switch was originally located. Photo (4) shows the original 2x Group 24 batteries, the 2 busbars, a Power Pulse battery maintenance widget, and a shunt for the Link 10 inside the battery compartment.

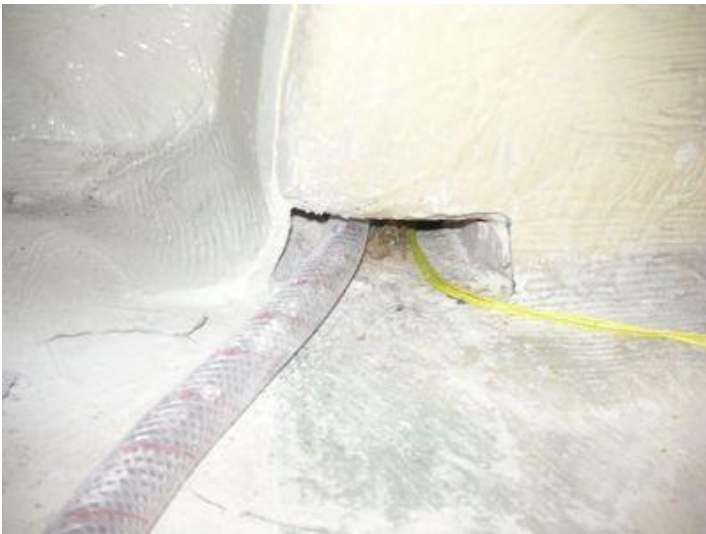
Barely visible in photo (16) is a dark clump of old adhesive sitting in the opening to the right of the aft tank water supply hose. It appeared to be excess adhesive for the conduit from the original build of the boat. A light tap with a screwdriver removed it, and now the path is clear to pass the 1 AWG cables through. The yellow strings are messenger lines to pull new cable. **However**, I found that I could reroute the hot and cold water hoses to the head sink between the manual bilge pump hose and the shower drain hose and reuse the now unused holes in the engine compartment to run the #1, 5, and 14 cables. See photos 55-57 for more clarity. This pass through from under the aft cabin to the galley will be used for my electric 1 1/8" bilge pump hose.

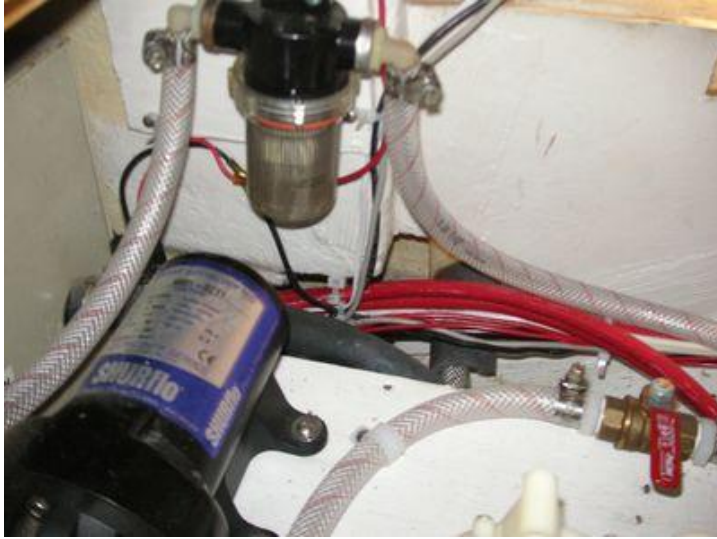
In photo (58) you can see I added insulation foam for 3/4" pipe on the water tank hose and band clamp to protect the cables and wires from chafing.

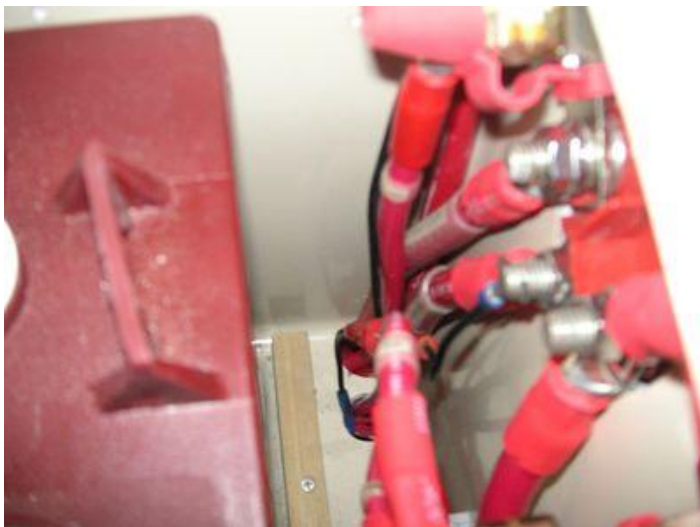
Photo (61) shows the cables entering the bottom of the battery box thru the larger of the two existing holes and connecting to the back of the 1-2-Both battery selector switch in the battery box, the “always on” busbar, and the house battery bank. Remember I said I was glad there were two holes? This is why, it is big stuff. *NOTE: although the battery selector switch posts extended into the battery compartment, the back of the switch was slightly recessed so I was not able to tighten down the cables. Adding a SST washer to each post allowed me to tighten each post and get full contact as required.*

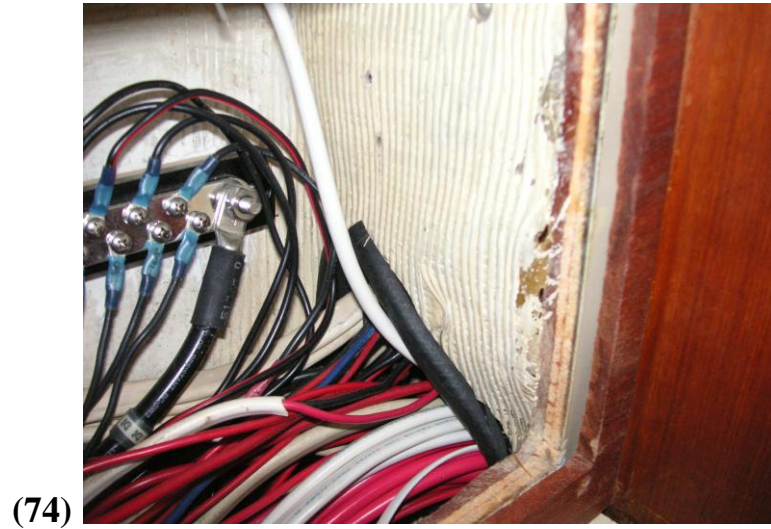
Finally photos of the wires running from behind the Main Distribution Panel, to the battery box area. Photo (74) shows the bundle exiting from behind the Main Distribution Panel with a chafe guard I made from some extra fuel hose, and photo (75) shows where they pass under the macerator pump/motor and pick up the external regulator wires.

REVISION B – 10-11-2016 Section 10 was revised to change photo #74 to show the chafe guard I made from spare fuel hose used to protect wires passing through the bulkhead behind the Main Distribution Panel. The schematic and cable ID #'s are unchanged.
