1987 MK 1 Catalina 34 Adding A 2nd Electric Bilge Pump

By Jon Windt; s/v Della Jean

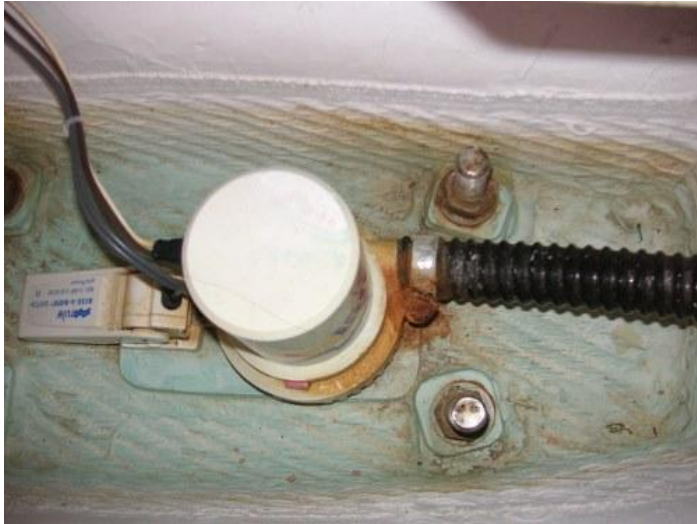
Photo (1) is the existing Rule 1500 pump and switch mounted on an ~ 5/16" raised surface glassed into the bottom of the bilge. Notice the severely rusted hose clamp. I was not able to loosen it so used my Dremel tool to cut the metal band to remove it. Photo (2) is the aft most bilge section. The 1 1/8" hose for the Rule 1500 and one of the in line check valves ran along the bottom of the bilge and through a ~2" hole in the port to starboard stringer to attach to the pump located in the center bilge section. Also in this bilge section is the end of 1 1/2" manual bilge pump hose. It had a screen tie wrapped over the end to keep debris from being drawn into the hose and eventually the pump. The screen was torn and the hose clamp for the in-line check valve was rusted.

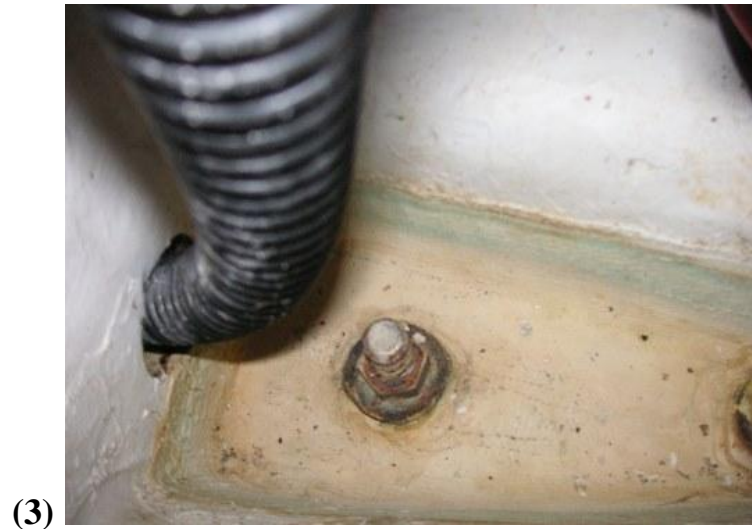
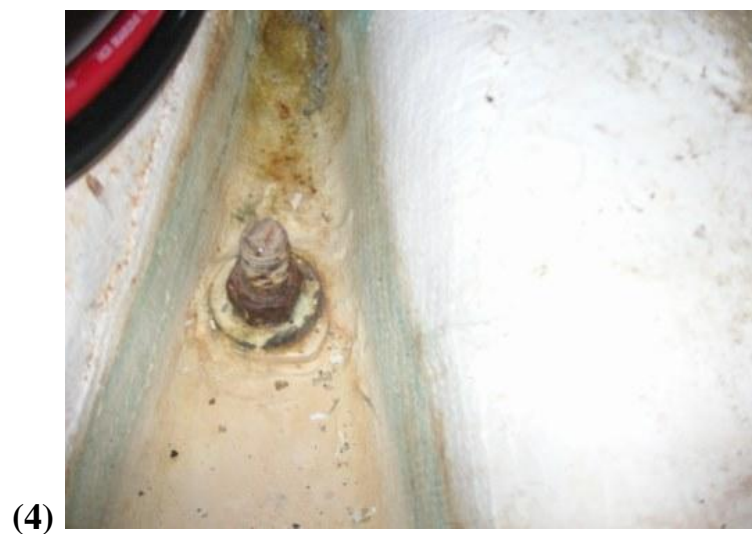
Photo (3) is the 1st keel bolt in the aft bilge section with the bilge hoses moved out of the way. Photo (4) is the 2nd keel bolt in the aft bilge section also with the bilge hoses moved out of the way. Both showed quite a bit of corrosion from the standing water that **used** to sit in this section. One of my first upgrades was to install a SST propeller shaft and change the packing gland material to a Gortex product. Now this section remains dry. Later in this write up are photos after I cleaned all the keel bolts With Davis brand FSR.

As I mentioned earlier in the description, the keel bolts were very corroded in the aft section of the bilge due to the standing water that used to always be there. I used a product called FSR from Davis to clean them up. Photos (14) and (15) show the results. Not like new, but a lot better.

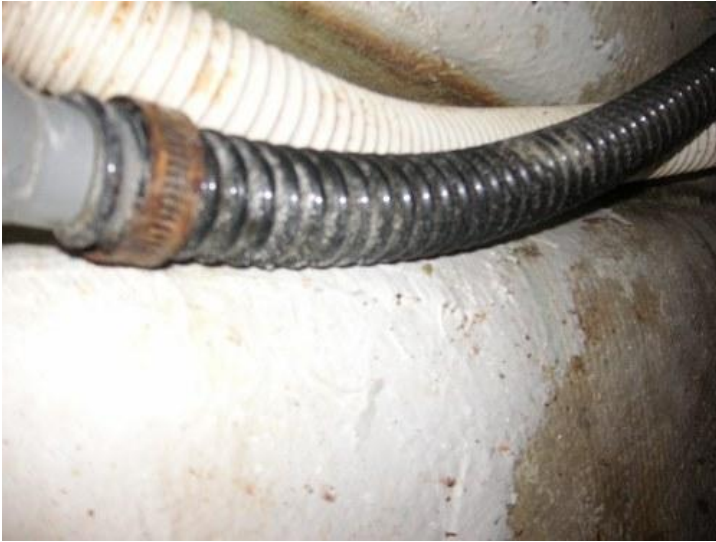
Photo (5) is the same bilge section but farther aft under the subfloor showing another rusted hose clamp on the 1 1/8" bilge hose. I point these out because this is the primary bilge pump system that could fail, even with a good pump and switch. I suggest you look at your bilge hoses and clamps, even if not planning to change anything.

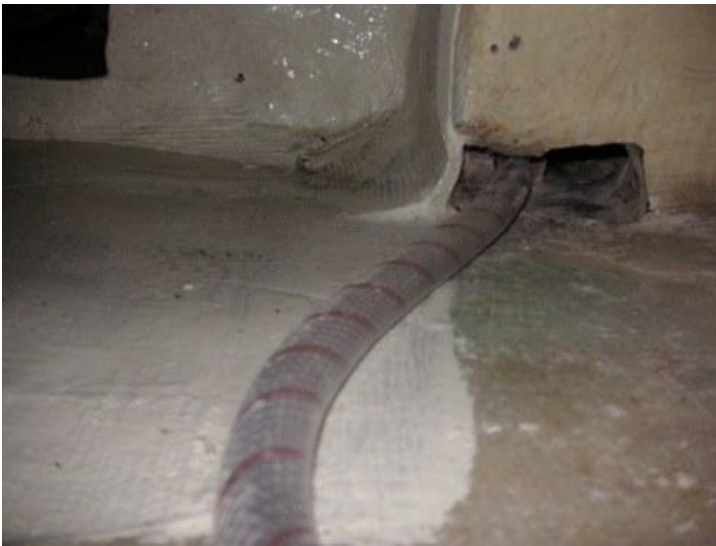
Photo (6) is under the aft cabin on the starboard side. The hose shown is the 1/2" fresh water supply line from the aft water tank going to the galley sink area where it connects into the main fresh water line with the starboard water tank prior to the fresh water pump. Previously I had run the starter, alternator out, and main negative cables through this opening. I found a way to route those cables more directly to the engine compartment. See photo (7). This routing change is both better electrically, and it gets the hot and cold fresh water hoses to the head sink out of the engine compartment which then frees up this opening to run the 1 1/8" bilge hose for the Rule 1500.

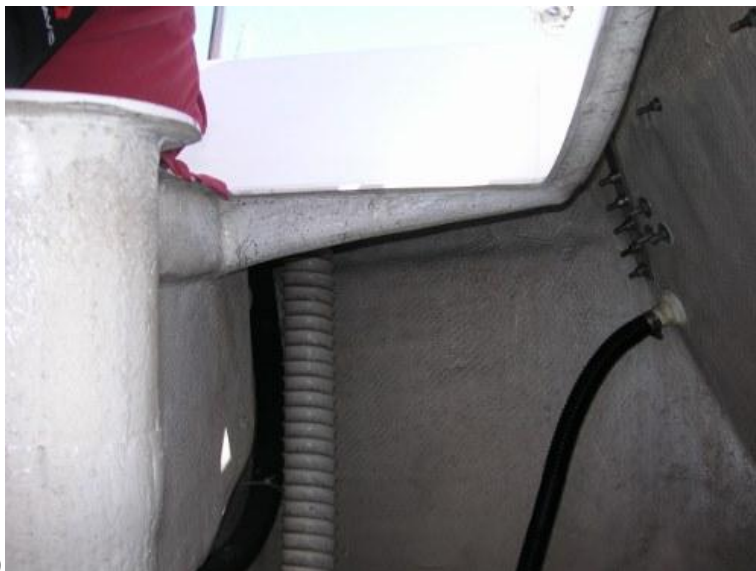
Photo (8) shows the thru hull for the 1 1/8" bilge hose. The thru hull is located high on the starboard side of the transom near the split back stay chain plate.

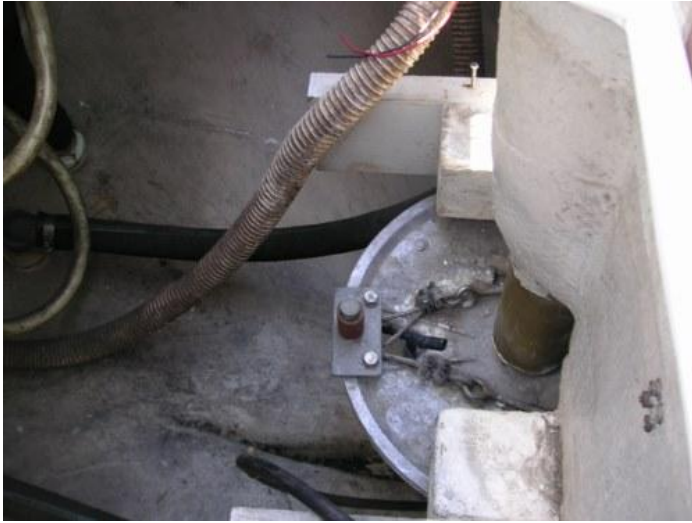
Photo (9) shows the manual bilge pump hose in the aft lazarette with the propane locker and shelf protecting the radial removed. The manual bilge hose discharge thru hull is very low on the transoms centerline just barely out of the photo. The two light colored hoses are the vent lines from the propane locker moved out of the way to get in this area to work.

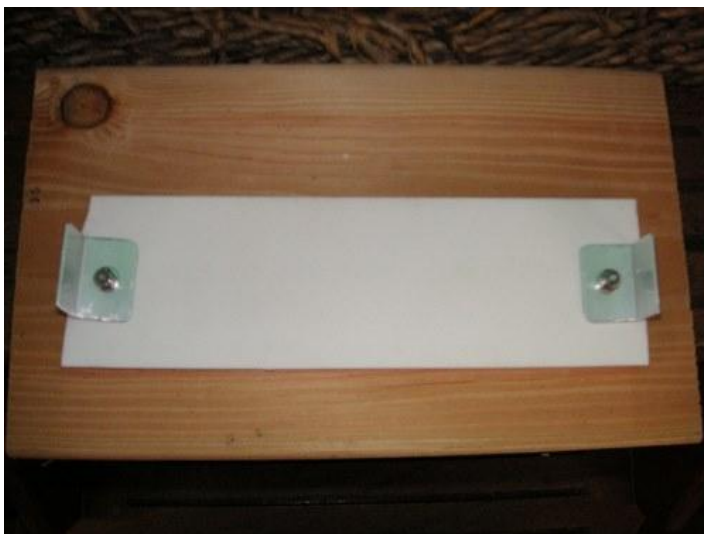
Photo (10) shows an example of the aluminum angle mounting method ready to be bonded into the bilge. To bond the aluminum angles to the bilge, I used West Systems 610 to epoxy. This is the float switch shelf with the aluminum angle fastened with SST #8 pan head machine screws, washers, and nyloc lock nuts at each end. The shelf is upside down to show the angles.

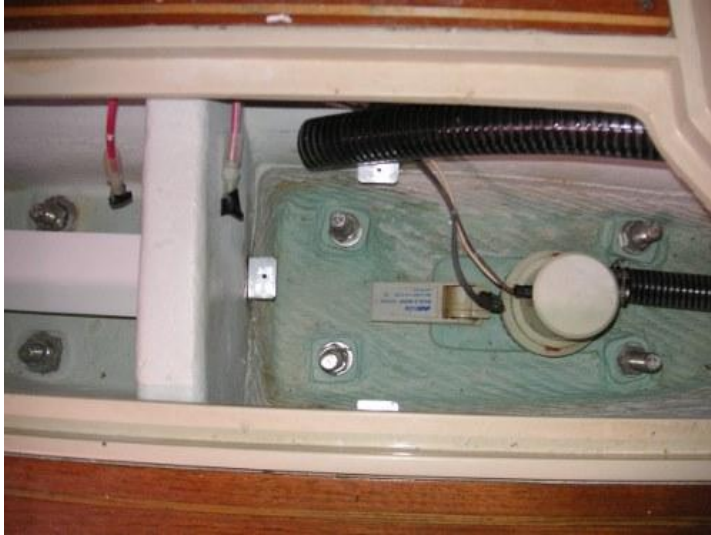
I then used each shelf to hold the angles snug against the bilge while the epoxy cured. This method also helped ensure the shelf was flat and at the right height in the bilge. Photo (11) shows the new float switch shelf installed in the bilge section just aft of the mast step, and the 3 aluminum angles to mount the new pump shelf over the keel bolts and Rule 1500 float switch in the center bilge section. The pump shelf was removed for clarity.

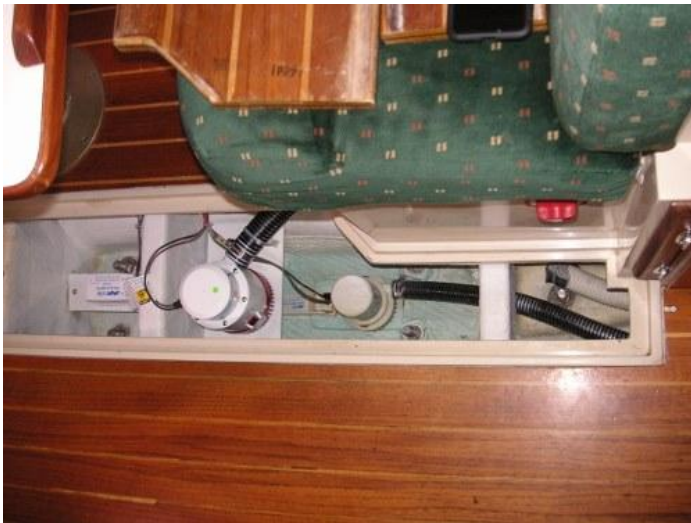
Photo (12) shows the new 2 electric pump bilge system with wires and hoses connected. Photo (13) is a closer view of the installed pumps. The 3700 1 1/2" bilge hose has a tie wrap attaching it to the shelf to pull it down to get a straight run to the pump connection.

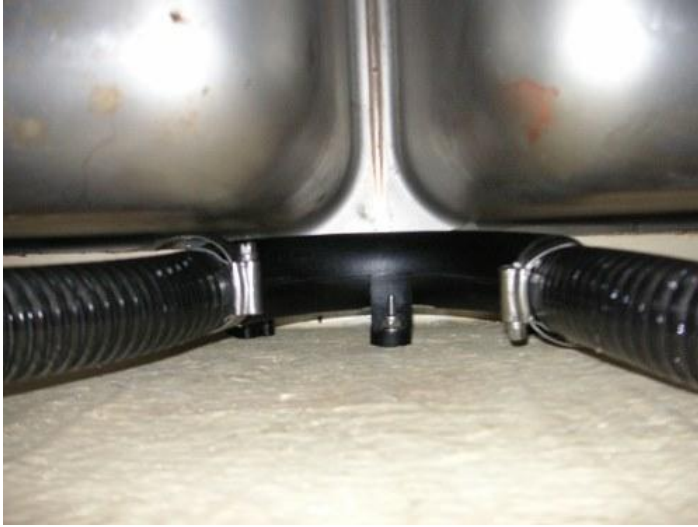
Photo (16) is a view from underneath the galley sink looking up to see the newly installed 1 1/8" vented loop and connecting to/from bilge hoses. The vented loop is up as high as it can go and still leave a small air gap between the top of the loop and the underside of the wood support for the galley countertop. I used my 90 degree drill adaptor to drill a hole for a #8 truss head SST screw to fasten the vented loop with a SST nyloc nut to the bulkhead. Photo (17) shows the screw head visible from the outside of the sink cabinet.

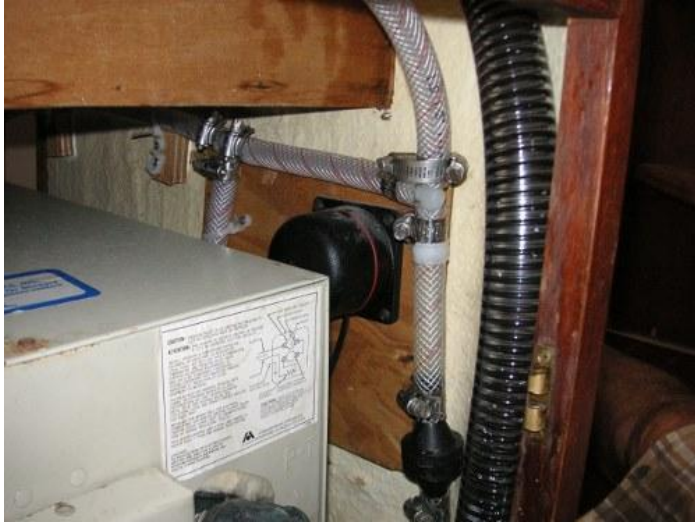
Photo (18) shows the 1 1/8" bilge hose running up the galley sink bulkhead from the Rule 1500 pump, over the sink drawer frame to the vented loop. Photo (19) shows the 1 1/8" bilge hose after the vented loop running down the galley sink bulkhead on the other side of the drawer frame to pass underneath the galley floor on its way to the area underneath the aft cabin.

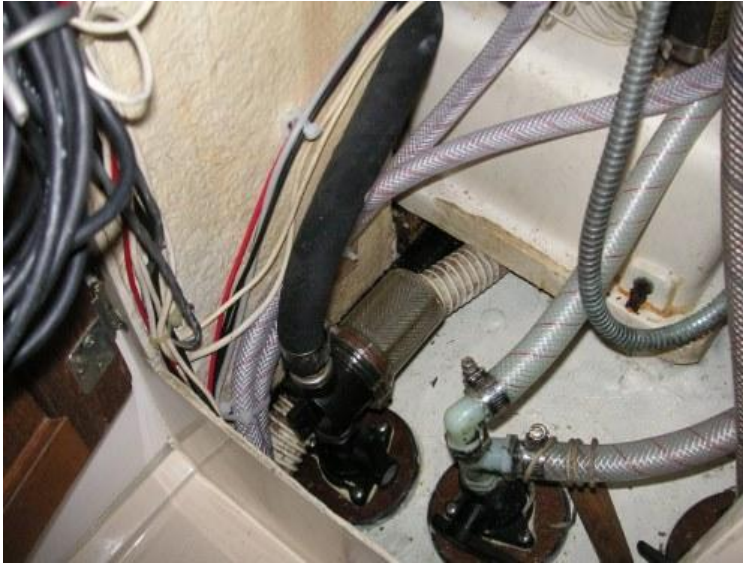
In photo (20) you can see the white manual bilge 1 1/2" pump hose. Tucked behind it is the Rule 3700 1 1/2" bilge pump hose. Previously the manual 1 1/2" and Rule 1500 bilge pump 1 1/8" hoses ran through this area making access to the raw water and head sea water sea cock handles awkward to open and close. This arrangement makes access very easy. In the lower left corner of the photo you can see the hot & cold fresh water supply hoses going to the head sink from the galley sink that I rerouted out of the engine compartment.

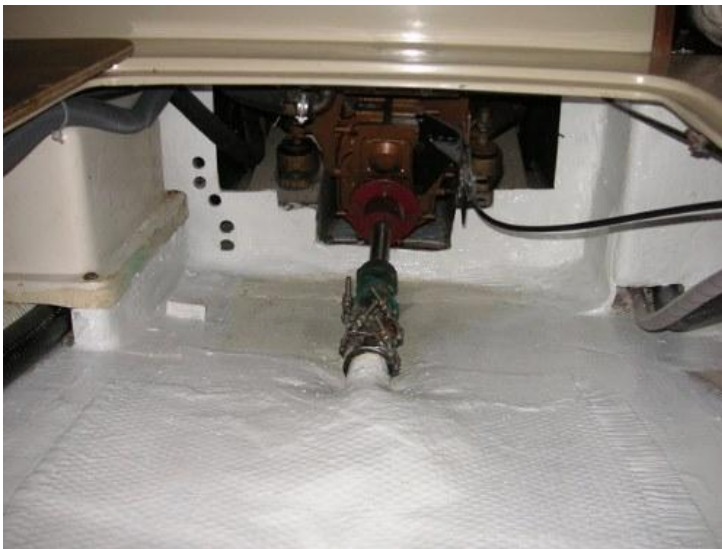
Photo (21) is taken underneath the aft cabin with the mattress and wood cover removed. The air vent lines are moved out of the way for clarity. The left side of the photo you can see the 1 1/2" bilge hoses running underneath the Aqualift muffler. It is a snug fit, but they both fit without putting pressure on the muffler. On the right side of the photo you see the 1/2" fresh water supply hose from the aft tank and the 1 1/8" bilge pump hose from the galley sink area.

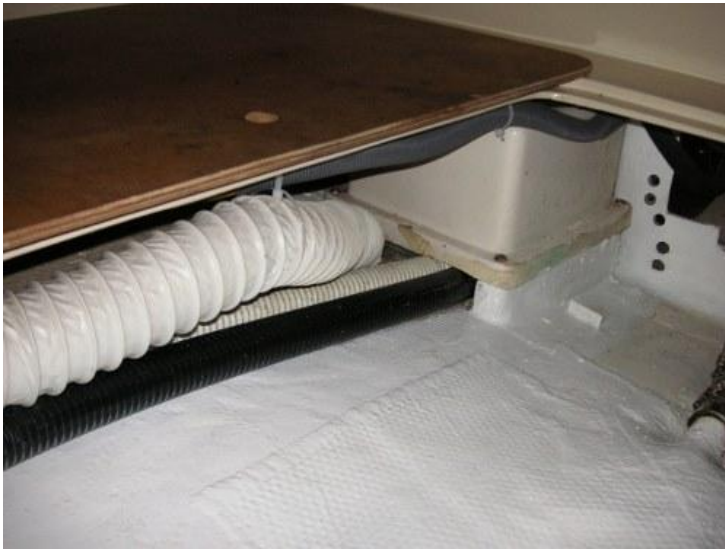
Photo (22) is a closer view of the 1 1/2" hoses passing under the Aqualift muffler.

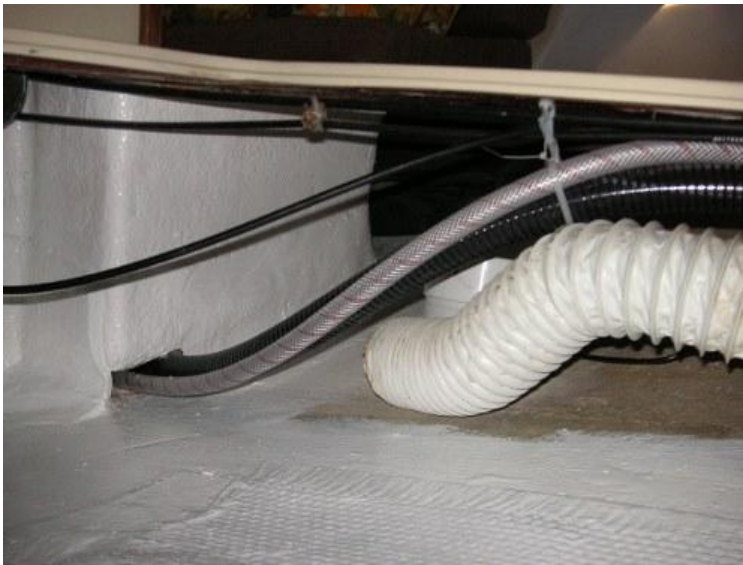
Photo (23) is a closer view of the water supply hose and the 1 1/8" bilge pump hose.

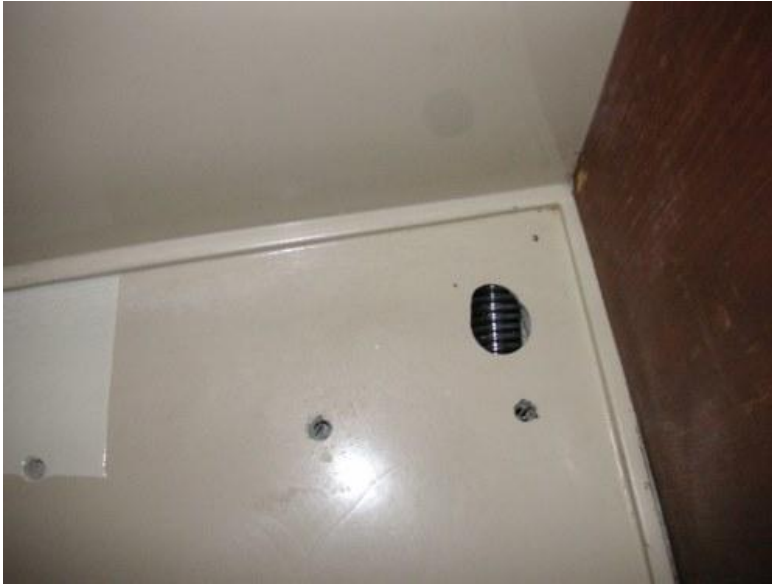
Photo (24) shows a hole I needed to drill into the subfloor. It is in the corner where the fiberglass bulkhead before the aft cabin mattress and the teak engine compartment bulkhead meet. The hole was needed because the area under the sub-floor needed some grinding to enable the 1 1/8" hose to slide through.

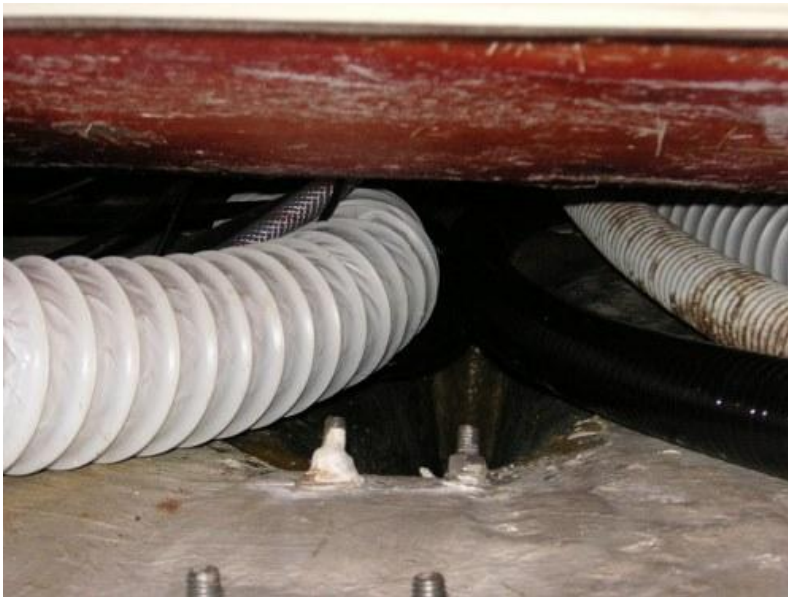
Photo (25) shows the bilge pump hoses, and the large air vent hoses passing from under the aft cabin to the aft lazarette under the aft water tank.

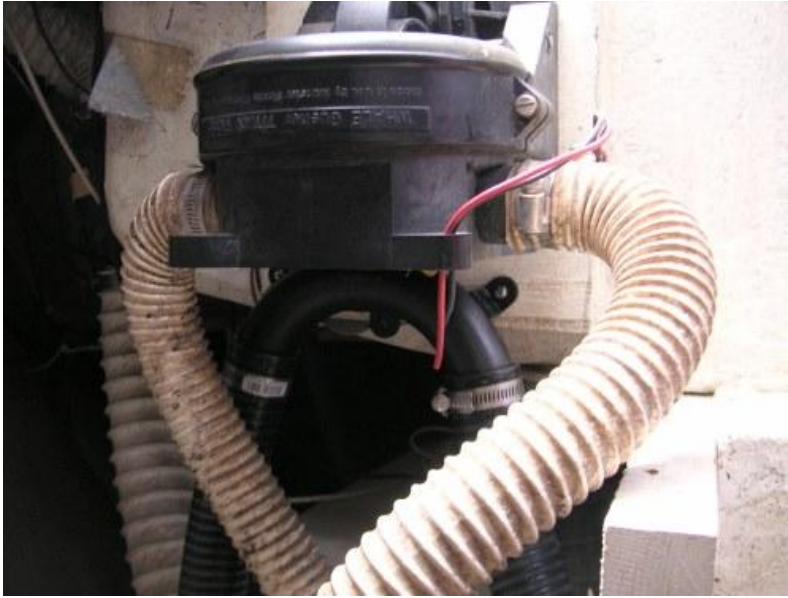
(26)

After the hoses leave the aft cabin and enter the aft lazarette they run port and starboard. In photo (26), the 1 1/2" bilge hoses run port and connect to the manual Whale pump and the new 1 1/2" vented loop I added just behind the Whale pump. 4.

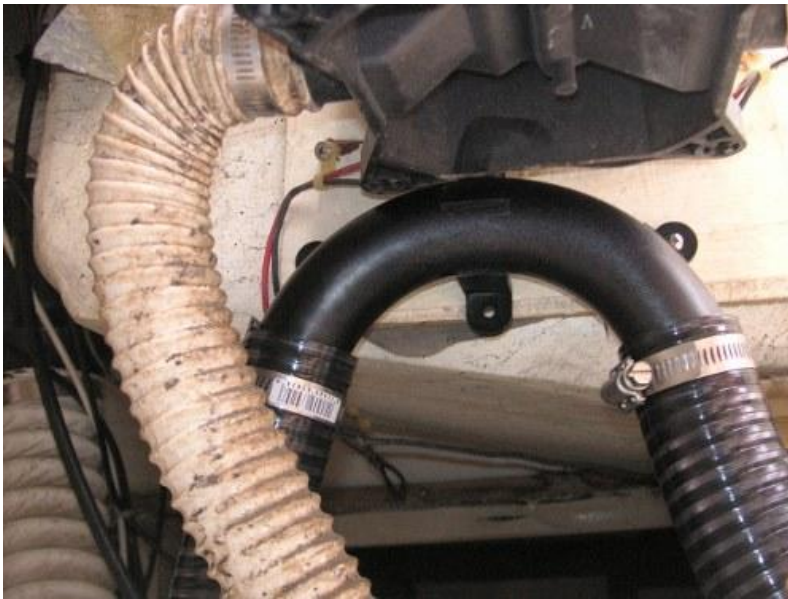
Photo (27) is a closer view of the installed 1 1/2" vented loop.

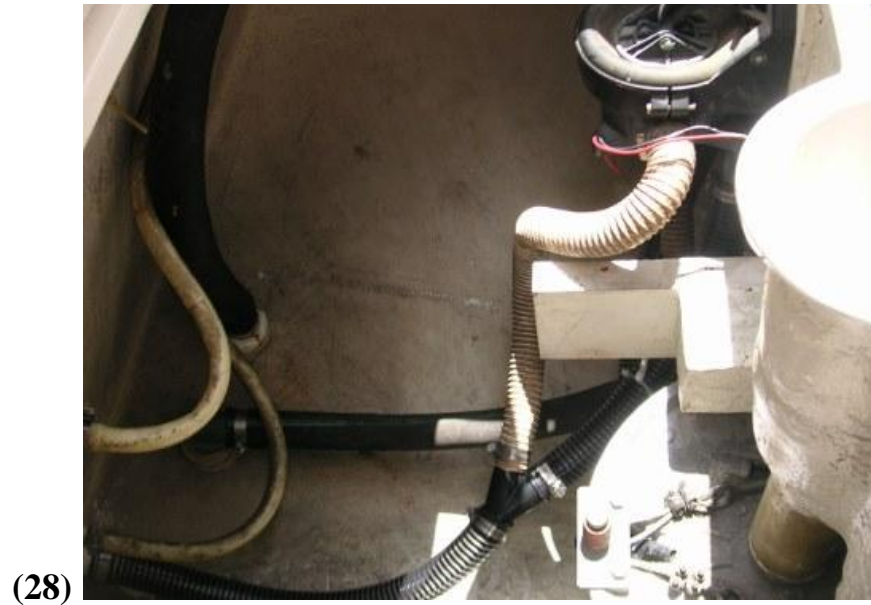
Photo (28) shows the Whale manual and new Rule 3700 electric bilge pump discharge hoses tied together and connecting to the 1 1/2" thru hull at the bottom of the transom they both now share.

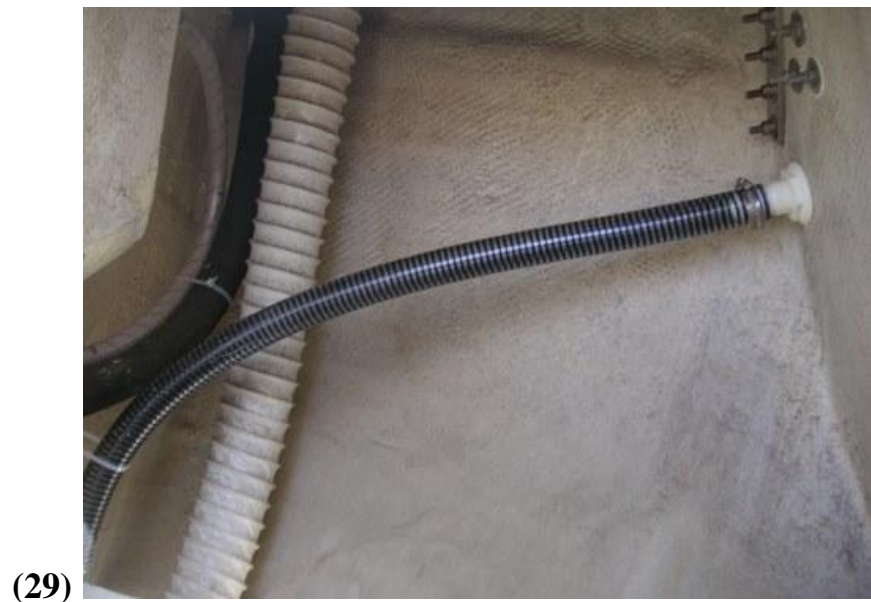
In photo (29), the 1 1/8" bilge hose from the Rule 1500 runs to starboard and connects high on the transom near the backstay chain plate. When I tested the system, water shot straight out of the thru hull approximately 6 inches beyond the transom.

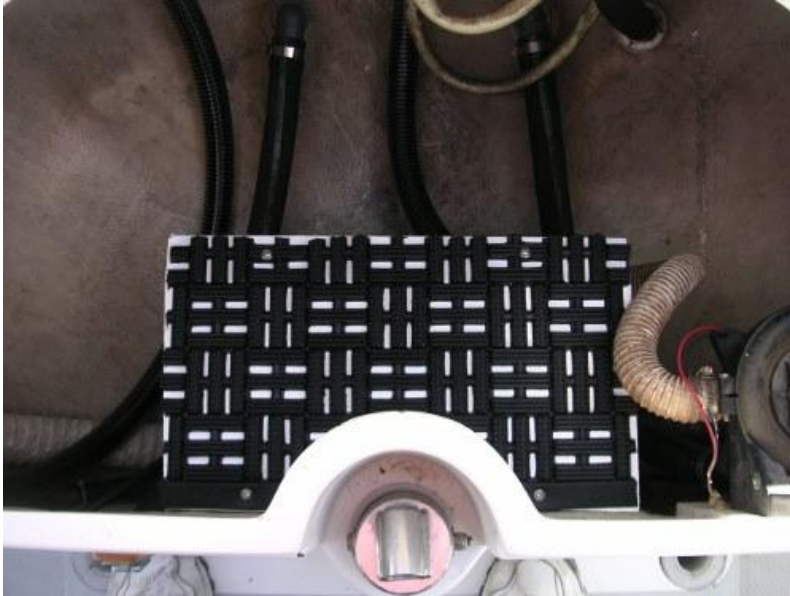
Photo (30) is of the wood cover in the aft lazarette protecting the radial from damage. I removed the propane locker and installed a non skid mat so this can be used as a step to get into the lazarette easier. I will be making a new propane locker to hold one 11# tank for the galley and one 5# tank for the BBQ. I will be installing it in the aft lazarette on the starboard side as my next project.

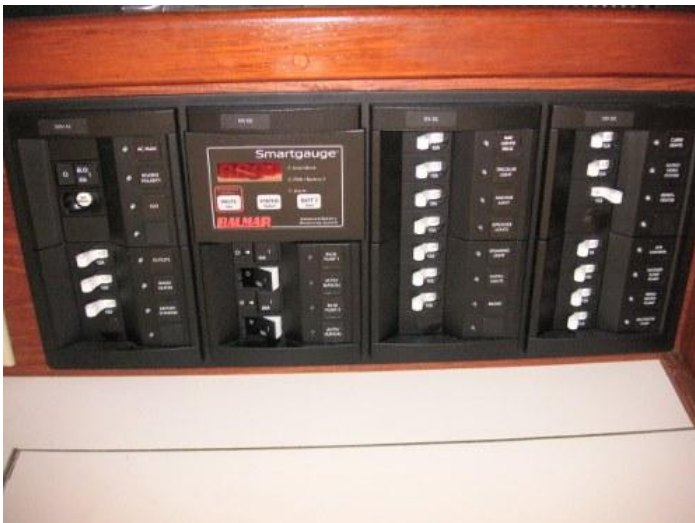
Photo (31) shows the Main Distribution Panel with both bilge pump breakers turned on. The bilge pump breakers are directly below the Smartgauge battery monitor. The Rule 1500 on/off/Auto breaker is first and the Rule 3700 on/off/Auto breaker is second. The Rule 1500 is labeled “Bilge Pump 1” and has a 10A breaker. The Rule 3700 is labeled “Bilge Pump 2” and has a 25A breaker.
